# The Determination of Deteriorations on The Mısırlıoğlu Bridge (Konya, Turkey) by Non-Destructive Techniques (NDT)

**Keywords:** Deterioration, Konya, Mısırlıoğlu Bridge, non-destructive tests (NDT), Sille

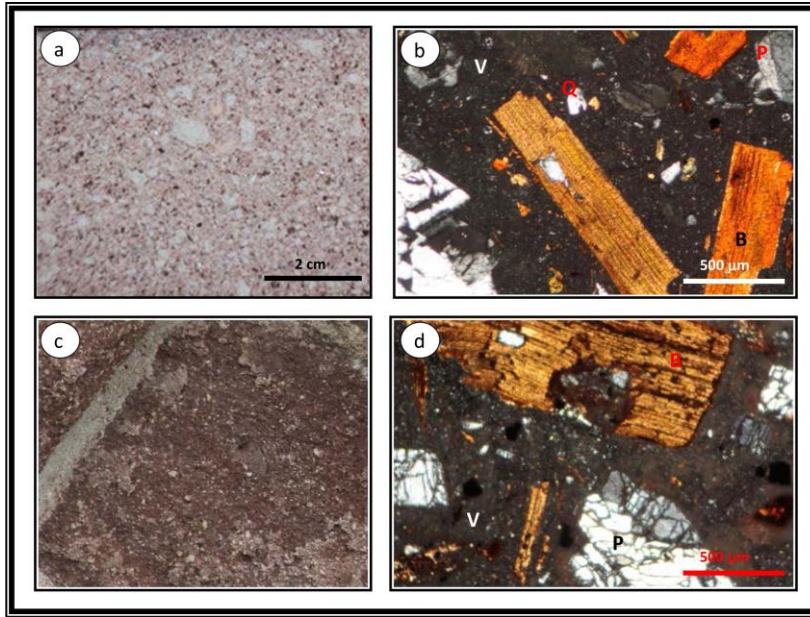
Sille stone has a light-dark pink colour, and the rocks have aphanitic porphyritic textures in macro samples (Figure 2a, c). In the polarized microscopy of the fresh samples of Sille stone taken from the quarry and the decomposed samples taken from the bridge, 29% plagioclase, 26% volcanic glass, 19% biotite, 17% plagioclase microlite, 8% quartzite, and 1% opaque mineral were observed (Figure 2b, d). The geochemical composition of both fresh and decomposed samples is presented in Table 1. According to the TAS diagram proposed by Le Bas, Le Maitre, Streckeisen, and Zanettin (1986), the samples are named as dacite (Figure 3). Thin section examination and geochemical data of the samples exhibit similar characteristics. According to the obtained data, this bridge is made of Sille stone.

**Figure 2.** Macroscopic image of samples a) fresh, c) deterioration, microscopic image of samples b) fresh, d) deterioration (crossed polars)(P:plagioclase,B:biotite,V:volcanic glass, Q: quartzite).

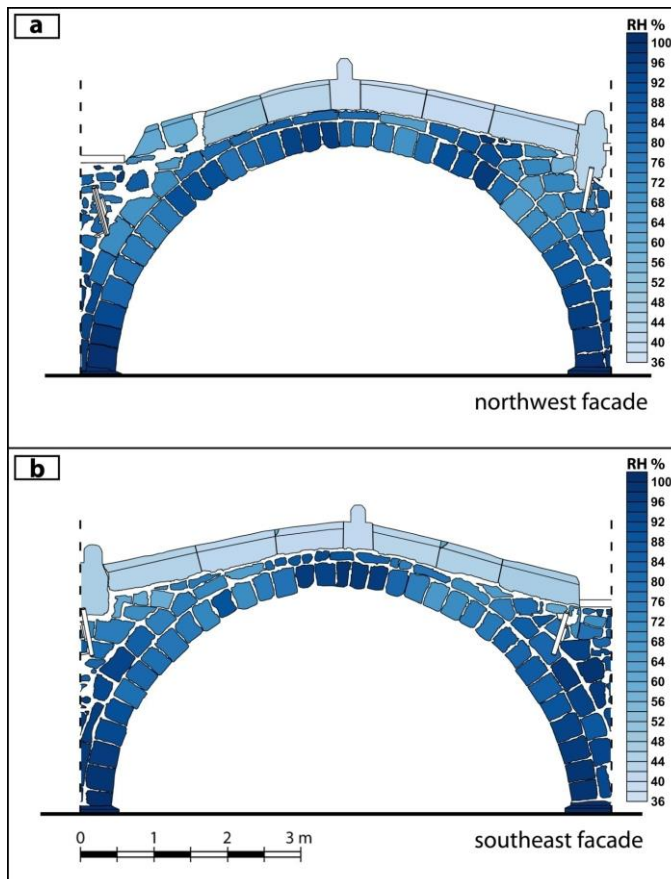
**Figure 5.** Relative humidity maps of stones in the Mısırlıoğlu Bridge, a) northwest facade, b) southeast facade.

The relative humidity values of the building stones used on the outer surface of the bridge vary between 36% and 100%. Upon examining the relative humidity maps, the presence of high humidity in the abutment and arch of the structure draws attention. The presence of humidity in the abutment is associated with the rise of the creek water under the capillary effect. The presence of humidity in the arch is due to the evaporation and then condensation of the creek water when it reaches the structure. Furthermore, different sizes of the stone facings forming the bridge floor are explained by the fact that the water leaking from the surface is drained from certain points of the arch (Figure 6).

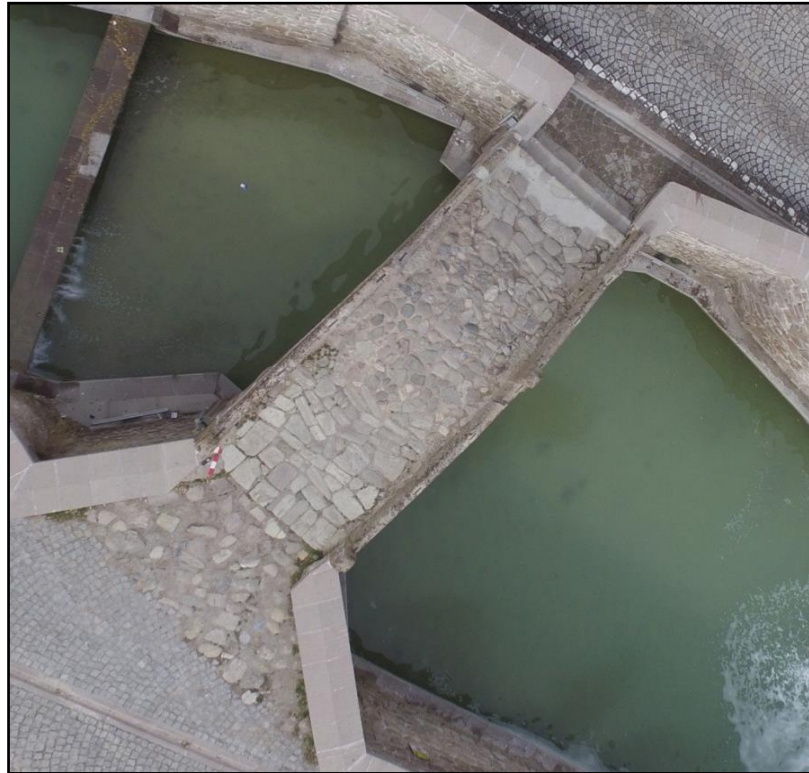
**Figure 6.** Aerial photograph of the Mısırlıoğlu Bridge.

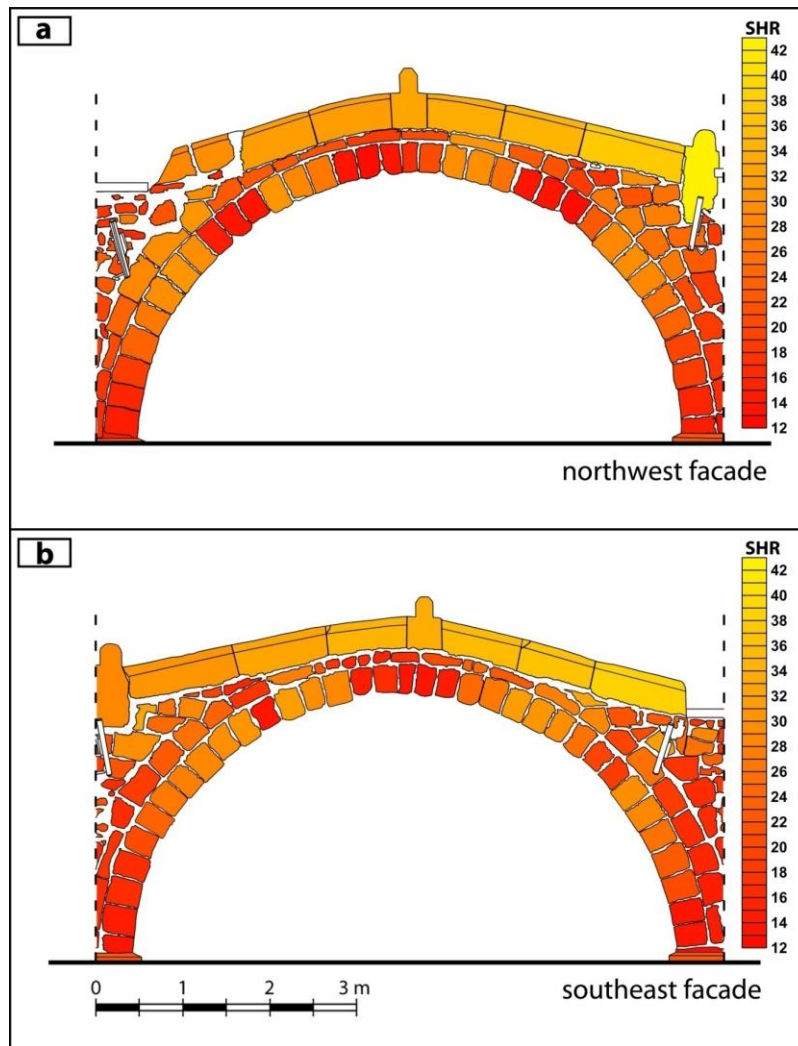
**Figure 7.** SHR distribution maps of the building stones in the Mısırlıoğlu Bridge, a) northwest facade, b) southeast facade.

The Schmidt hammer rebound values in the stones used on the bridge vary between 12 and 42. The UCS values of each building stone on the bridge were determined using the equation proposed by Fener, Kahraman, Bilgil, and Gunaydin (2005) (Equation 1). The statistical data on the estimated values in the northwest and southeast fronts of the bridge are presented in Table 3.

Upon examining the prepared Schmidt hammer rebound maps, the hardness values were found to be low in the abutments and arch of the bridge. Moreover, there is also a significant relationship between the deterioration process and sizes of the building stones (Gökçe, İnce, Fener, Taşkiran, and Kayabali, 2016; Korkanç, 2018). As stone sizes decrease, the ratio of deterioration increases and the SHR value decreases. Deterioration types such as spalling, rounding, flaking, and efflorescence were observed in stones in which the SHR value decreased (Figure 8-9). Upon comparing, the data obtained from the Schmidt hammer rebound and relative humidity tests, the SHR values decrease in regions where water is active and the most intense deterioration is observed in these regions.

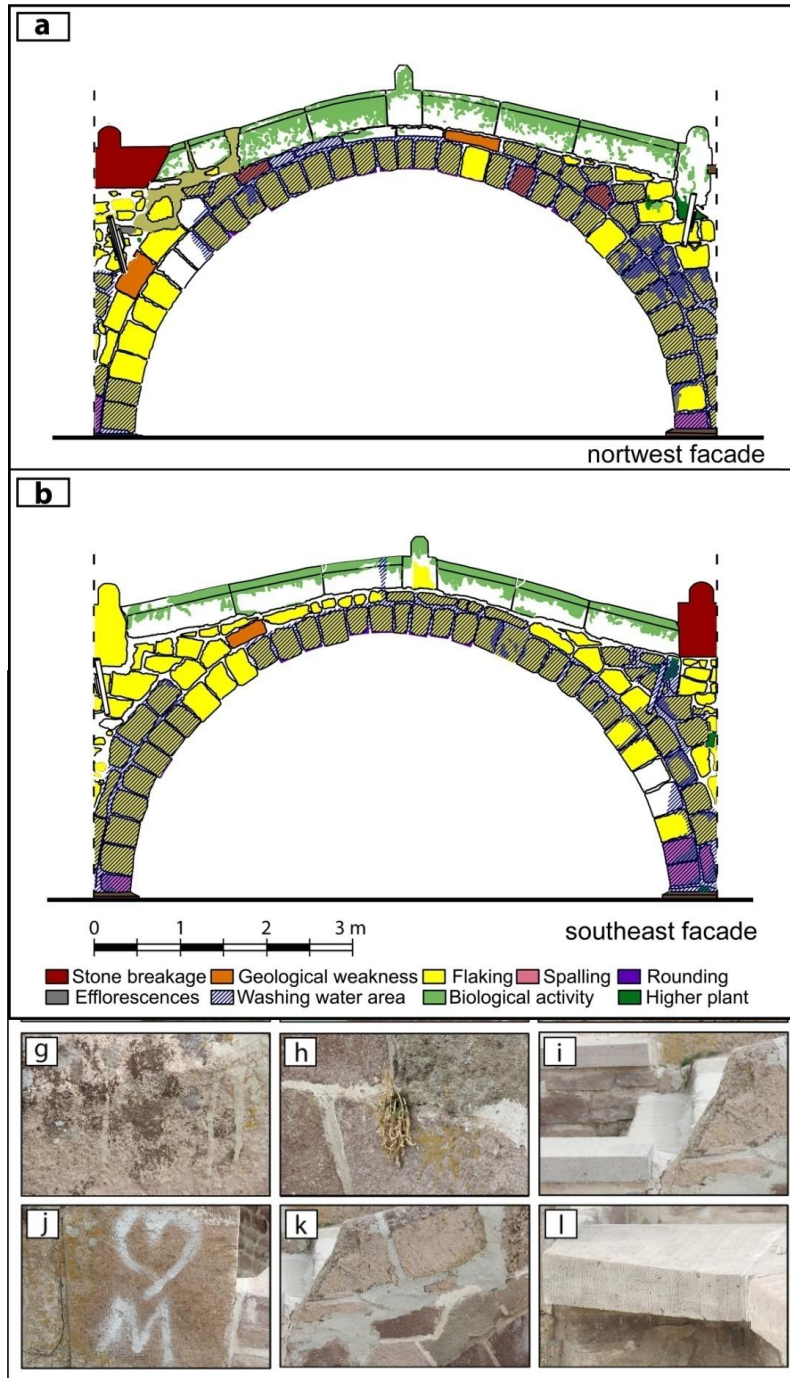
As a result of the examinations performed on the Mısırlıoğlu Bridge in Sille settlement, stone breakage, spalling, rounding, flaking, efflorescences, fissure (atmospheric); higher plant, lichen (biological), cement-based mortar, graffiti, and unoriginal stone (anthropogenic) deterioration types were determined, and then discoloration-deterioration maps were prepared (Figure 8, 9). Spalling (Figure 8a), flaking, and efflorescence types of deteriorations were determined in the abutments of the structure. In the arch part, rounding, flaking, geological weakness, and efflorescence deteriorations were determined (Figure 8b-e). The iron cramps in the railing systems on both sides of the bridge caused fissures due to thermal expansion and corrosion (Figure 8f). Intensive biological activities (lichen and algae) were observed in these regions (Figure 8g). The higher plant growth caused by mortar dissolution is partly noted in the structure (Figure 8h). Another problem on the bridge is man-made damage (stone breakage and graffiti) (Figure 8i and j). Cement-based mortars applied unconsciously to the bridge (Figure 8k) caused efflorescence due to the salts they contain. Furthermore, unoriginal stones were used during the rehabilitation of the creek area (Figure 8l).

**Figure 8.** Deterioration views in the Mısırlıoğlu Bridge; a) spalling, b) rounding, c) flaking, d) geological weakness and rounding, e) efflorescence, f) fissure, g) biological activity, h) higher plant, i) stone breakage, j) graffiti, k) cement based mortar, l) unoriginal stone.
