**FIELD STUDY: PROBLEMS OF ACCESSIBILITY TO ISTANBUL METRO BUS FACED BY WHEELCHAIR USERS**

## Wheelchair Users' Accessibility Problems in Public Transportation- Case of Metro Bus

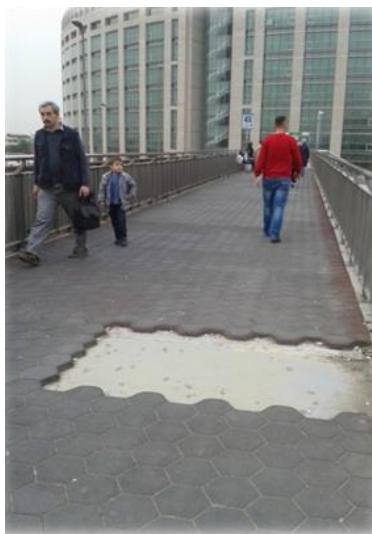
Figure 1.

**Figure 1, 2.** Çağlayan Metrobus Station-Floor covering deficiency, Zincirlikuyu Metrobus Station-40 cm height kerb to reach the

To bring the platform width to the standard level and remove the floor covering defects are actually very low cost, but it is a result reached by conscious and willing technical personals. It is not a design problem; it is a management problem. The standard width of the platform is many times obstructed by adscititious elements (water machine, flower pots, etc.). Instead of putting them arbitrary, municipalities should them allow under the standards. The stations' floor covering defects, are a result of the insufficient maintenance and repair works of the municipality.

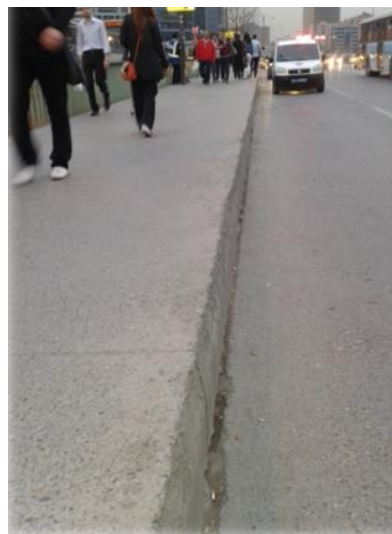
Figure 2.

covering on pedestrian paths etc. should be remembered. For example, in the Zincirlikuyu station the disabled passengers should climb on 40 cm high pavements to reach the elevator placed on Büyükdere Caddesi. In this situation it is inevitable to redesign the pavements according to accessibility standard and the ramps must be provided at kerbs with a convenient grade. Furthermore the insufficiency or absence of wayfinding elements on the platform makes the individuals problems in finding the direction of the way to go. The visibility and readability of the information signs should be an obligation for highly legible and comprehensible urban environments.

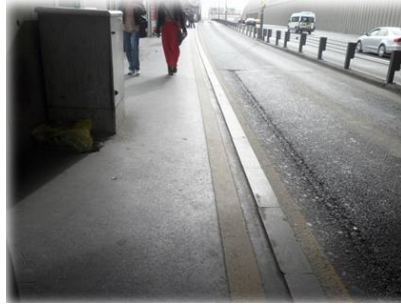
**Figure 3.**

**Figure 3, 4.** Too narrow platform (80 cm)Edirnekapı, Too narrow entrance for wheelchair users (67 cm) Bayrampaşa.

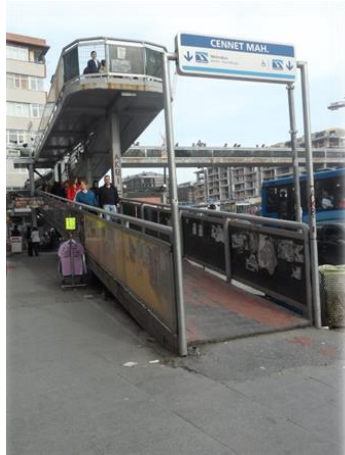
**Figure 5.**

**Figure 5, 6.** Too high ramp (14%) Cennet Mahallesi, Elevator Sefaköy (good provision). elevator.

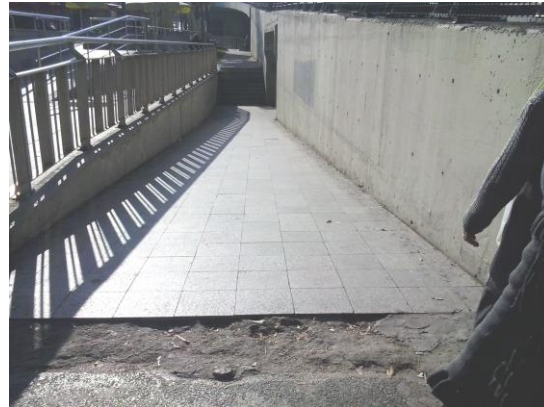
**Figure 7.** Ramp on the way to Söğütlüçeşme Station (Photograph: Selhan Usal, 2013).
