Cultural Heritage Across Borders: A Comprehensive Examination of the Restoration of the St. Nicholas Memorial Museum (2021-2023)

Serap Sevgi*

St. Nicholas Church is a remarkable Byzantine structure located in the Demre district of Antalya, in the southern region of Türkiye. The church and its accompanying tomb were built in the 5th century AD in memory of St. Nicholas after his death. It became a sacred cultural center and a pilgrimage site throughout the Middle Ages. Throughout history, the church underwent multiple reconstructions and substantial repairs necessitated by invasions, earthquakes, and other factors. During the Late Middle Ages, a flood of the river Myros submerged the church under approximately 6 meters of alluvial deposits. The excavations, which began in 1862 and have continued intermittently to this day, have uncovered significant remains, which were subsequently restored in accordance with the conservation approach of their respective periods. However, certain ruins persist within privately owned areas. Although the church largely maintains its structural integrity, ongoing excavations within the Ministry of Culture and Tourism's designated areas in the monaste

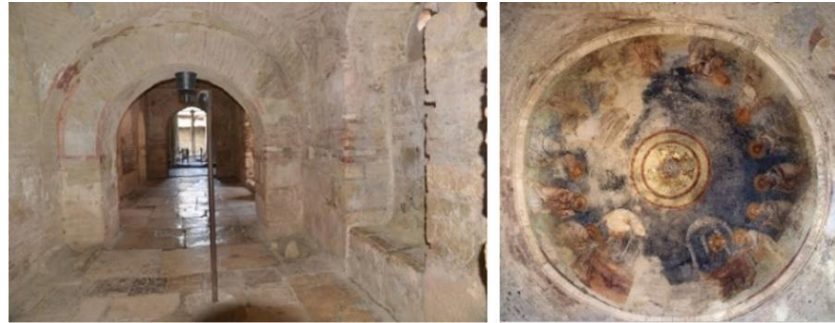
western section suffered a collapse during 19th-century repairs (Figure 19), leading to damage in specific areas of the floor in that region.

Figure 19. The outer narthex that closes off the western corridor arch and its collapsed vault (AMoCT-PR-4)

The restoration initiative included the reintegration of a segment of the missing western corridor vault, employing stone materials and hydraulic lime mortar. This approach aimed to ensure compatibility with the original materials, thereby reinstating the architectural integrity of the structure in terms of its original form, materials, and intricate details.

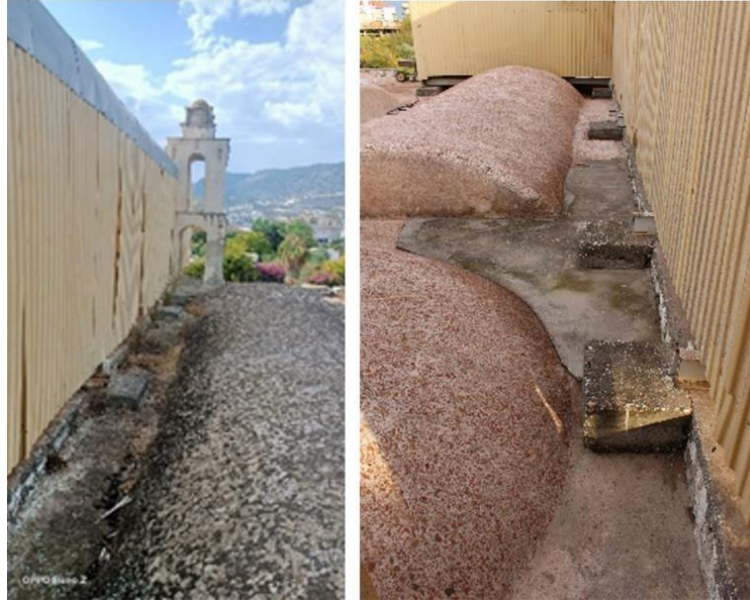
Russians in 1862 and covered with a thick protective layer. Due to inadequate slopes in certain areas of the protective layer, the cracks in the vaults caused moisture to infiltrate, resulting in salt efflorescence. Subsequently, a steel-framed and plastic-covered protective roof was erected over the church's south wall, supported by concrete pillars (1986-1989). However, these pillars impeded the drainage of roof water, resulting in the closure of gargoyles (Figure 23).

Figure 23. Mortar of the protective roof (AMoCT-PR-4)

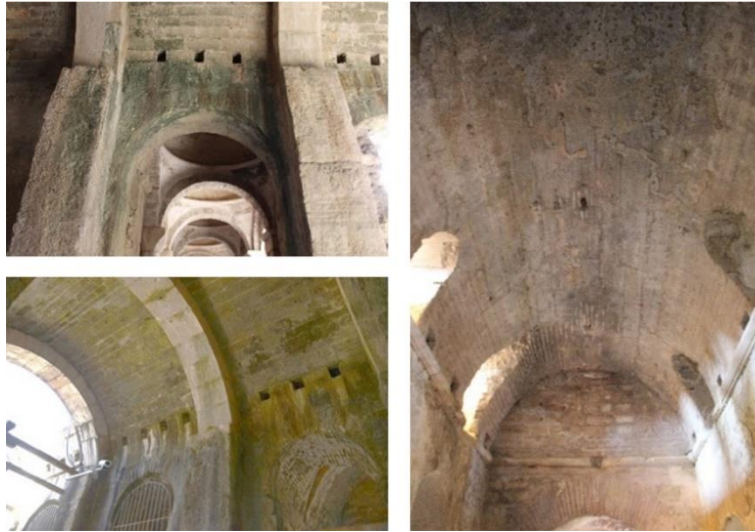
stages of deterioration. We observe repairs with cement-based mortar in sections with high salt content, including the central nave. (AMoCT-PR-1).

Figure 24. Microbiological formations on the internal walls (AMoCT-PR-4)

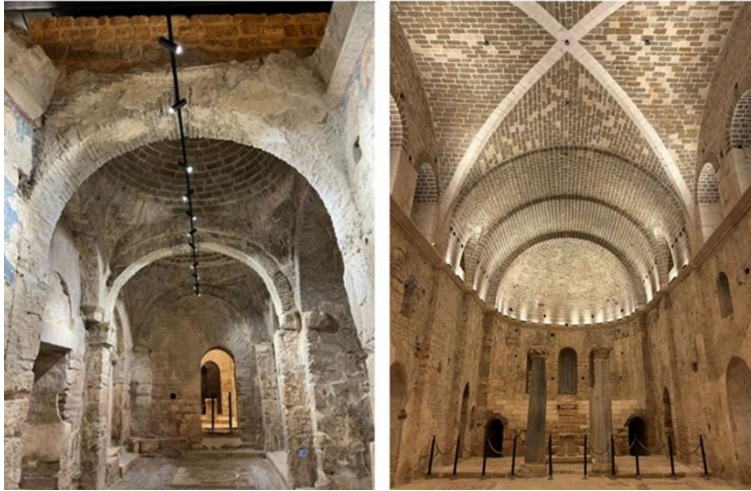
Figure 25. Southern Nave and the Naos after implementation (AMoCT-PR-4)

deterioration occurred, the restoration strategy considered various repair periods in the structure's history. Material consistent with the original content, as determined through material analysis results, was applied. To maintain authenticity, smaller dimension stones were introduced during the restoration (Figure 25).

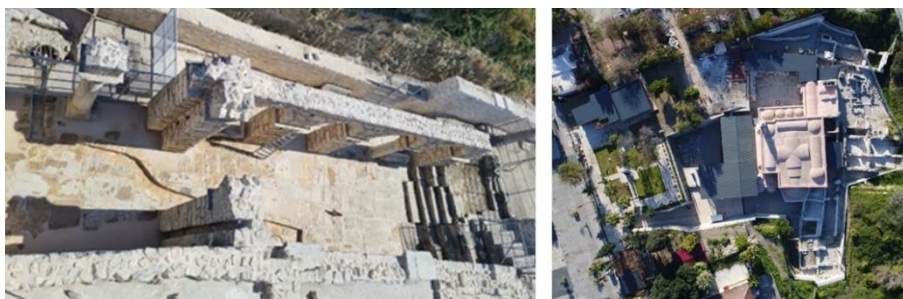
Figure 26-27. After the application of the cleaning, conservation, and capping of the remains (AMoCT-PR-4)

For protection against external weather conditions, a stone and lime-based capping was applied to the remains uncovered during the excavation process. As part of the 19th-century Russian restoration, a lime-based protective mortar layer containing brick fragments was preserved on the dome and vaults of the church. To treat the cracks in the mortar layer, hydraulic lime-based material was used by applying the microinjection technique. In addition, a protective coating with vapor permeability and water-repellent properties was applied to fortify against the deterioration process. The deteriorated joints within the domes and vaults were filled utilizing original materials. Furthermore, slopes were arranged in necessary areas to allow effective drainage of accumulated rainwater on the upper structure. The enclosed gargoyles were restored to functionality, and the addition of titanium-zinc rainwater pipes at the gutter ends enabled the water to be directed to the drainage wells to prevent water flow onto lower-level spaces (Figure 26).

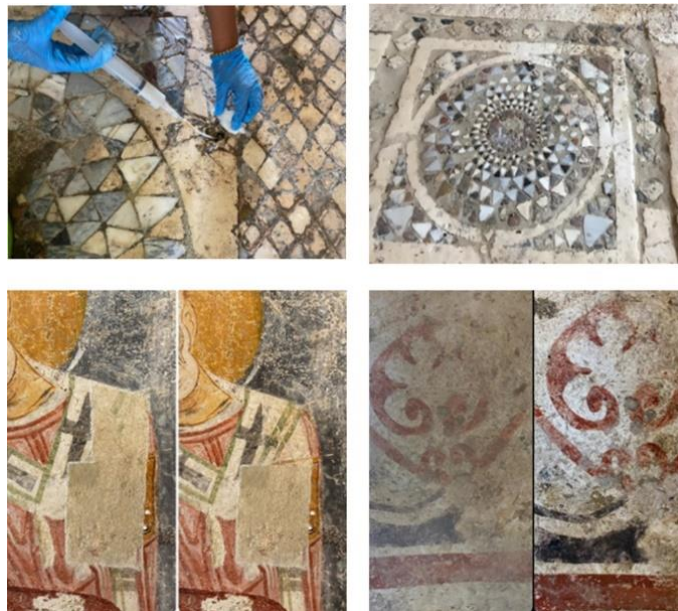
Figure 28-29. Conservation applications on opus sectile panels and wall paintings (AMoCT-PR-4)

The unskilled implementations on the opus sectile floors of the church underwent a thorough cleaning process, with particular attention to the examination of the rudus (coarse mortar) and nucleus (fine mortar) layers in regions affected by ground subsidence. In addition, the bedding mortar layers and gaps between the opus sectile elements were completed. Chemical cleaning methods were applied to heavily soiled surfaces exhibiting calcification, while mechanical cleaning procedures were employed to address microbiological formations and surface accumulations. To address structural issues, broken pieces within the opus sectile unit elements were reinforced. Fragments obtained from excavations, with identifiable positions in areas exhibiting losses, were carefully placed on panels. In cases where positions were indeterminable, mortar filling was utilized to complete the restoration (Figure 28). Concerning murals, reinforcement of gaps between the plaster and the support layer was executed using the injection method following the removal of dust accumulations and salts. Borders were strategically applied to the edges of the plaster to prevent separation between the plaster and the support layer. It is noteworthy that previous repairs had involved the application of Paraloid B72 to the painting surfaces, creating a film layer that posed a potential risk to the paint layer during removal. Consequently, no intervention was undertaken in this regard (Figure 29).

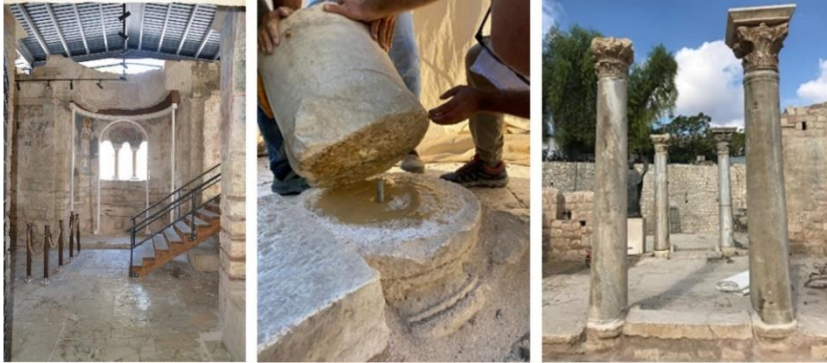
Figure 30. Reinforcement of SEC I dome drum and completion of columns (AMoCT-PR-4)

Section losses resulting from masonry deterioration and voids on the walls were addressed by completing those by using smaller-sized stone materials that were compatible with the original composition. Furthermore, efforts were directed towards the consolidation of columns, integration of broken floors, and the comprehensive repair and leveling of damages to the infrastructure (Figure 30).

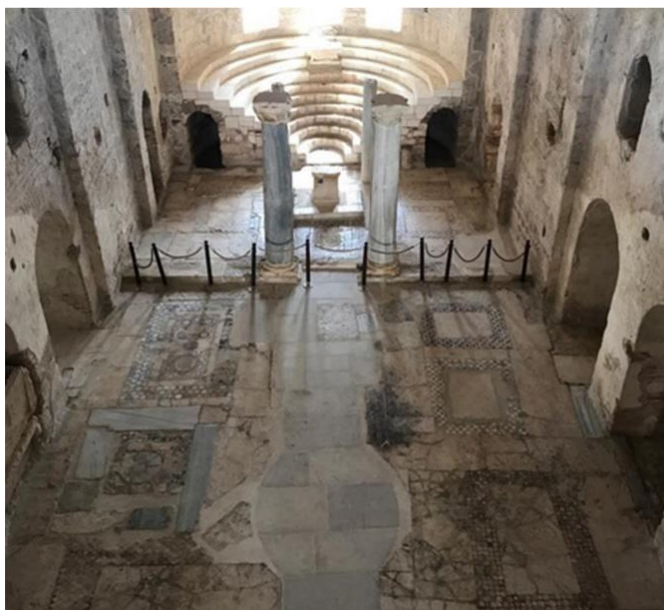
Figure 31. Floor and the traces of the pulpit in the naos (AMoCT-PR-4)

Previous unskilled applications made with cement-based mortar were cleaned utilizing non-damaging mechanical methods to preserve the integrity of the original materials. Interventions were carried out based on the original material content, details, and application style. Unskilled repairs at the pulpit location within the naos, opus sectile panels, and natural stone paved floors were dismantled. Archaeological excavation was methodically conducted on the floor, with the acquired information informing subsequent restoration efforts. The excavation site within the naos, serving both worship and museum functions, was conscientiously resealed, preserving the historical traces of the pulpit's original location, and a new floor was laid using contemporary stone materials (Figure 31).

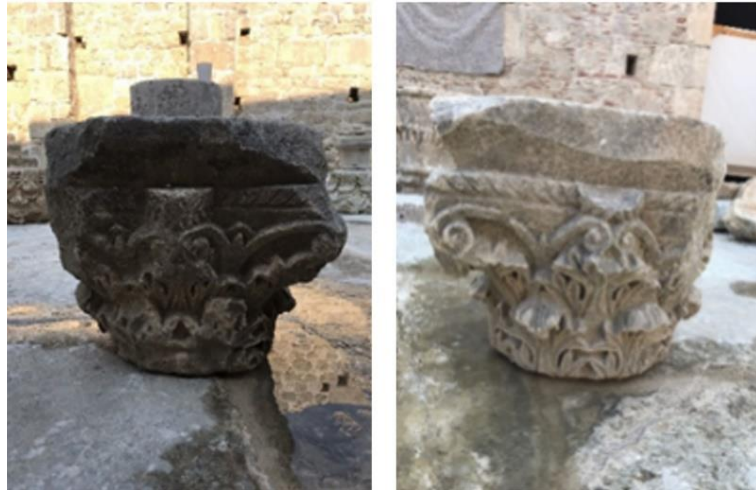
Figure 32. Liturgical materials before and after cleaning (AMoCT-PR-4)

The extensive growth of Deep-rooted vegetation on the church walls was removed using herbicide-type pesticides. To preserve the integrity of the outer stone patina, a series of trials involving water, mechanical, steam, and chemical cleaning methods were conducted (Figure 32). However, surface cleaning of exhibited archaeological remains was not carried out in this restoration process.
