Evaluation on Accessibility in Historical Environments in Turkey: Ankara Ulus Environment Example

I. TBMM/ War of Independence Museum Accessibility Assessment

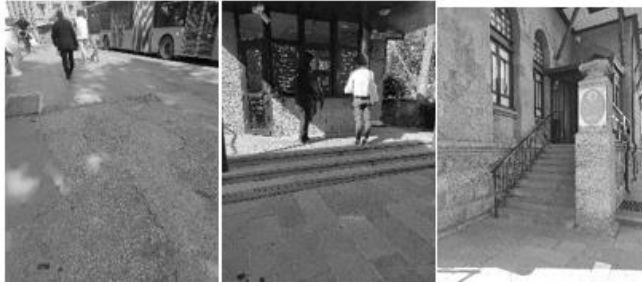
Figure 3. Ramps

Problem: The pavement is inclined down to road level. However, it creates a problem because the combination of road and pavement is

broken. There are three steps to the ticket office. There is no ramp. Access to the museum is by stairs only (Figure 3).

Suggestions: There is an area for a fixed ramp to the ticket office. Likewise, there is space for a ramp on the left side of the museum entrance. However, in such buildings, if the ramp length is not visually preferred due to the floor height, a solution can be provided by having a Scewo (Stair Climbing Wheelchair) (Figure 8).

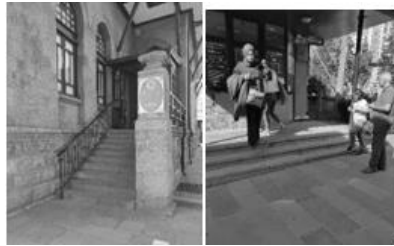
Figure 5. Stairs and Handrall

Problem: There are no warning surfaces in front of the stairs. There are no anti-slip strips on the stair steps. Handrails must be uninterrupted, as seen in the image. The applications need to be corrected. The staircases in front of the ticket office are projected. This situation causes people with muscle disorders to get their feet stuck on protrusions (Figure 5).

Suggestions: Anti-slip strips should be added to the stairs, and warning surfaces should be added in front of the first and last steps. The risers of the steps of the stairs in front of the box office should be renewed so they are free of protrusions. Handrails per standards: They should be uninterrupted, in Braille alphabet, and of appropriate size on both sides of the stairs.

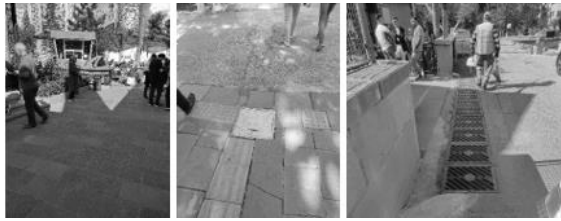
Figure 7. Floor Covering and Guide/Warning Marks

Problem: Some areas have guide and warning marks on the pavement. However, it has been determined that it was not done consciously. The guide tracks coincide with delay covers and grills at some points. There are gaps in some places. Non-slip material was chosen for the floor of the museum garden. There are grills when entering the museum garden. It poses a problem for wheelchairs and visually impaired canes.

Suggestions: Guide and warning surfaces should be added at necessary points. Grilles should be covered with suitable material, or grills suitable for disabled people should be preferred (Figure 6).

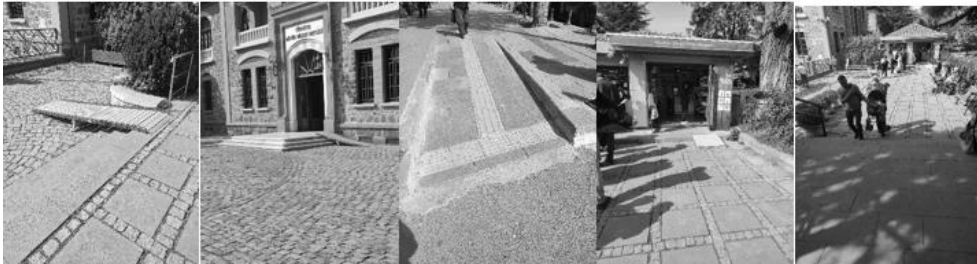
Figure 10. Ramps

Problem: Ramps have been added to the sidewalks corresponding to the building entrance. Ramps are included in the standards; It does not comply with the article "Vegetation should be done on the side surfaces of one-way inclined ramps."

There is a level difference between the road and the ticket office of the museum. There are only stairs in this part. However, disabled citizens can approach the building from the entrance where they take their vehicles (Figure 11). As seen in the pictures, portable ramps have been added to the gift shop, ticket office, and museum, but to reach these places, an individual must first go down the stairs. With this application, it is observed that something was thought of, but the plot from the sidewalk to the entrance to the building still needs to be considered. As a result, other existing ramps are unimportant for disabled individuals who cannot go down the stairs.

Suggestions: The area where vehicles can enter can be turned into a corridor up to the ticket office with the necessary dividers for people with disabilities, age groups, and baby strollers. In this way, access to the area is easily achieved.

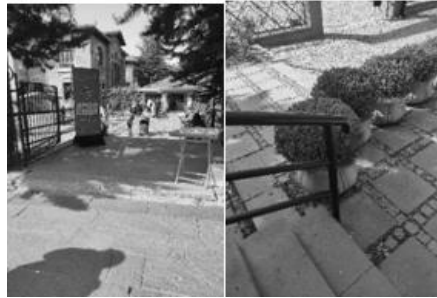
Figure 11. Staircase and Handrail

Problem: There are no warning surfaces in front of the stairs. There are no anti-slip strips on the stair steps. Handrails must be continuous. The image shows that the application is faulty (Figure 11).

Suggestions: Anti-slip strips should be added to the stairs, and warning surfaces should be added in front of the first and last steps. Handrails following standards: They should be uninterrupted, in Braille alphabet, and have inappropriate dimensions on both sides of the stairs.

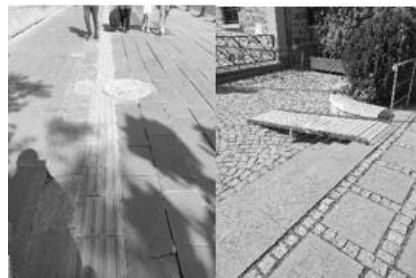
Figure 12. Floor Covering and Guide/Warning Marks

Problem: Some areas have guide and warning marks on the pavement. However, it was determined that it needed to be done more consciously. The guide tracks coincide with delay covers and grills at some points. There are gaps in some places. Non-slip material was chosen for the floor inside the museum, but there are many gaps between the cobblestones applied to some parts. These gaps cause difficulty in walking, even for individuals without disabilities (Figure 12).

Suggestions: Guide and warning surfaces should be added at necessary points. Due to the harmony of the cobblestone historical building with its surroundings and location in a small area, it will no longer be difficult for disabled individuals with gap-free applications.

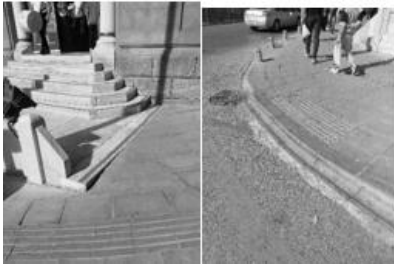
Figure 14. Building Entrance

Problem: Ramps have been added to the sidewalks corresponding to the building entrance. Ramps are included in the standards; It was applied as a ramp inclined in three directions. However, there is an application error since a rainwater channel was added. The pavement has a guide and warning surfaces, but the warning surface needs to be placed correctly. In addition, the stimulating and guiding surfaces should be contrasting to the ground color and be noticeable. Currently, it is applied in the same color as the pavement.

Suggestions: A portable ramp can be added to the building entrance when necessary. The water channel in front of the sidewalk ramp should be removed. Guide and warning surface colors should be changed.

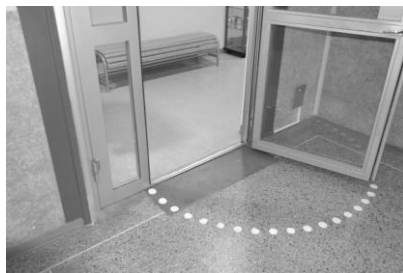
Figure 16. Stimulating Surface Alternative

Problem: There are no warning surfaces in front of the stairs. There is no handrail (Figure 15).

Suggestions: Stimulating surfaces should be added before the first and last steps. There are different alternatives for stimulating surfaces (Figure 16). Surfaces that are visually compatible with the structure should be preferred. Handrails per standards: They should be uninterrupted, in the Braille alphabet, and of appropriate size on both sides of the stairs (T.C., 2020).

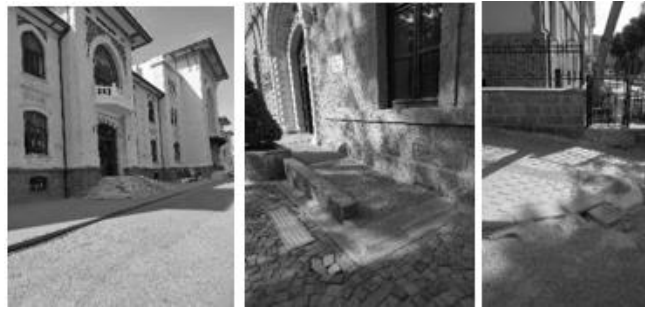
Figure 21. Ramps

Problem: Ramps have been added in places on the campus, but some buildings cannot be accessed (Rectorate Building). The existing ramps were not built consciously. Some ramps do not have curbs, handrails, warning surfaces, and guide tracks. Some of them need help to provide the required slope and landing distance. Some ramps have obstructions such as maintenance hole covers, and there is a level difference between the road and the ramp, and they do not end at the road level. There is a water trough at the ends of some ramps (Figure 21).

Suggestions: Another problem encountered regarding accessibility is the idea that there is no need for accessibility in buildings or areas used by personnel. There may be disabled, temporarily disabled, and pregnant people among the working personnel. Considering this situation, ramps should be added to all buildings, especially the rectorate building. Water gutters should be removed from the parts corresponding to the ramp. The campus is conducive to the addition of ramps.

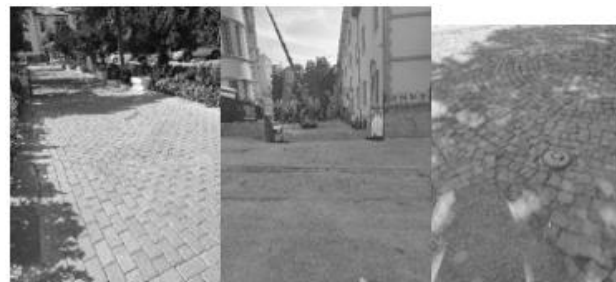
Figure 22. Floor Covering

Problem: No warning surfaces or guide traces were found on the campus. Floor materials were generally chosen appropriately, but many gaps exist between the cobblestones applied to some parts. These gaps cause difficulty in walking, even for individuals without disabilities (Figure 22).

Suggestions: Guide and warning surfaces should be added at necessary points. Cobblestone was used in a specific area. It is thought that its replacement will maintain the integrity of the campus. In areas such as campus, guide tracks can be used to a minimum by adding Braille-embossed visually impaired maps at the entrance. This will not affect the stimulating surfaces.

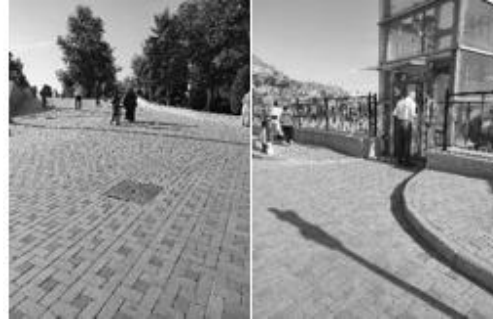
Figure 24. Ramps

Problem: No warning surfaces appear to have been added in front of the ramps. As seen in the image on the right, a ramp was not added to the sidewalk to the right of the elevator but was added to the one to the left (Figure 24).

Suggestions: Ramps that can be arranged must be made per the standards. Considering that it is not possible to renew some ramps, in such cases, disabled citizens should be directed to the elevators with audio and visual signs.

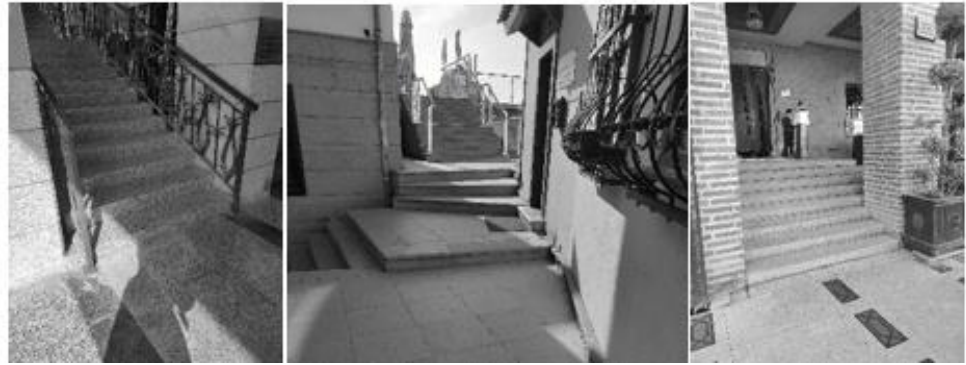
Figure 25. Staircase and Handrail

Problem: There are no warning surfaces in front of the stairs. There are no anti-slip strips on the stair steps. Handrails must be continuous. Some step risers are protruding. Sliding material is used in some stairs (Figure 25).

Suggestions: Anti-slip strips should be added to the stairs, and warning surfaces should be added in front of the first and last steps. Handrails following standards: They should be uninterrupted, in Braille alphabet, and have appropriate dimensions on both sides of the stairs. It is obvious that there are too many stairs in the existing area and not everyone can be made up to standard. In such cases, disabled individuals should be directed to the correct stairs with audio and visual signs.

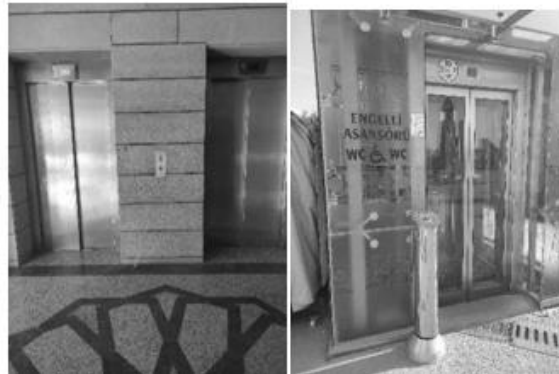
Figure 26. Lifts

Problem: There are many elevators, but some elevators need help. As seen in the image on the right, there is an elevation and a grill in front of the disabled elevator (Figure 26).

Suggestions: It is currently impossible to adapt all elevators to disabled people. Our recommendation is to direct disabled individuals to the elevator that has access to all floors. This elevator's necessary markings and problems can be solved and made accessible.

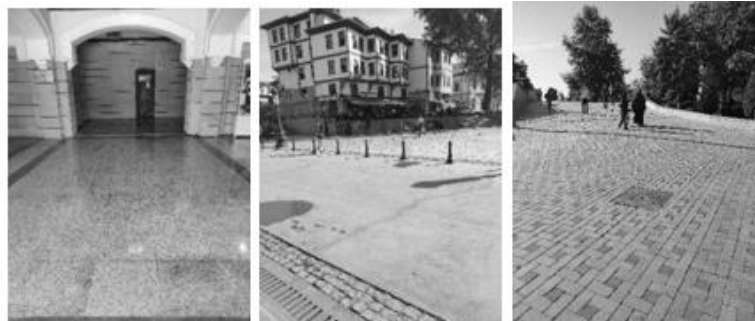
Figure 27. Floor Covering and Guide / Warning Marks

Problem: Slippery floor material was used in some areas. No guiding or warning traces were found (Figure 27).

Suggestions: Guide and warning surfaces should be added at necessary points. Contact with disabled individuals in areas where slippery flooring materials are used should be minimized. However, as in the current example, many places used by disabled individuals have slippery surfaces. Such floors should be replaced when costs allow. Care should be taken to keep the areas that cannot be changed or those that have to be used for a while longer dry, and non-slip carpets should be added when necessary (rainy weather, winter months) to prevent slipping. However, this is a temporary solution. These types of carpets present some difficulties depending on their type. Another more practical solution is to use anti-slip solutions.

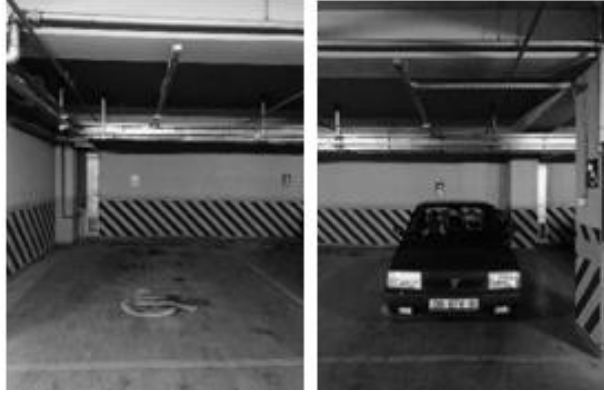
**Figure 28.** Disabled Parking Lot

Problem: It has been observed that there is disabled parking and markings.

Suggestions: There appears to be disabled parking. Signage is available and located close to the elevator. The floor paint needs to be renewed regularly, which is noticeable in the current situation (Figure 28).
