A Comparative Analysis of the Change of Kula Traditional Turkish Housing Architecture in The Last 50 Years

Table 15. Comparative Analysis of Hocacılar House

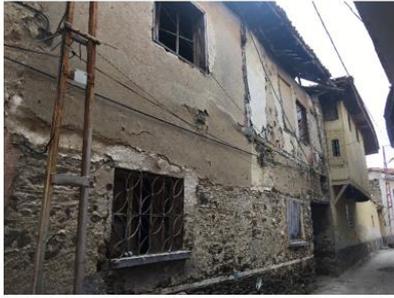
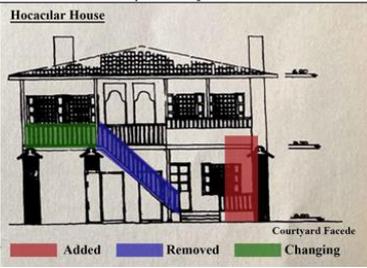
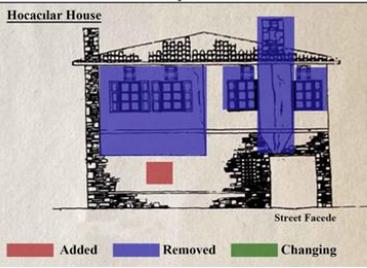
Hocacılar house is one of the abandoned buildings in Kula district. Although the building is standing; It has suffered a lot of damage because it was abandoned and not maintained. Looking at the street façade, both material deterioration and material losses are seen. As a frontal change, it is seen that the bay window and chimney have been canceled. The bay window was closed, and a double wing window was opened.

A new window was opened in place of the chimney, and the windows on the right and left of the chimney were filled with filling material. A new window was opened on the ground floor. At the courtyard facade, the staircase parallel to the sofa was canceled and a new brick staircase with iron railing was added adjacent to the east wall and perpendicular to the sofa. In addition, the balustrades of the sofa have undergone changes locally (Table 15).

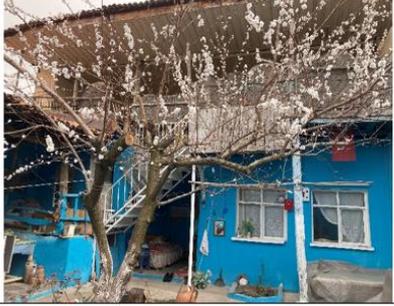
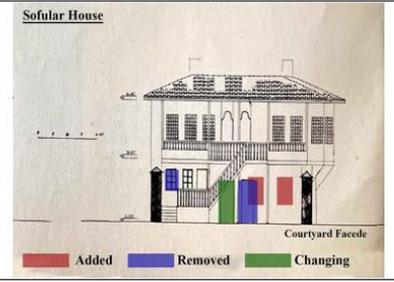
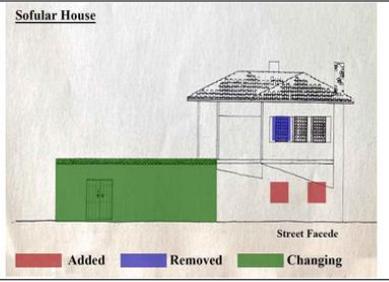
Table 16. Comparative Analysis of Sofular House

The 'Sofular' house is a building that has not changed to a great extent but has undergone some interventions in order to provide the comfort conditions of the time. It is a building used as a residence. Looking at the street facade, it is seen that the garden wall was raised and the garden gate was built with an arch. The leftmost one of the three windows on the upper floor bay window has been closed.

surface of the canceled door. On the first landing of the staircase, there are two windows in the 1969 survey. Today, there is one original window. It is estimated that there was an accidental error in the 1969 survey (Table 16).

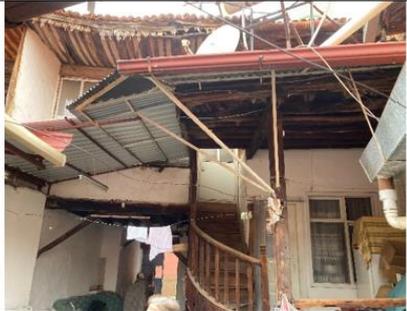
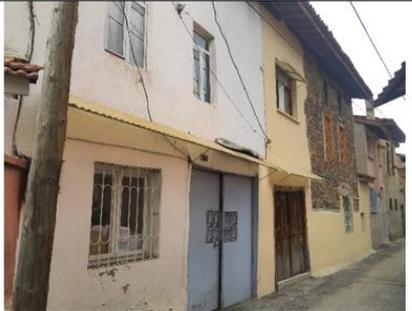
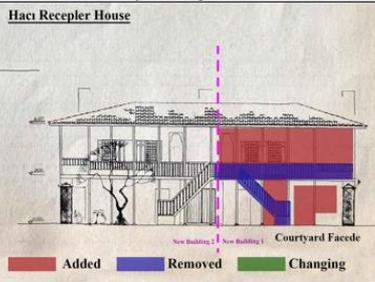
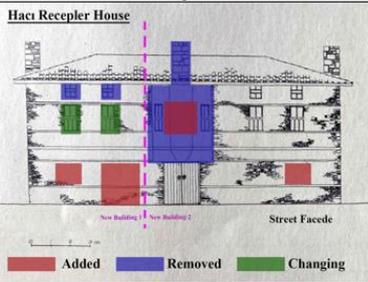
Table 19. Comparative Analysis of Hacı Recepter House

Hacı recepter house, which was originally a single building, is used as two separate buildings today. For this reason, another entrance door was added on the façade facing the street. To provide comfort conditions, one window has been added to the spaces on the ground floors.

The chimney, bay window and windows on the bay window in the middle of the building have been canceled. It was replaced by a single window. Two windows on the upper floor left side of the building (new building 1) were replaced with PVC windows. Also the skylights have been cancelled. On the right (new building 2), the original windows are repaired and continue to be used.

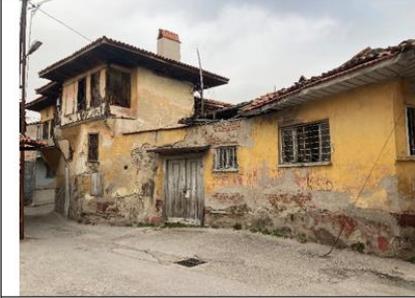
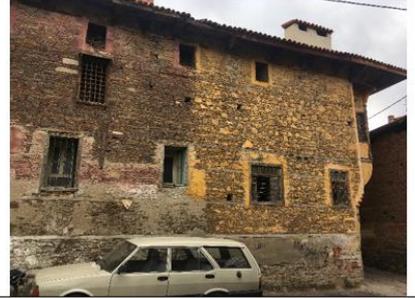
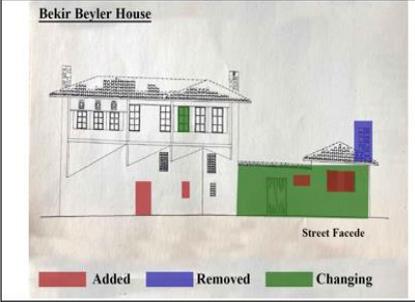
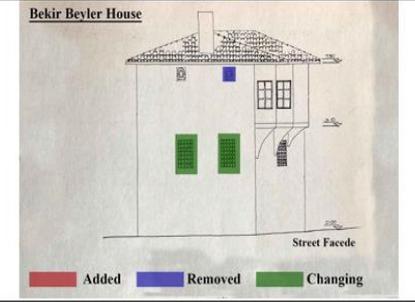
Table 20. Comparative Analysis of Bekir Beyler House

Since this structure, which preserves its originality to a great extent, was not used, local deterioration began to occur. The garden wall of the building and the parts of the outbuilding on the right facing the street were demolished and rebuilt as a brick wall. In this new wall, a window was opened next to the door and a single larger window was opened in place of the two windows of the outbuilding. In addition, the chimney of the outbuilding was canceled. When we look at the street façade of the main building, the leftmost window of the overhang on the far right has been closed.

A doorway was opened at the lower level of the overhang in the middle on the ground floor. Another small window was found next to the opened doorway. The small windows on the floor are covered with wooden material. When we look at the second street façade, although the window locations in the old survey drawings and the current window locations and number are correct, when we look at the size and construction systems of the windows, it has been determined that they are not original. In addition, the upper right window was closed with stone filling (Table 20).

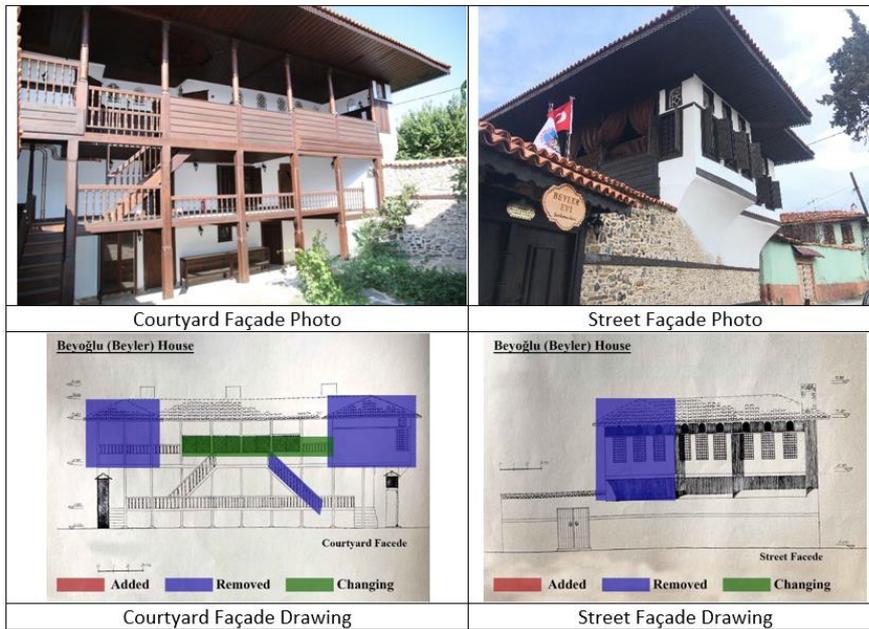
Table 22. Comparative Analysis of Beyoğlu (Beyler) House

This building, which was restored in 2016, serves as a culture house and cafe. When the survey drawings of Tosun (1969) are examined, it is seen that three layers of protrusions were made on the street façade. Although the leftmost pavilion is the room, in the photo in the same source, the pavilion room part is not visible. If we evaluate the street façade through the drawings, it is possible to say that the mansion room was removed at some time. Apart from this, there is no change in the façade. When we look at the front of the courtyard, it is determined that the two mansions and the window on the right hand side have been removed. In addition, the upper floor life railings were renewed during the restoration and replaced with a different model (Table 22).

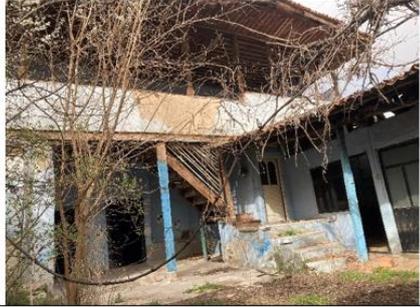
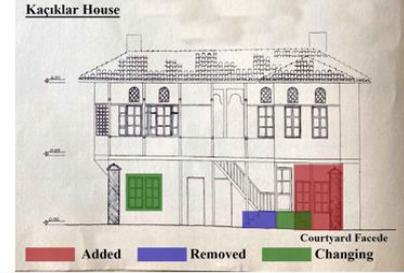
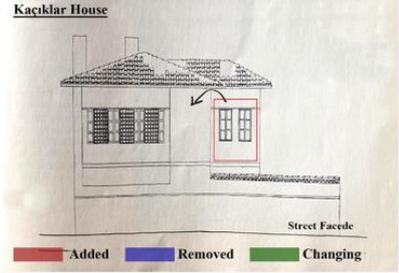
Table 23. Comparative Analysis of Kaçıklar House

This residence, which is a classical traditional Turkish house, is not used today. One of the 2 staircases with 4 steps providing access to the main staircase on the courtyard facade of the house has been canceled and the direction of the other has been changed. Two windows on the left side of the ground floor were combined into a larger single window. In

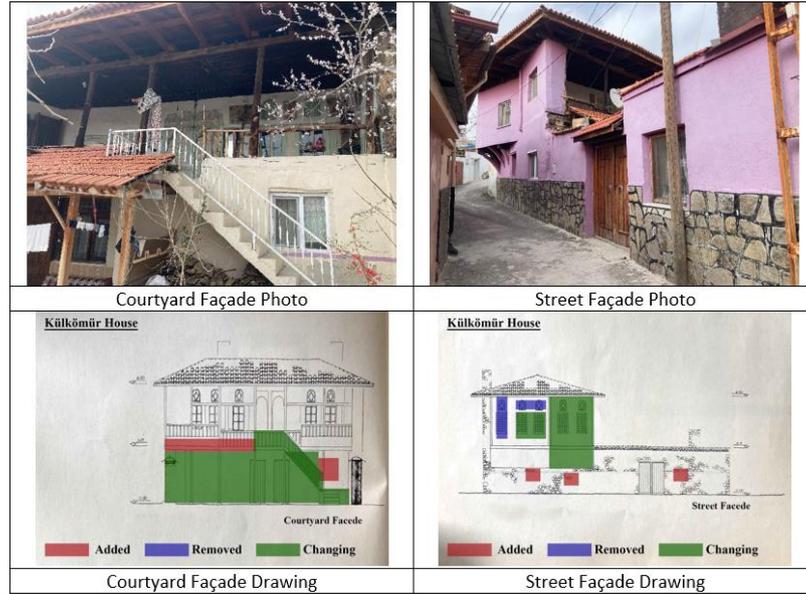
Table 26. Comparative Analysis of Külkömür House

There are changes on the facades of the 'Külkömür House' compared to the original. There are two projections in the archive photos, but the projection wall on the right was canceled and pulled back and the two windows above it were turned into a single large window. The top window on the left-hand overhang and the right-most window have been cancelled. In addition, the other two windows were combined into a single window. On the ground floor, three windows were opened in order to provide today's comfort conditions.

On the courtyard front, the ground floor wall has been completely renovated to provide comfort conditions, and windows and doors have been opened. The first four steps of the staircase leading to the upper floor were canceled and rebuilt as a single arm reinforced concrete. On the ground floor, a porch has been added to protect from the weather (Table 26).

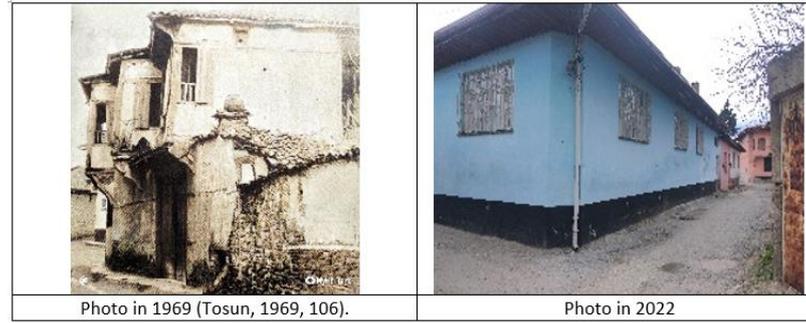
Table 27. Comparative Analysis of Büyük Gödeliler House

It was determined that the old two-storey house was demolished and four separate new buildings were built in its place (Table 27).

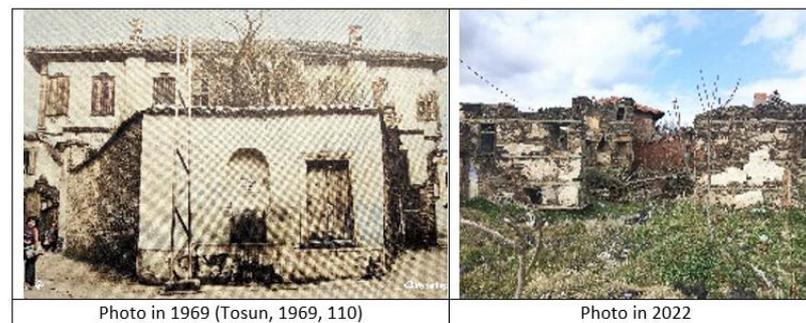
Table 28. Comparative Analysis of Küçük Gödeliler House

The two-storey house was found in ruins. It was not included in the evaluation due to its ruins (Table 28).
