# Conservation of The Historical Town of Izmit Through The Restoration of Pertev Mehmet Pasha Mosque

## Abstract

The conservation of Pertev Pasha Mosque should not be considered as a mere practice of static or architectural restoration but as an integrated project to implement all those principles adopted by the "Conservation of Historic Towns Chart" (ICOMOS, 1986-87).

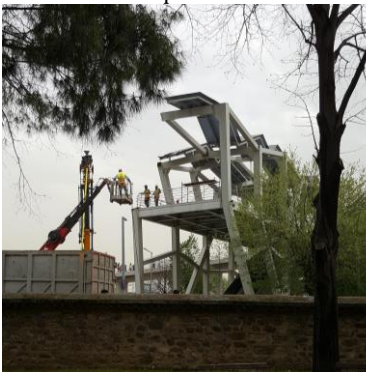
<sup>2</sup>During the workshop, the aim of the project in order to reduce the contrast between the contemporary architecture and the mosque was accepted by the municipality, which has already carried out the demolition of the coverage of bridge, as shown in the picture below.

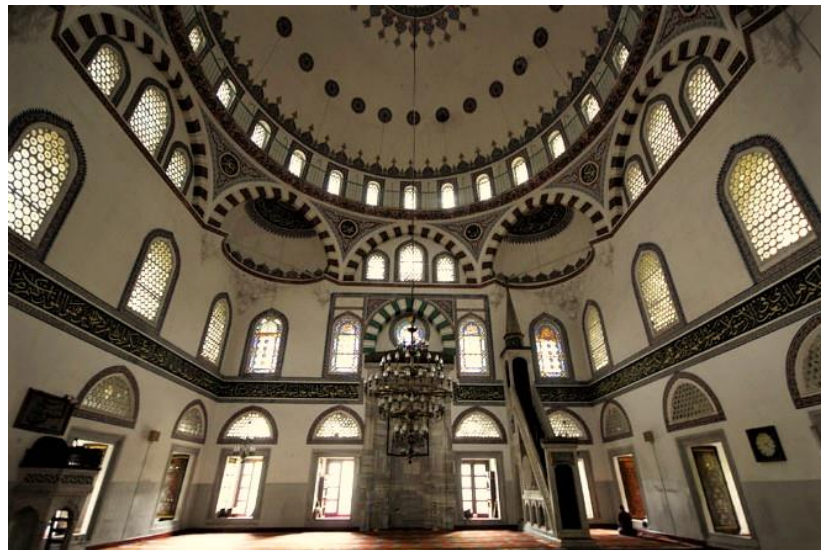
The interior is richly decorated and the floors are covered in carpet so that the faithful can easily kneel. The "mirhab" is small and is surmounted by a semi-dome forming together the "sancta sanctorum" of the mosque. The "minbar" is the pulpit of the mosque and is located on the west side of the Prayer Hall. Both elements are made of marble and enriched with geometric decoration.

**Figure 5.** Photo of the interior of the Pertev Pasha Mosque by Chiara Cusolito

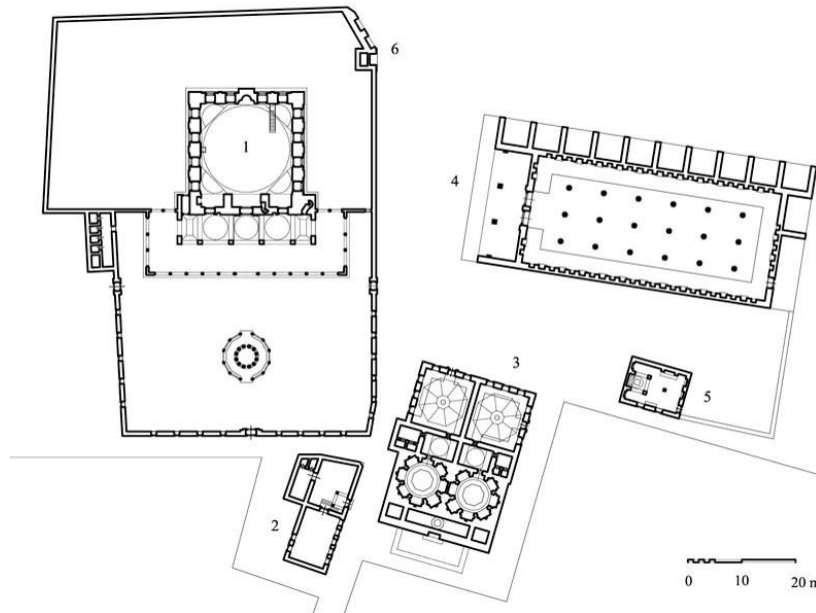
**Figure 6.** Monumental complex  
Pertev Mehmet Pasha:

- 1 Pertev Pasha Mosque
- 2 Elementary School
- 3 Turkish Bath
- 4 Caravanserai
- 5 Refectory
- 6 Fountain

The Turkish bath, of which some remains are visible today, was located in the north-western part of the mosque, the school to the east and the caravanserai was lost completely during the earthquakes in the southwestern part.

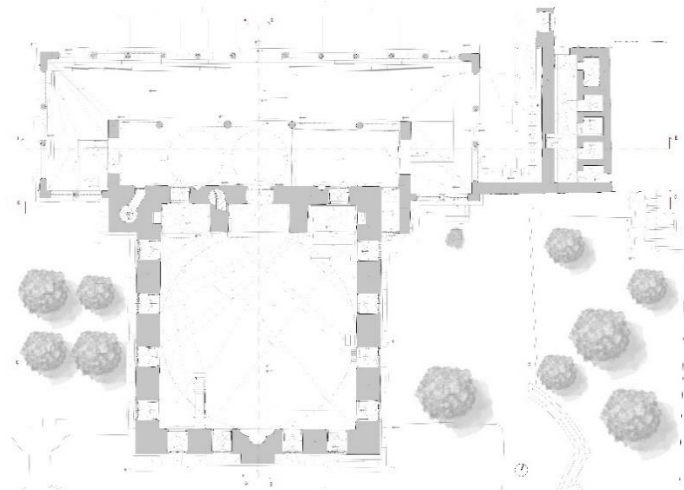
**Figure 7.** Ground floor plan of the Pertev Pasha Mosque

In order to translate the geometry of the artifact into conventional symbols a representation scale of 1:50 and the ISO standards for drawings have been adopted. The plant is almost a perfect square, the waste between the two walls is less than 1m over 22 meters in length. The plant is symmetrical with respect to the east-west axis, while it is asymmetrical compared to the north-south axis, due to the presence of the Narthex.

The dome has a diameter of 20 meters and rests of the wall with a thickness of 1.8m and height of 12m. The entire mosque, including the drum and the dome, is 28 m high, while the minaret of a square plan reaches 38m. The walls that close the prayer hall have eight openings on each side, while on the drum there are 12 openings along the entire circumference. Moreover, there are no significant differences in the plan and the presence of architectural barriers that prevent access to the main hall have not been detected.

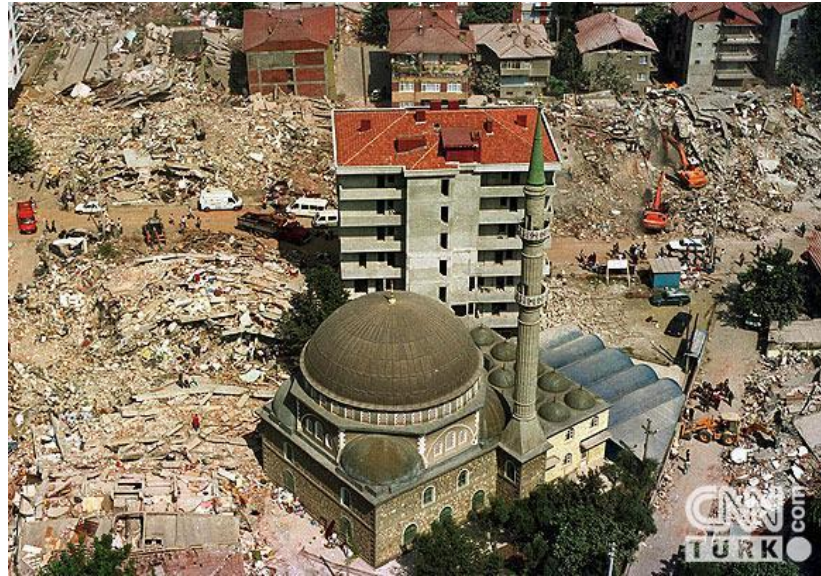
**Figure 8.** Mosque Pertev Pasha after earthquake of 1999

The mosque has not suffered major damage, except for a lesion on the south wall at the height of the window. There are no dangerous situations and metallic chains were introduced in the side domes replacing the wooden ring of the dome with one in steel. However, the entire surface of the tuff is affected by micro-cracks and superficial disintegration.

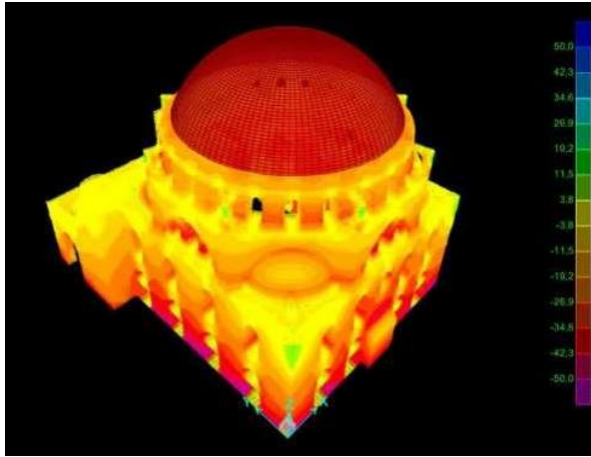
**Figure 9.** Static analysis, vertical loads. Sap model realized by Engineer Mehmet Selim Ökten

The model shows that the structure responds very well to vertical loads, while it has a very small shear stress located near the drum at the existing crack.

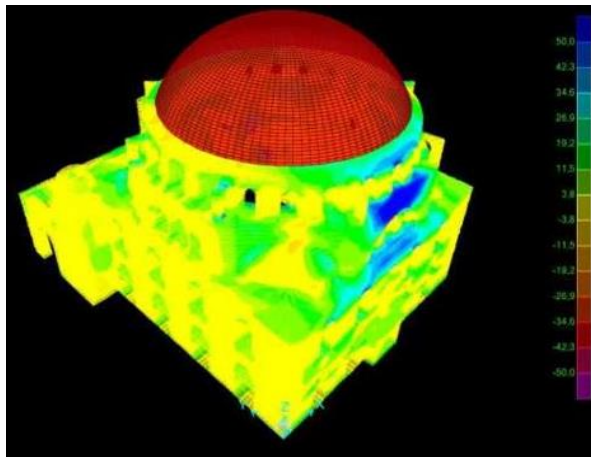
**Figure 10.** Solicitations of the earthquake along the y axis sap model realized by Engineer Mehmet Selim Ökten

It is also noted that the masonry on the south side, once again, results to work with less compression homogeneity, presenting localized points of cut near the windows. Comparing it with the compression values of the north side where they are homogeneous on the whole surface, it can be deduced that this structural imbalance is due to the presence of the Narthex on the north side which compensates for the thrust of the dome. The dome simulations, on the other hand, show that the whole surface works with compression and there does not appear to be breaking mechanisms in the central part. The dome is very similar in both directions, presenting higher values of compression near the key and traction on the supports.

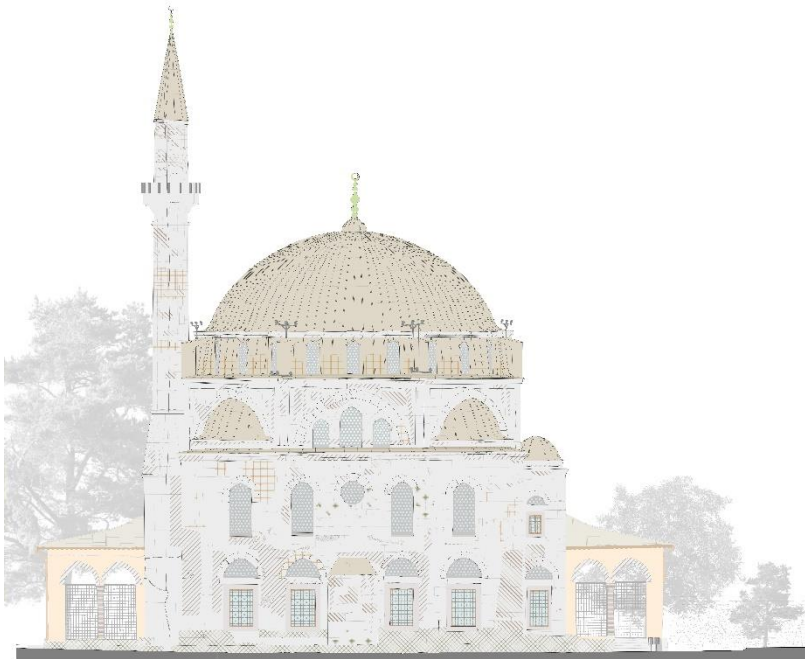
**Figure 11.** Survey of degradation, south-east prospect

The survey of the deterioration has pointed out that the walls are mainly affected by the presence of soluble salts both outside and inside. This is due to the mineralogical composition of the tuff and its high porosity which makes it a particularly sensitive to water (De Gennaro, 1991). The most widespread pathologies of the elevations reported are also the most dangerous for the structural and visual integrity of the masonry. This is often affected by a chromatic alteration which is both wide, diffuse and punctual (Laurenzi Tabasso, Agostino Bureca e Giorgio Palandri, 1987). Looking closely at the surface a different kind of chromatic alteration can be seen: in the lower parts of the mosque. It has a greater blackening due to the combination of IT being dissolved in exhaust gas and weathering; in the upper parts, instead, they act almost exclusively the degrading action of atmospheric agents. Moreover, the external masonry is weakened by the presence of circular cavities. These cavities are sometimes quite deep and seem to be interconnected; they have an irregular pattern on the surface and are more present in the parts most exposed to wind. In some places the phenomenon has degenerated until disintegration and pulverization of the stone in some parts of the wall element have occurred. On all the elevations, it is easy to notice the presence of white efflorescence, which can even reach a few centimeters. It is very likely that the crystals are also within the wall parameter. The saline sub-efflorescence is very dangerous because the migration of the internal crystals outwards during the cycles of freezing and thawing causes the appearance of alveoli on the stone, altering the surface of the product. They can be formed either inside the wall parameter (sub-efflorescence) or on its surface according to the saline solution flow rate with respect to the rate of evaporation at any time and at every point (G.Rocchi, 1990). The presence of black crusts has been observed in areas protected from water run off and heavy rain. The patina covering the stone appears dark in color, variable in thickness, irregular in shape, compact and anchored to the substrate. This type of deterioration alters the surface of the mosque and increases the risk of possible damage due to the effect of thermal variations until it causes phenomena of disintegration, erosion and alveolarization. In fact, in the parts

where the deposits have become detached, due to the different thermal expansion, a disrupted and deteriorated stone surface can be seen. In the parts of the surface exposed to the action of water and wind, the loss of a superficial layer of material can be noticed. The stone is eroded and visibly damaged and the surface is not homogeneous. Other types of deterioration can be seen around the eroded surface, such as disintegration and scaling. The erosion is more extensive in correspondence of dark colored crusts due to the different thermal expansion. Finally, at the height of the base there is the presence of fungi, molds and vegetation.

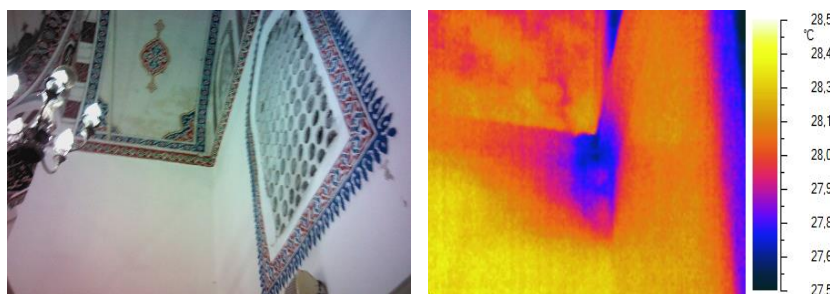
**Figure 12.** Corner brickwork and mezzanine vault

Through the use of thermography in internal environments, it has been found that the internal plaster appears well adherent to the masonry even if it has some localized detachment. Below the vaults of the mezzanine, made of stone and squared with regular blocks, different temperatures are detected, which may be the result of the presence of moisture and interstitial condensation.

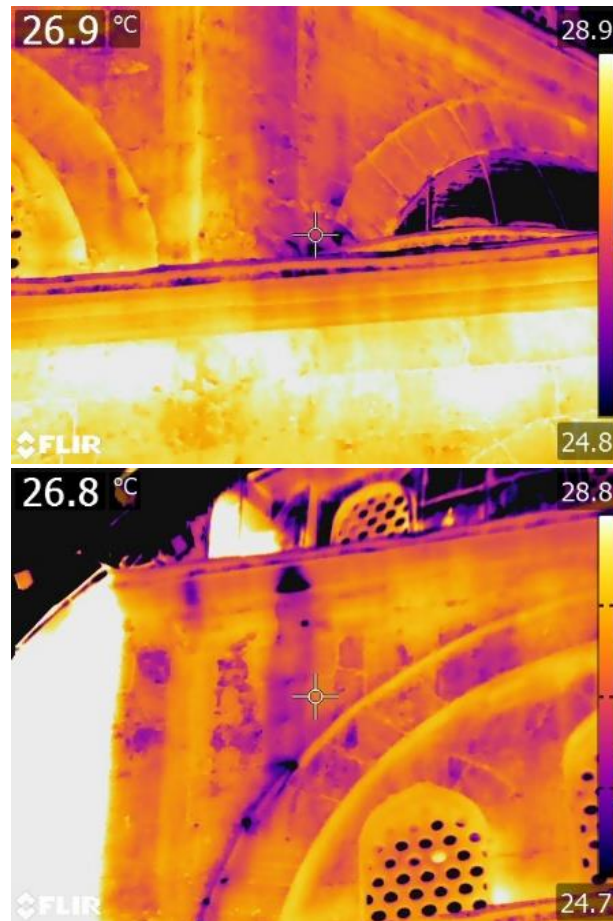
**Figure 13.** From this photo you can see the different materials used on the side domes, thanks to the different emissivity factor. The presence of mineral salts below the cornice is evident and presence of water in the wall

Externally, on the other hand, the mortar restoration to restore the cohesion of the masonry in the joints of previous intervention could be observe, an infiltration located in correspondence of the rainwater to the left of the north-east prospect and ensure that the masonry, by orographic conformation of the ground and for constructive and morphological characteristics, it is not subject to rising damp.
