A Restoration Criticism of Historical Buildings According to Thermal Comfort Conditions through Ali Gav Madrasah

Mihrimah Şenalp*
A. Deniz Oktaç Beycan**

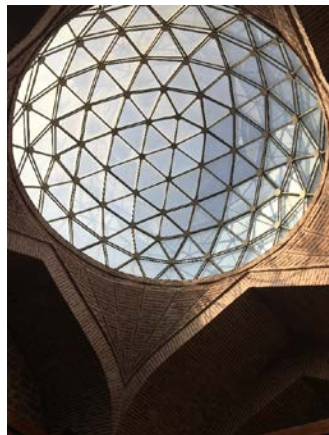
Figure 3. Top Cover Of The Courtyard

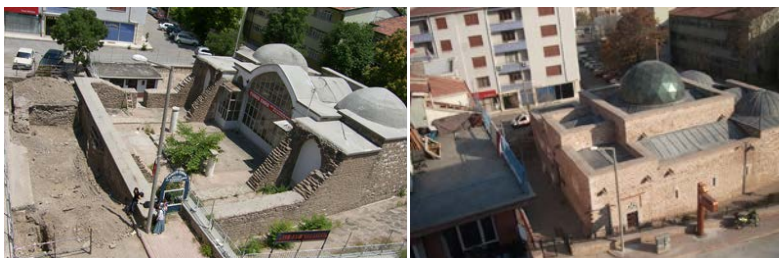
Figure 4. Madrasah Before and After Restoration-(Aynur Yilmaz's Archive)

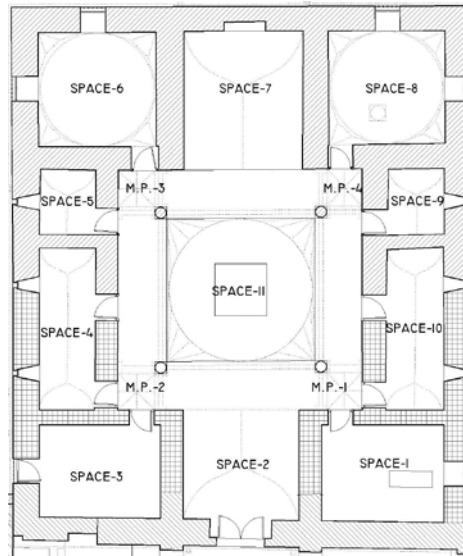
Figure 5. Madrasah's Plan Schema and Place Names (Ceray Architecture Restoration, Konya Metropolitan Municipality)

reduction and to ensure user satisfaction. The data taken during the periods when the heating system is operating and not operating is shown in the diagram according to the space names shown in the schematic plan (Figure 5).

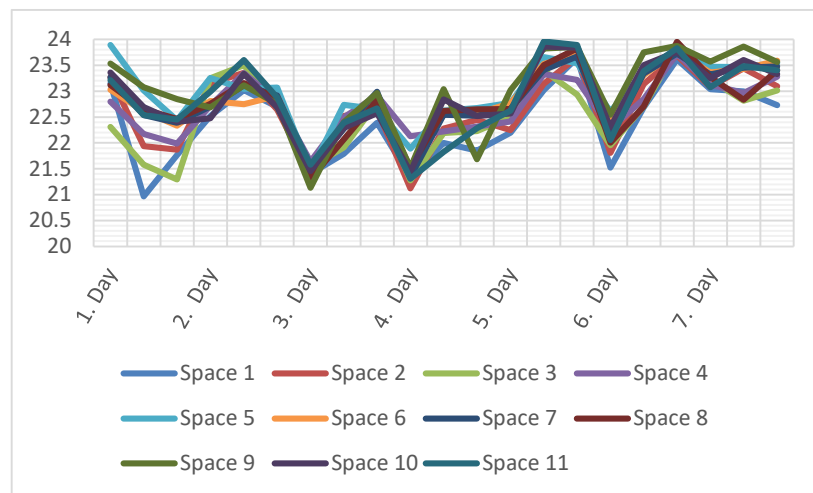
Figure 6. Heating System works Period's Temperature Diagram of Places (Şenalp, 2019)

As a result of the measurements made, the temperature value for the period (summer period) without heating system exceeds the ideal level due to the high ambient temperature. Since the temperature can be adjusted manually in the period when the heating system is running (winter period), the temperature value is generally constant and it is also thermally positive.

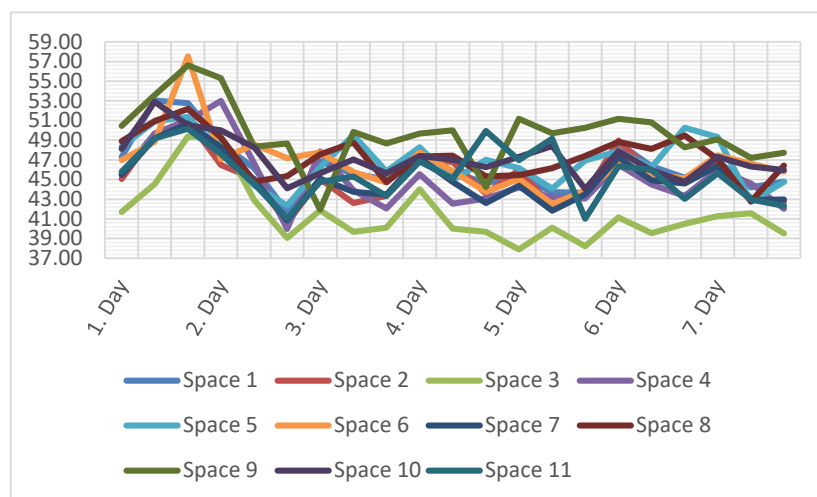
Figure 8. Heating System works Period's Relative Humidity Diagram of Places (Şenalp, 2019)

Moisture factor is determined as the main reason for the lack of thermal comfort in the measurements made during the period when the heating system is running and is not. The other two factors based on the measurements are sufficient to provide ideal conditions especially during the operation of the heating system, while the comfort level in the structure falls back due to the high amount of humidity in the indoor environment.
