**ICONARP**  
*International Journal of Architecture & Planning*  
Received 07 Apr 2019; Accepted 20 May 2019  
Volume 7, Issue 1, pp: 286-313/Published 28 June 2019  
DOI: 10.15320/ICONARP.2019.76-E-ISSN: 2147-9380

# Moving Techniques For Traditional Buildings As An Architectural Preservation Method

**H. Hale Kozlu\***  
**F. Burcu Batukan Dördüncü\*\***

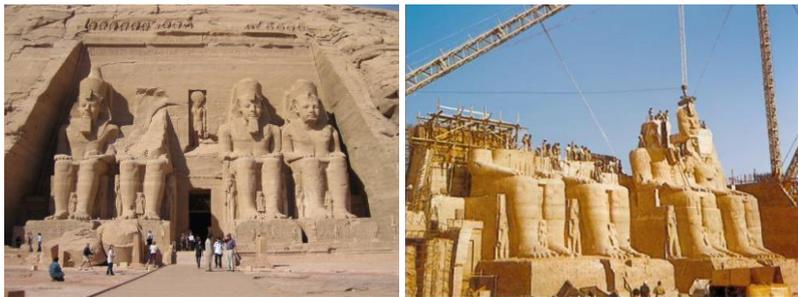
**Figure 1., 2.** Abu Simbel Temple (URL 1) and process of moving (URL 2)

One of the most known works moved by this technique, is the Temple of Abu Simbel in Egypt. The temple, taking place in the World Heritage List of UNESCO, was carved into sandstone cliffs in 1250 B.C. (Figure 1) As a result of the rising water of the Aswan Dam on the Nile in the 1960s, a rescue project was initiated by UNESCO. Within the scope of the project between 1960 and 1968, the temple was removed from its place (Figure 2) and relocated in a higher position (Allais, 2013).

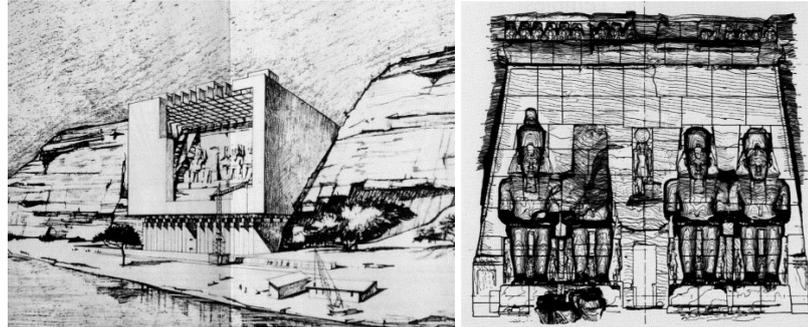
**Figure 3., 4.** Abu Simbel Temple moving schemes (Allois, 2013)

Prior to transporting, the monuments were filmed, photographs were taken, and photogrammetric measurements (plans, sections, facades, details) and survey were prepared. (Figure 3, 4). The soft sandstone which forms the main rock has been stabilized in an effort to save the monuments from being torn down, and dispersion during transportation. The giant sculptures processed on the rock were severed to form large blocks with fine stone saws. The 7047 blocks are numbered and removed by hydraulic

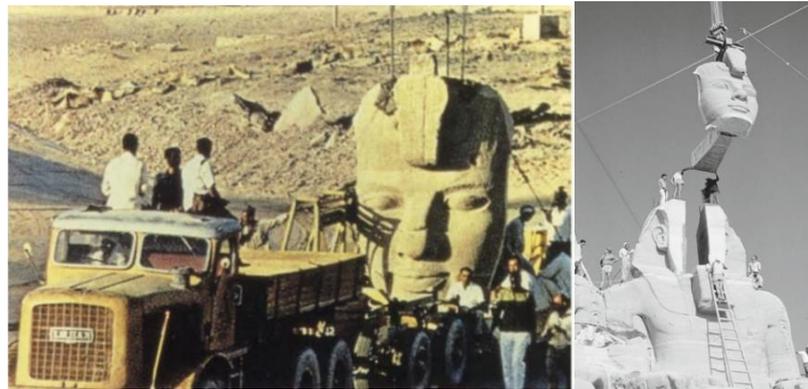
**Figure 5., 6.** Transporting process of building components (Hawass, 2000; Kirwan, 1963)

jacks. The sculptures were located 200 meters behind and 65 meters above the current location (Figure 5, 6)

When assembling the blocks, a mortar produced from the sand of the area was used, and epoxy mortar was injected on the surface to secure it. In the new location of the monuments, an artificial hill with concrete shell structure was formed behind the large sculptures in order to simulate the surrounding landscape. After the rock blocks had been severed, it was mounted on this reinforced concrete structure (Kirwan, 1963; Ahunbay, 1996, Allois, 2013).

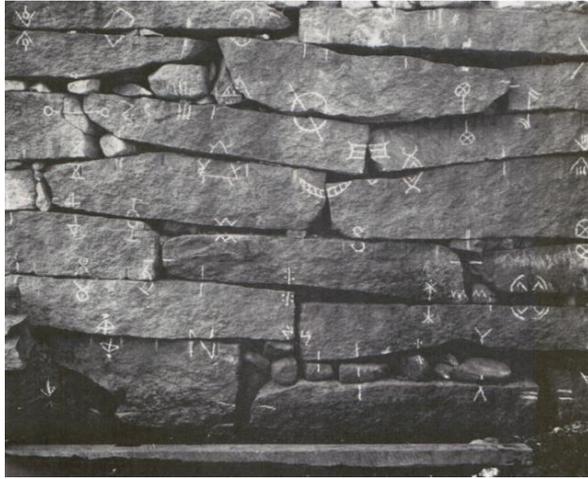
**Figure 7.** Ledger lines used in the numbering and dismantling stage (Curtis, 1979).

Before the dismantling stage, each stone row and each stone in the interior and exterior facades are numbered at ashlar buildings. Horizontal and vertical lines are drawn to show the relation of stones with each other and with adjacent stones. Detailed pictures

of the general condition of the building are taken (Figure 7). Then the stones are carefully dismantled and stacked in order so that the horizontal rows are not mixed. The blocks that are disintegrated during the dismantling and which cannot be reused are replaced by a new material which is compatible with the original. Stone parts are then assembled on the prepared base in accordance with the previous numbering scheme (Ahunbay, 1996).

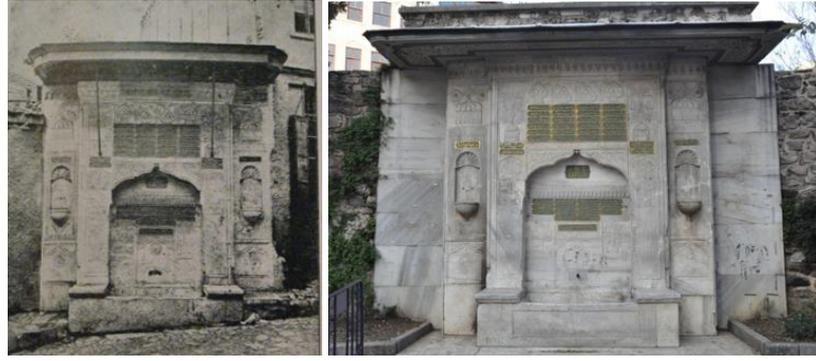
**Figure 8., 9.** Old and new views of the Bereketzade Fountain (Pilehvarian & others.)

Enumerating each piece during disassembly and reassembly process is commonly applied procedure in many countries of the world and in Turkey, as well. Small buildings such as fountains have been usually moved, sometimes to nearby to current location, sometimes to different settlements of the city. In particular, there are many examples of historical fountains that remain on the route during road widening or new road works. Tophane Kılıç Ali Pasha Fountain was moved to the corner of the complex when it was at the corner of the barracks opposite the mosque. The Hekimoğlu Ali Pasha Fountain, which was originally on Kabataş embankment, taken to the Kabataş pier square when Meclisi Mebusan Street was opened in 1957. Sadrazam Koca Yusuf Pasha Fountain, next to the Fındıklı Mosque, was removed from its original place to Kabataş during widening the Tophane-Dolmabahçe road. II. Abdülhamit Fountain located in front of the Nusretiye Mosque was moved to the corner of Maçka Park because of road widening works, too. The Bereketzade Fountain (Figure 8, 9) located next to Bereketzade Ali Efendi Mosque in Galata, was moved to the square where Galata Tower has been located (Can, 1993; Pilehvarian & others, 2000; Urfalıoğlu, 2008; Memiş, 2013).

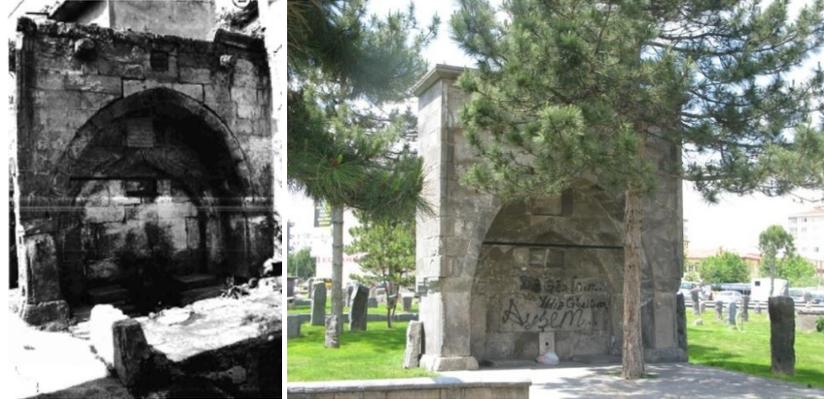
**Figure 10., 11.** View of Hacı Mehmet (Kaptan Pasha) Fountain before moving (Archive from K.K.V.K.B.K.) and its location in Seyyid Burhaneddin Cemetery (Batukan, 2017)

Unlike above mentioned examples which were carried to a nearby place of the same street, or district where they were originally located Hacı Mehmet Fountain (Figure 10, 11), Hüsrem Fountain (Figure 12, 13), Binbaşı Hacı Hayri Fountain and Kalemkırđı Mosque were moved to completely different districts of Kayseri Town Centre. Some of these fountains were moved to Seyyid Burhaneddin Cemetery from different locations of the city during the road widening works, and it was tried to be exhibited in a kind of open air museum. Similarly, Kalemkırđı Mosque was moved near Seyyid Burhaneddin Cemetery and opened for worship services.

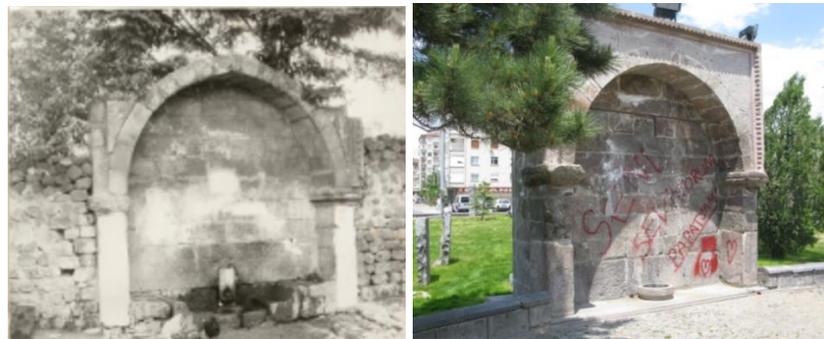
**Figure 12., 13.** View of Hüsrem Fountain before the relocation (Archive from K.K.V.K.B.K.) and its location in Seyyid Burhaneddin Cemetery (Batukan, 2017)

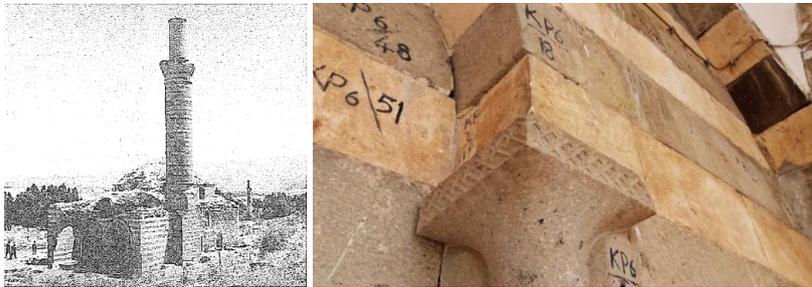
**Figure 14., 15.** The state of the Baysungur Mosque before the moving (Danık, 2004) and the numbering of its stones during the transportation process (Parlak, 2004).

Baysungur and Çelebi Ali Mosques in the district of Pertek in Tunceli were moved from the old Pertek to the new Pertek because of the threat of falling under the waters of the Keban Dam Lake. The stones, that were enumerated and dismantled, were

transported to Pertek Town Centre depending on study outcomes found at Faculty of Architecture of the Middle East Technical University between 1971-73, and were re-assembled in the place where it is today. (Figure, 14, 15). They have been opened to worship service. In this process, the stones were separated from each other by means of pickaxes hammers and levers. The dismantling process was started from the minaret, then the mihrab, minbar, windows and other stone faces were removed, and all of them were put and arranged in a row around the building. The dome and rubble stone walls were taken in the last stage. The structural elements were reassembled on the concrete foundation and reconstructed in the place (area) where it was moved. During reconstruction new materials were used. (Tükel & Bakırer, 1970; Danık, 2004; Parlak, 2004; Burat, 2006).

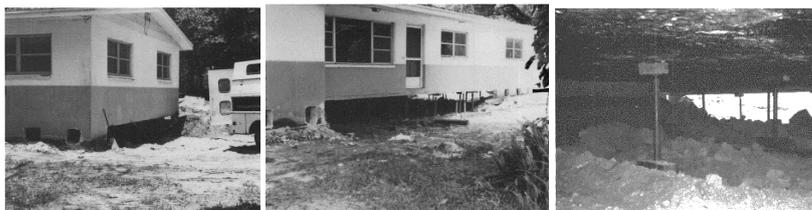
**Figure 16., 17., 18.** The process of separation from the foundations of the structure (N.F.P.C., 1990)

The process of moving buildings intact is a technique applied in many countries, especially in the USA. Unlike the techniques of separating the structure into its components it is essential to maintain the integrity of the building while performing this process. In this context, first of all, after the preparation of the survey, restoration and static projects, the building structure is separated from the existing foundations with the help of temporary supports or with the suspension technique (Figure 16-18). If necessary, precautionary measures are taken to reinforce structural elements by strapping or connecting equipments. The building, which is lifted with the help of lever jacks, is transported to the new location with the chosen technique and the assembly process is carried out on the reconstructed foundations.

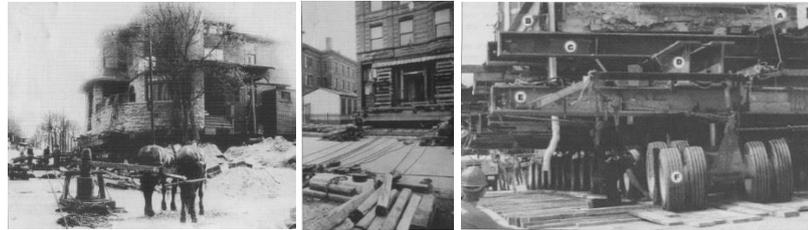
**Figure 19., 20., 21.** Examples of equipment used in traditional and modern methods of moving historical buildings (Goblet, 2006)

With the advancement of technology, this process has been being fulfilled by using equipment such as railroad tracks, skids, hydraulic jack and pistons, pallets (Figure 19-21). In general, three different ways are observed by tracks, by cylindrical rods and slides or by road vehicles such as trucks and trailers (Lu & others, 2010)

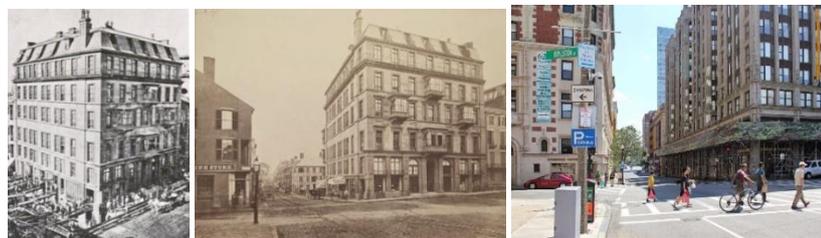
**Figure 22., 23., 24.** Transporting process and new location of Pelham Hotel (Close, 1875; Curtis, 1979; URL 3)

Implementation of the technique of moving buildings has been seen commonly in the United States that goes back to the 18<sup>th</sup> century. However, examples of moving by tracks have been usually seen in the 19<sup>th</sup> century. Considered to be the first example of a large masonry structure in the country, the Boston Pelham Hotel was built (Figure 22). The hotel, built with stone and brick material (Figure 23) has weighed about 5000 tons. In order to expand the road in the first stage, it was thought that some of the spaces in front of the hotel were to be demolished but it was determined that the transportation of the hotel could be fulfilled (realised) at a lower cost than the cost of this process and the building was suitable for moving. With a carefully prepared rail system, the hotel was towed about 2.54 cm in 5 minutes towards its new place, and, finally total replacement distance reached to 4.21 meters (Figure 24). During this 3-month-long transportation process, non-stop services were provided by utilising flexible pipes in plumbing and gas services, while workplaces and some hotel rooms on the first floor continued to serve during the moving process (Close, 1875; Curtis, 1979).

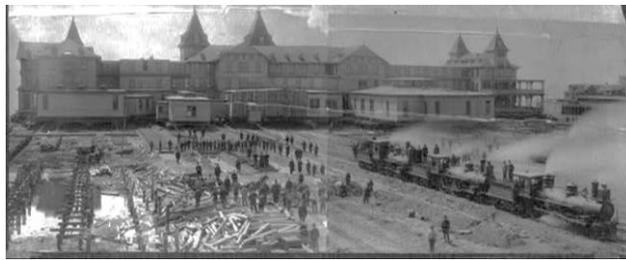
**Figure 25.** Transporting process of Brighton hotel in 1888 (Peltola, 2008)

Although the hotel was not a historical building and only a twenty-year-old building when it was moved, it was replaced by technological equipments instead of human or animal labour. The Brooklyn and Brighton Coast Railroad, the owner of the hotel, thought that moving the building in parts would cause the cost to rise. Thus, they decided to carry this building, which weighed approximately 600 tons, by using locomotives for towing. At a cost of about \$ 12,000, the building was carried 180 meters from the sea to the land (Figure 25). 112 platform cars were used for the transportation of the hotel and cars were connected to each other by using 168 lumber. In order to place the building on the platform cars, 13 hydraulic jacks with high weight lifting capacity were used. After the building was lifted, the cars were slid underneath the building and the building was towed to the new location by 6 locomotives (Peltola, 2008)

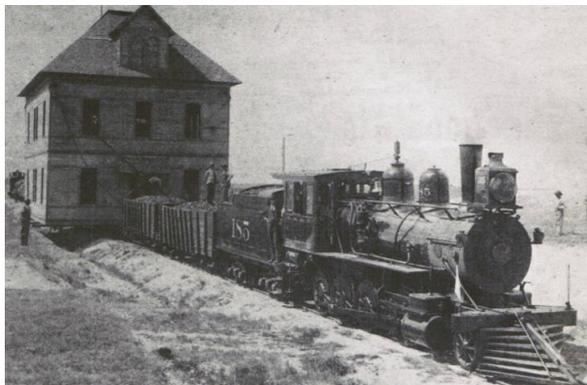
**Figure 26.** Transporting process of the Box Butte Courthouse by the locomotive (S.A.A. 1899; Curtis, 1979).

A similar process applied to the Brighton Hotel was held in Nebraska in 1889 for the Box Butte Courthouse, as well. As the Burling railway passed through the entire town of Box Butte, it was decided to move the district centre to the Alliance district, and decided to move the existing ten-year-old courthouse instead of constructing a new one. Approximately 95 tonnes of masonry building, by using 9 platform cars, was moved 14 km far away from its current location at the speed of 10 miles per hour (Figure 26) on the Burling railroad (S.A.A. 1899; Curtis, 1979)

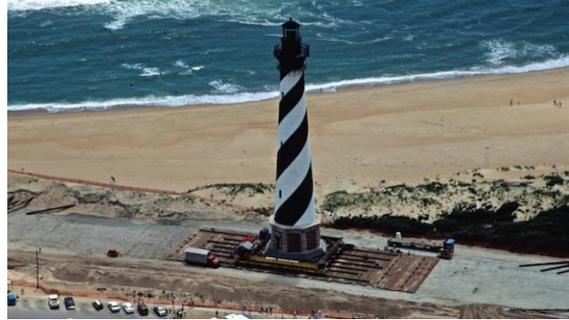
**Figure 27.** Transporting process of the Cape Hatteras lighthouse (Booher ve Ezell, 2001)

North Caroline Cape Hatteras building, the highest lighthouse in the United States, was moved 880 m away from its current location in 1990 due to ground abrasions caused by ocean waves.

The lighthouse, which measured 63.4 meters high, and a 2540 tons weight, was transported on tracks to its new place (Figure 27). Moving process took 23 days and cost about \$ 10 million (Booher ve Ezell, 2001; Peltola, 2008)

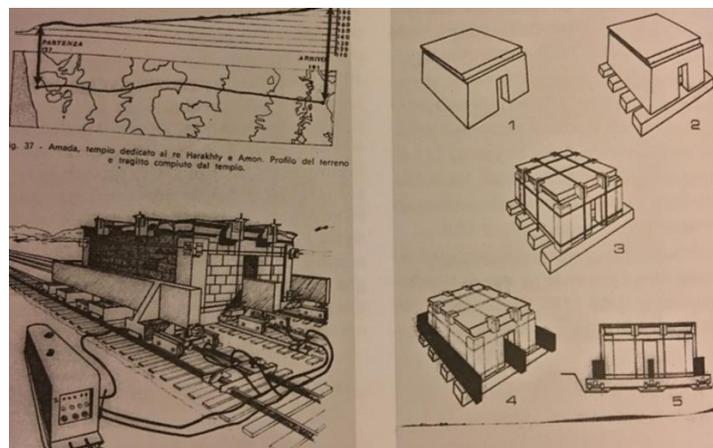
**Figure 30.** Transporting process of the temple (Ahunbay, 1996)

During the transportation process, after the temple was placed on the reinforced concrete foundation beams, its circumference was strapped tightly. Pulling on tracks was carried out with the help of beams passing through the monument, and through two sideways of it (Figure 30) (Ahunbay, 1996).

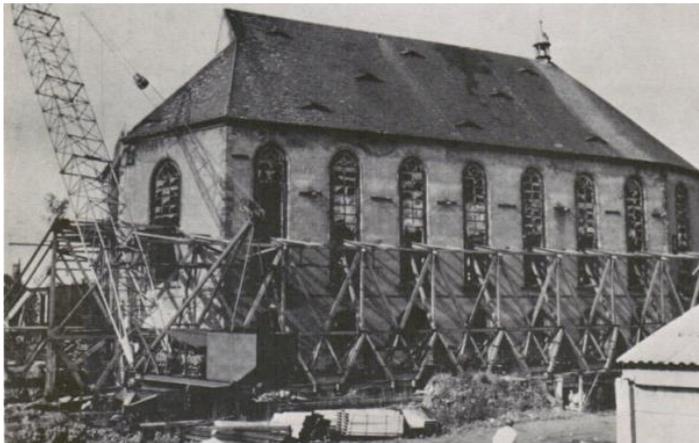
**Figure 31.** Transporting process of the cathedral (Curtis, 1979)

One of the historical relics carried by tracks in Europe is the Cathedral of the Assumption of the Virgin Mary in the Town of Most in Czechoslovakia (Figure 31). Due to the weakening of the ground by the tunnels dug during the operation of the coal mines, and collapses in the tunnels, it was lowered to 841 meters down from top of the hillside where it was constructed in the mountain in 1975. Firstly, the structure of the cathedral was reinforced, then, the walls of the cathedral were severed close to the ground and it was taken on a track system. The structure cut off from the ground was placed on the steel truss and carried down from the hillside at a low speed (Curtis, 1979; Ahunbay, 1996)

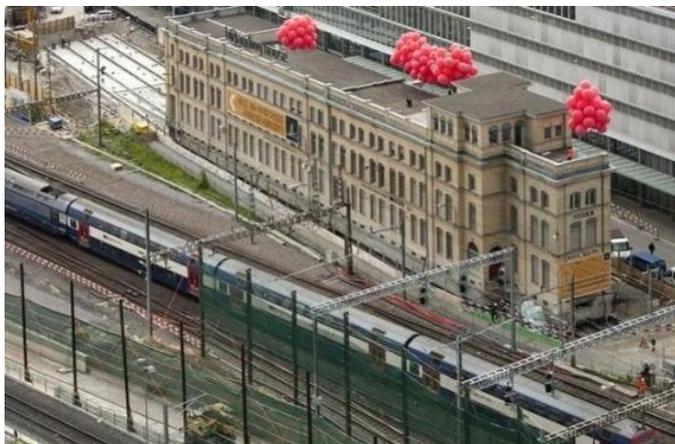
**Figure 32.** Transporting process of Oerlikon Machinery Factory (URL-6)

The Oerlikon Machinery Factory (Maschinenfabrik Oerlikon (MFO)), a 122-year-old building in Zurich, Switzerland, was moved 60 meters forward from its settlement by sleds as it intersected a railway being overhauled (Figure 32). The structure, which was separated from the foundation, was placed on the piles and was placed on the foundation previously excavated after being transported by tracks. The transport of 6200 tons of building at a speed of 4 km per hour was carried out at a cost of \$12.7 million. (URL-6)

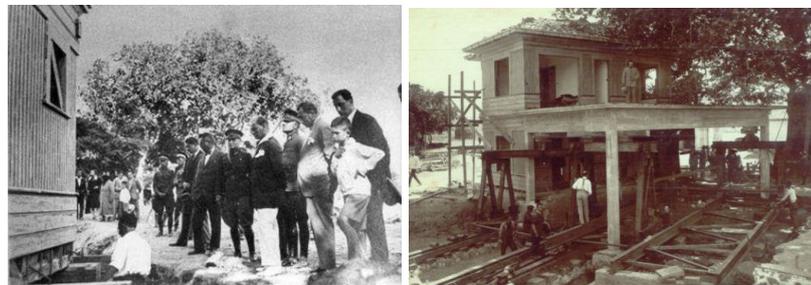
**Figure 33., 34.,** Transporting process of Yalova Atatürk Mansion (Bulut, 2013)

In Turkey, Atatürk Mansion in Yalova Thermal District is the oldest example of moving a building on the tracks. When Atatürk visited the mansion in 1930, the workers informed him that a branch of the plane tree next door was wreaking damage on the roof and wall, and asked for permission to cut the branch of the plane tree stretched out on the mansion. Atatürk, instead of cutting the branch of the plane tree, wanted them to move the building on the tram tracks to a place a little forward of the building. The relocation of the mansion was carried on in two stages. First, the terrace part of mansion was hauled, and then, the main building was moved on the tracks so, the building was moved about 5 meters away to the east (Figure 33, 34). Thus, the Mansion was rescued from being demolished, and plane tree survived. After that the mansion began to be called as the “Walking Mansion” (Ulusu, 2008).

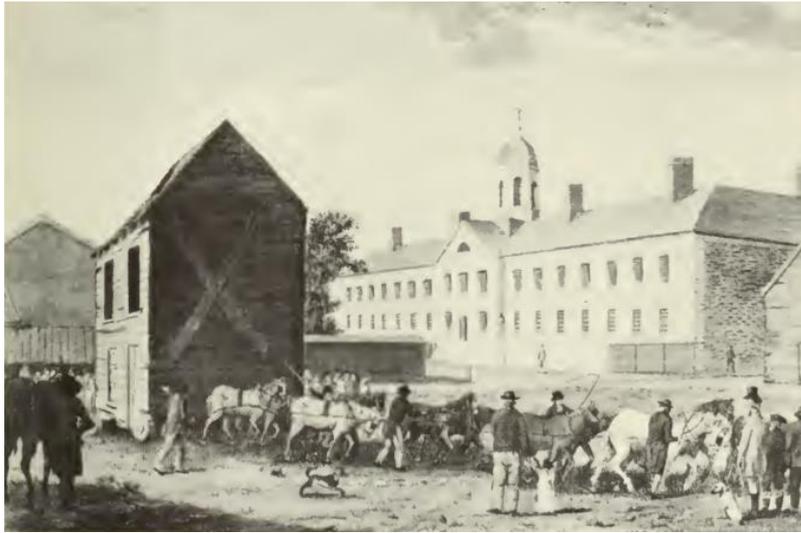
**Figure 35.** Moving a building in Walnut Street-Philadelphia in 1799 (Curtis, 1979)

*“The relocation of buildings by the sleighs, wheels and rollers has been a fairly common occurrence in the United States since the late 18th century. The cross bracing was used to provide added support for the structure during its move on wooden wheels.”* (Figure 35) (Curtis, 1979)

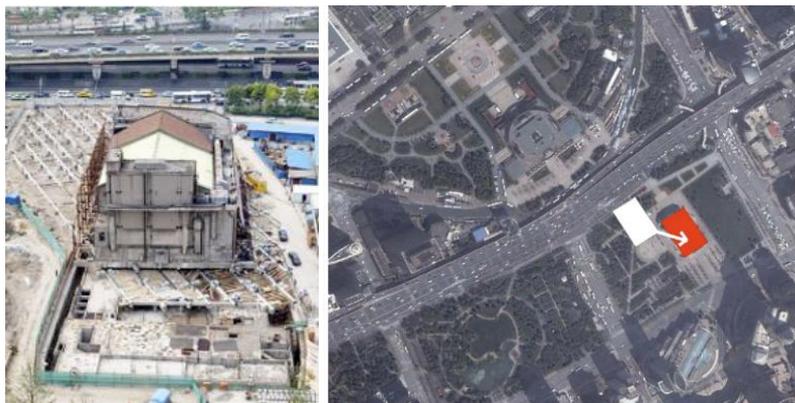
**Figure 36., 37.** Transporting process and the new location of the building (URL 7)

Moving by sliding has been often preferred in China. The Shanghai concert building, which has weighed 4500 tons, was moved up to 66.46 meters forward and 3.38 meters upwards in 2004 by using a sliding platform to prevent noise and environmental pollution coming from the motorway next to it (Figure 36, 37) (URL 7)

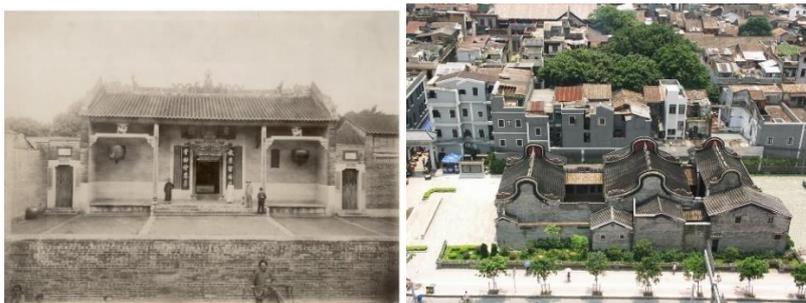
**Figure 38., 39.** Old and new view of Jinlun City Hall (URL 8)

**Figure 40., 41.** Transporting process of Jinlun City Hall and Quyuan Temple (Lu ve diğ., 2010)

The place of the Jinlun City Hall in Qing Dynasty, China, was relocated by sliding 102.5 meters using cylindrical rods in 2001 (Figure 38, 39). Another example of the method of moving by cylindrical rods is the Quyuan temple in China (Figure 40, 41). The temple was moved to a location 3 km further in 1976 in order to be rescued from being underneath the water of the river (Lu and others, 2010).

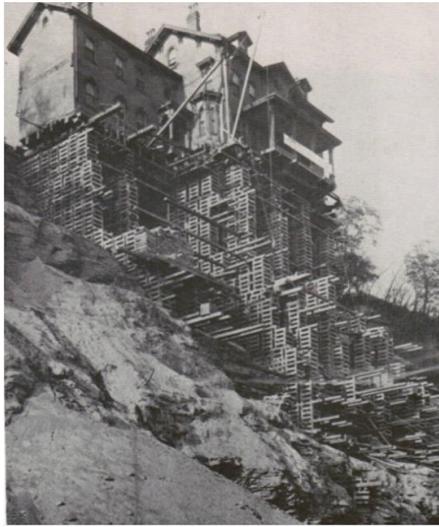
**Figure 45.** Transporting process of Captain Samuel Brown's mansion (S.A.A., 1923; Curtis, 1979)

The mansion of Captain Samuel Brown, on the edge of the Monongahela river in Pennsylvania, USA, was moved in 1903 due to its existing site's being stood on the Baltimore and Ohio railway route. The landlord decided to move his property to a big orchard belonged to him, and it was 50 meters above the building's existing location. In order to move the building weighed about 800 tons, 8 planks 30x40 cm of size and 25 m. of length were placed underneath of the building. First, the structure was lifted up to 9 meters by means of two cranes connected to the peak of the cliff next to the house. (Figure 45), Each crane used in this process was pulled by two horses. This process was repeated 4 times, and was

moved 60 meters back and 48 meters up the original site of the house (S.A.A., 1923; Curtis, 1979).

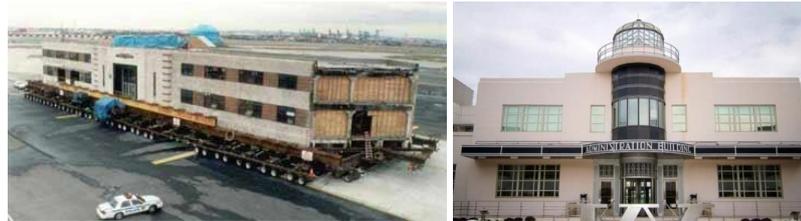
**Figure 50., 51.** Transporting process of the terminal building (URL 10)

The building numbered 51 at the New Jersey Newark International Airport was moved 1.2 km away from the airport during the renovation and expansion works there (Fig. 50, 51). The moving process of the terminal building, which weighed 7400 tons, lasted for 5 months. Before moving, the terminal building was disassembled into three parts and transported by 176 wheeled vehicles at a speed of 30 meters per hour. The building is currently used as an airport administration building (PANYNJ, 2017).

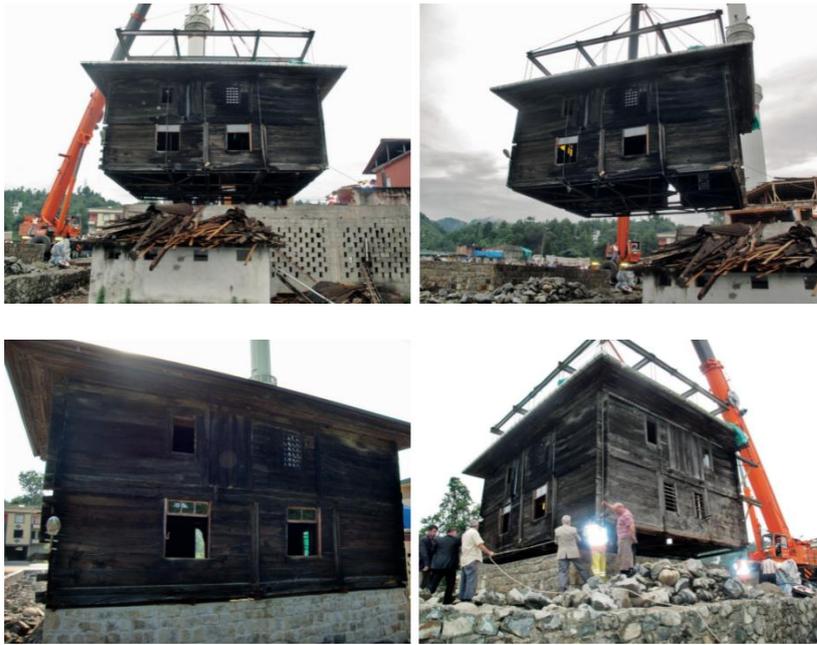
**Figure 52., 53., 54., 55.** Relocating the mosque in its new position by means of a crane (Sav, 2012)

Another example of moving buildings in Turkey is Kalkandere Hüseyin Hoca Köyü Sahil Camii's relocation in Rize. The wooden mosque, left unattended in Keler, where was an over-migrating village, was moved to Hüseyin Hoca Köyü in 1977. For the mosque was constructed by timber only and without a foundation it was, for the first step, placed over a warehouse for tea purchasing. After the warehouse became dilapidated after 34 years it was moved for the second time. After removing the non-original roof, steels laid diagonally under the building, and steels laid over the building were attached together by calculating centroid of area, and formed a steel cage in which the building was placed. The building was lifted by a crane and placed in a lot 20 meters far away (Sav, 2012) (Figure 52-55).

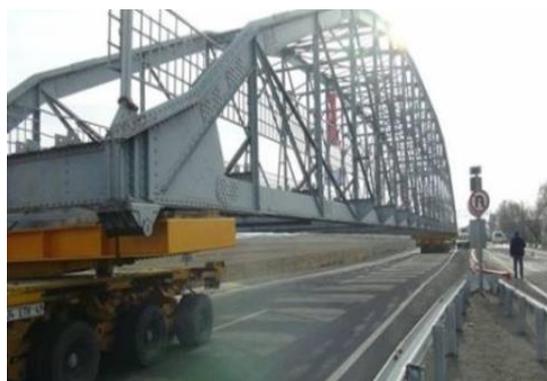
**Figure 56.** Transporting process of the bridge (Sömen and others, 2015)

There has been an on-going dam construction on the Stream of Kars in Susuz district of Kars. Whereas, the historic Çamçavuş Iron Bridge, built by Russians in 1899, was located on this stream. The bridge was 65 meters long, 5.60 meters wide and weighed about 100 tons. Since the construction of the dam has been on-going, and by the time it will have been finished it will have had a dam reservoir, and the bridge will have been underneath of the waters, the bridge has had to be moved to the Campus of Kafkas University. Thus, the bridge was taken by the General Directorate of Highways from its location by means of hydraulic system vehicles in 2015, and it took them two days to transport it to the Campus<sup>58</sup> (Sömen and others, 2015) (Figure 56).

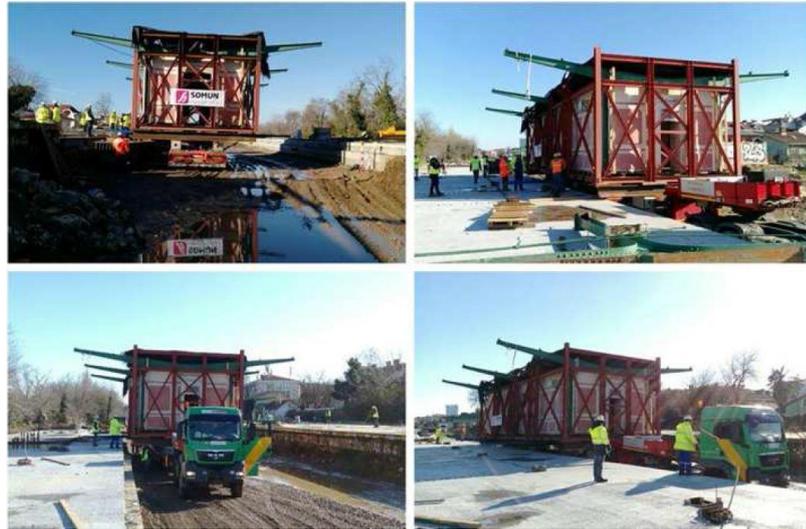
**Figure 57., 58., 59., 60.**  
Transporting process of Yeşilköy Train Station Building (URL 9, URL 10)

During the construction of Marmaray, it was decided to move the Yeşilköy Train Station Building between 2016-2017. In order to accommodate the 4.16x5 m sized structure on the truck's trailer, a cage system that inwardly and outwardly surrounded the building was designed and the total weight of the building increased to 90 tons. The building was removed from the ground

with hydraulic jacks and tracks were installed underneath. It was placed on the truck's trailer with the help of tracks and hydraulic pistons and moved to its new position at a distance of 90 m. Before transportation ground was reinforced on the road in order to prevent any collapse due to the weight of the vehicle and the load on it (Kösebay, 2007, URL 9). (Figure 57-60)

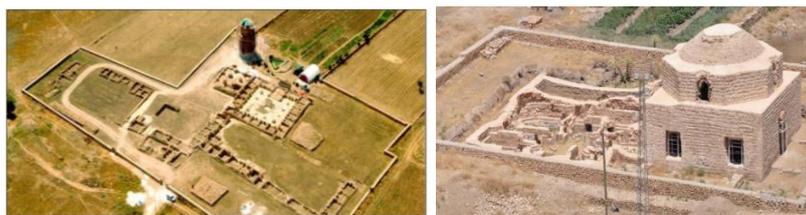
**Figure 61., 62.** Zeynel Bey Complex and Artuklu Bath (Ulucam, 2016)

One of the significant operations of moving buildings, carried out in recent years, in Turkey, has been the relocation of Zeynel Bey Tomb and Artuklu Bath, located in Batman's Hasankeyf district. (Fig. 61, 62). A science commission has been established against the threat of the buildings being flooded by the Ilisu Dam. This commission has evaluated the alterations including protection, and recommended that the buildings be moved intact and should be placed in the Cultural Park in new Hasankeyf (Ulucam, 2016).

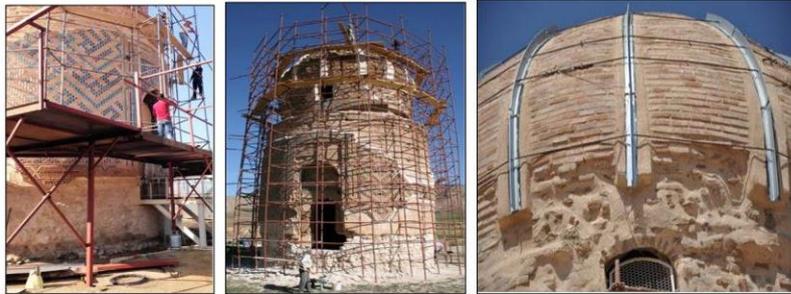
**Figure 63., 64., 65.** Restoration process before moving (Ulucam, 2016)

Before the tomb was moved, firstly, damage assessment and reinforcement studies were carried out (Figure 63-65). A high foundation for lifting the building was constructed around the tomb and 28 lifting beams were produced for being used on the lower parts of the walls. Lifting plate was completed by applying post tensioning of a 90 cm height, and 44 hydraulic jacks were installed. For transporting the buildings, SPMT (Self Propelled Modular Transporter), a vehicle capable of carrying the desired weight up to 4% of the slope on standard road conditions, was used, and tomb was transported by 6 SPMTs. In this context, accelerometers were placed on the building to measure the

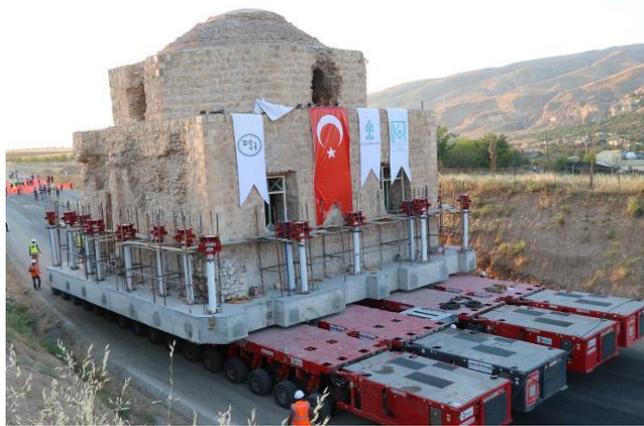
**Figure 66.** Transporting process of Artuklu Bath (URL 13)

movement of SPMTs during transportation. All these sensors and systems were integrated with the control module of the SPMTs that would carry out the transportation, and integrated with a special computer program prepared only for this building (URL 12). The Artuklu Bath, which was moved in 2018, was also relocated by a similar system. (Figure 66).
