The Evaluation of Cultural Identity by the Preservation of the Historical Heritage of Saint George in Mondonico

The project of preservation and valorisation of the built heritage in Mondonico, an ancient village of Dorio municipality (Northern Italy, Lecco lake area), is an example of diffusing knowledge, protection of the Cultural heritage.

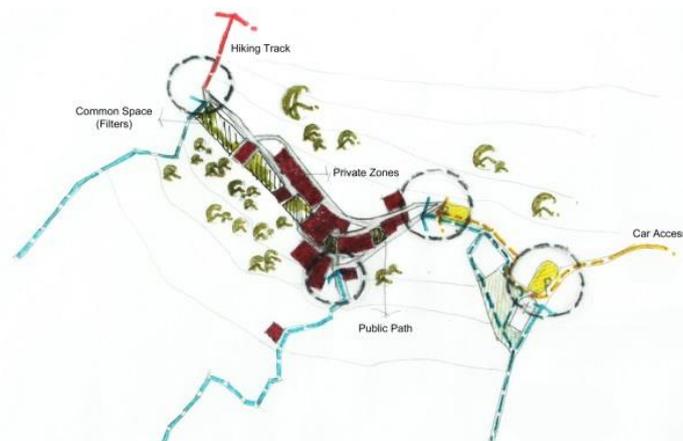
In Mondonico village, at the southern edge of the urban blocks, a small white church and its bell tower rise on the top of a small hill, close to the Mills valley.

Figure 3. Mondonico: the masterplan of the village

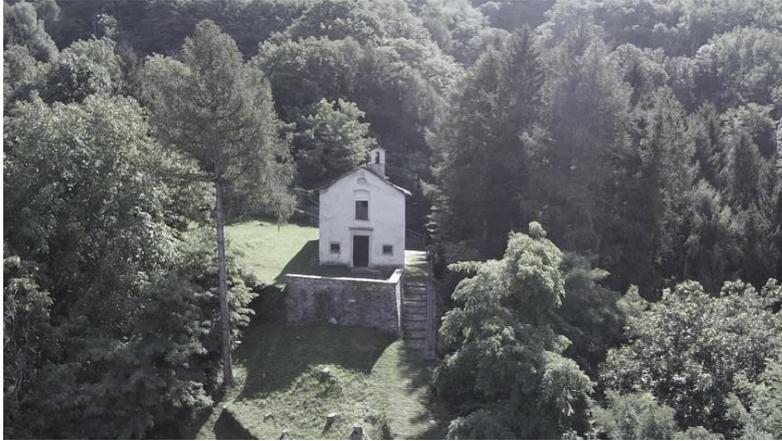
It is the first church built in Mondonico community. It is dedicated to the warrior martyr Saint George, a dedication very popular in the area. The inhabitants set the church in a sacred area separated from other buildings, instead of building the church in the middle of the other housing and farming constructions. Near the church, in the past, up to the 19th century, there was a cemetery. The church entrance has its orientation towards west, according to the tradition. The churchyard lies on an artificial terrace, on an upper level from the natural slope of the hill, supported by a constraining stone dry wall.

The courtyard has a double function: to create a respectful area in front of the church and build the base of the façade, together with the stairs on the side.

Figure 4. The church of Saint George in Mondonico, aerial view

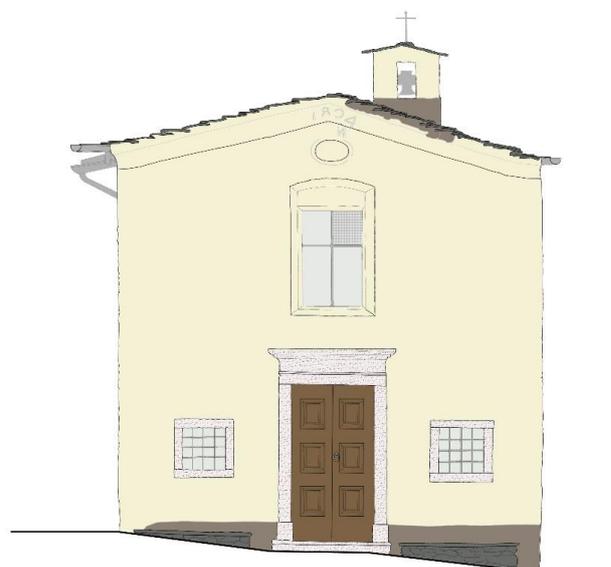
The survey on field is the second step towards knowledge. Material identification is important to understand the historical and cultural value of the church. The analysis was supported by a study upon traditional building techniques used when the church was built. The facades' analysis highlighted these materials:

- Local stone;
- Rough plaster as finishing material (civil plaster just on the main façade);
- Cement mortar for the basement part of the building;
- Granite for details: windowsills and doorsteps;
- Lime and cement mortars as patches on the walls;
- Iron for drainpipes and eaves;
- Wood for the entrance door and a window on the north side;
- Lombard cotto overlapped by Italian 'piode' made by local stone for the roof.

Figure 5. North-West elevation: an example of surface mapping of materials

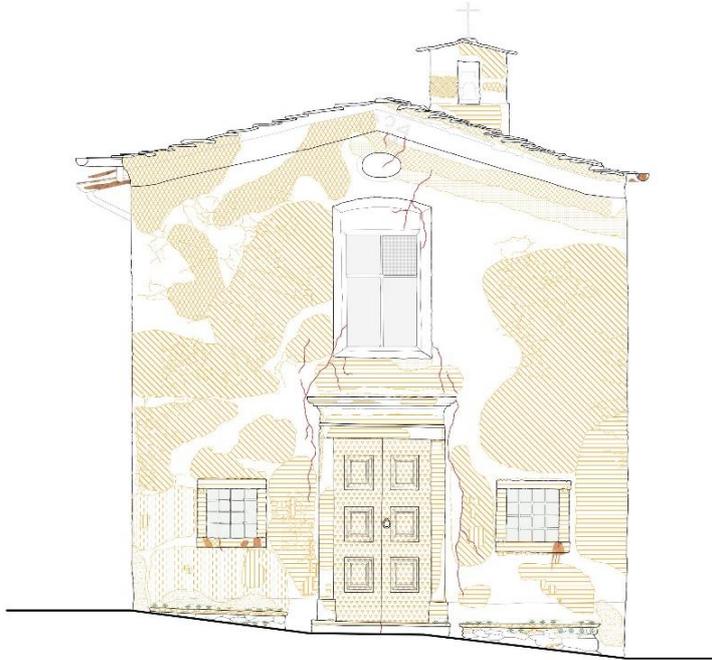
After an initial visual evaluation, the following hypothesis was proposed: “Lake Como’s climatic context, in combination with the microclimatic conditions of Mondonico, is the cause of surface damages including erosion, biological attack and overall degradation”. The deterioration survey has the aim of listing building’s damages and make theories upon the possible reasons that produced a particular pathology, that the diagnostic analysis later confirms or rejects.

Figure 6. North-West elevation: an example of surface mapping of damages

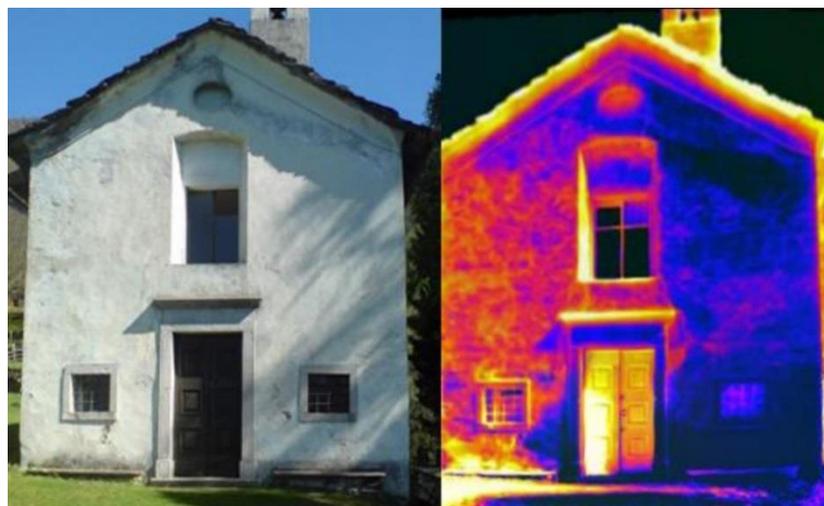
An infrared camera displays images with different color gradations that show surface temperatures. Each material has a different thermal capacity, this is the reason why are able to observe the differences between the high temperature of window frames made by granite and the low temperature of plaster in the thermal images. To analyze the main façade (on the north-west side): the right portion is partially shaded by trees, so it has a

lower temperature, while the left part is completely exposed to sunrays and it has a higher temperature. In the right portion, from the basement level to the windowsill, the temperature is quite low (15°C) compared with the rest of the façade; this can be suggestive of the presence of upwelling humidity with consequent phenomena of biological patina and plaster detachment. In the right upper part, there's another low temperature zone (15,5°C), which can be explained by the presence of water's seepage from the roof.

In the left portion, which is warmer, the basement part has a higher temperature (20,5-22°C); this is the typical effect produced by a plaster detachment, and this hypothesis is confirmed by the dull sound produced by knocking on the wall. There are some sporadic thermal gradients irregularly distributed along the entire façade; this is the effect of an uprising micro-cracking phenomenon and possible erosion.

Figure 7. North-West elevation: an example of application of infrared thermography

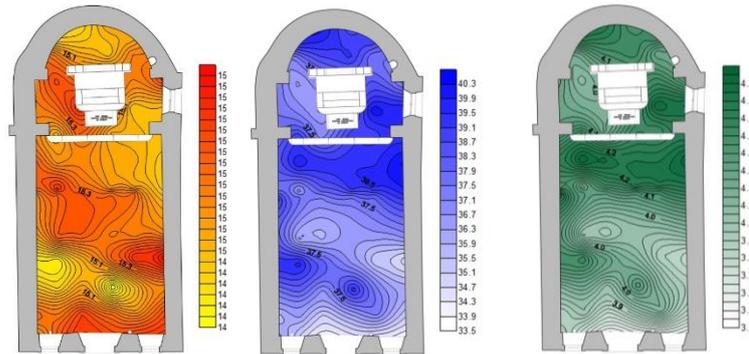
Figure 8. Psychrometric analysis: maps of temperature, relative humidity and specific humidity

The temperature data indicate that the eastern side of the apse is the warmest area inside the church because of the constant sunlight hitting this façade. The maximum amount of moisture was found in north and south facades, probably due to the lack of sunlight received.

The relative humidity data yield good results. The spread of humidity is relatively homogeneous and doesn't have any high concentration in a specific point. Data from specific humidity is similar to the relative humidity data.

Finally, after all the analyses, it can be said that the infiltration of water and moisture found in some points is linked to the phenomenon of capillary rise, leading to the formation of biological patina and mold. From a structural perspective, there is a possibility of failure at the foundations as observed from the cracks on the floor and on the main façade.

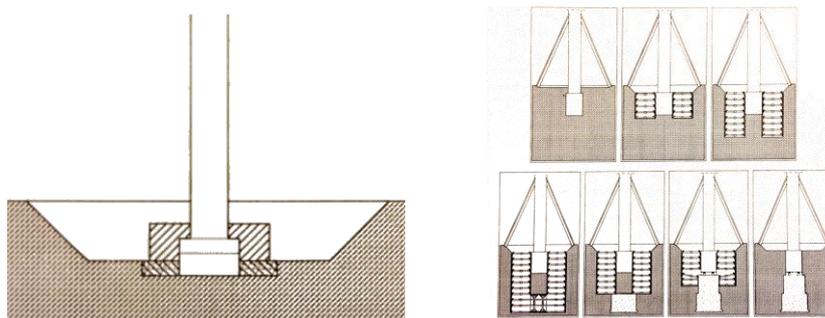
Figure 9. Consolidation backdrop with tiling bead and underpinning masonry (Carbonara, 1996)

To avoid the problem of the instability of the old shallow foundations to respond adequately to the loads and stresses transmitted from the building, the designer can prepare different principals. The static improvement of the foundations can take

place through the addition of elements in reinforced concrete that can be placed beside or below them.

Normally, you create works that increase the support section alongside the existing foundations with new structural elements connecting them closely with the original foundation walls. These interventions are not very invasive due to needless temporary works and limited excavation depth (50-100 cm).

This first hypothesis of intervention is to be excluded in our case study in view of the impossibility of engagement of the support elements to the original foundations stone.

In our case, we must recourse to underpinning placed at greater depth so that the original foundations may rest on the new structural elements without the need for fasteners. Another method of intervention to strengthen the foundations is the use of an underpinning piles or micro-piles. We resort to these solutions only in special cases of the presence of water or land very soft requiring high excavation depth. For the case under consideration this is a method too invasive, expensive and unnecessary (Carbonara, 1996). To understand the magnitude and evolution of all the cracks we need a careful periodic monitoring. With more accurate information, we can proceed to implement targeted interventions.

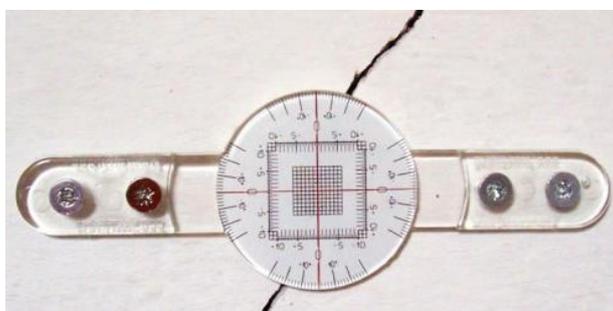
Figure 10. A simple and cheap tool for monitoring cracks

The structural cracking ensued the worst damage, probably due to the location (on a steep slope) and the soil. Without a rigorous monitoring of the cracks, it is not possible to design an appropriate intervention. It is strongly recommended to start structural monitoring, as soon as possible, with the aim to obtain the necessary data at least for the application of provisional strengthening that could prevent further damages.

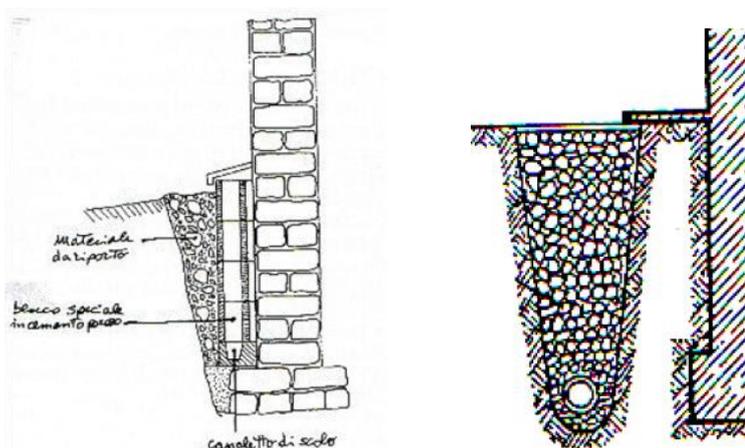
Figure 11. Scheme of two drainage methods

To remove water from the perimeter walls we propose a drainage system.

The first method consists of excavation on the left side of the foundation, to put at the base, a drainage pipe that collects water and conveys it in a controlled discharge. The excavation is filled with drainage material.

Another solution consists of constructing a gap like a trench. In this way, it is easier for the evaporation of water in the masonry, possibly absorbed by capillarity by the foundations. It is necessary to have a space of 40-50 cm to construct an effective gap. It is also important that the cavities are ventilated to ensure the air circulation and permit the elimination of moisture that evaporates from the wall. Even if expensive, this technique is one of the most effective ways to protect the walls of new buildings from contact with water. In our case, in a building with ancient foundations, the addition of this system is particularly complicated and invasive due to the presence of grid or metal flashing along the perimeter of the church. For these reasons, between the two drainage methods proposed, the first is preferable.

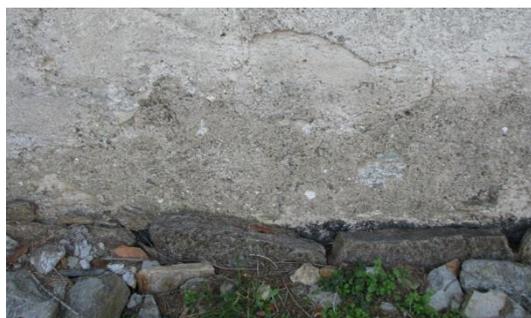
Figure 12. The western masonry of the Church

To perform the best removal of the water, it is proposed to redo the waterproofing layer bitumen (recommended thickness: at least 4 mm) already present at the base of the facade on the north-east and to arrange the stones in a protective sheath.

It is experimentally verified that for walls with a thickness ranging between 40 and 80 cm, as it is in this case, passive methods (waterproofing associated with drainage) decrease up to 2/3 the surface contact between building and ground.
