Conservations and Rehabilitation in Historical Urban Centres: Halit and Gaziosmanpaşa 22nd Streets, Tokat, Turkey

Emine Saka Akın*

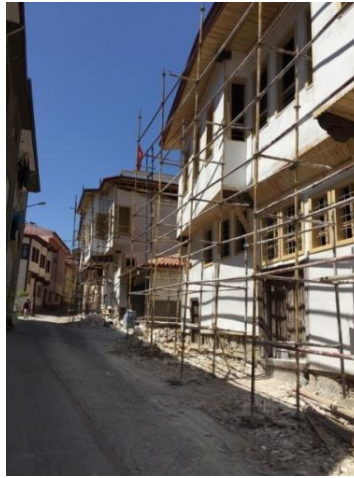
Figure 1. Restoration works just started in Halit Street (*by the author*)

settlement areas. As such, it is indispensable to increase the perceptibility of historical urban centres, which have entered into an evacuation process, and to augment their conditions of comfort. Local governments, associations, and citizens have to assume the important task of finding solutions to problems including economic, spatial, social and political issues by prioritizing the concept of lasting and sustainable space. Also setting as a target this area to be reused, the Governorate of Tokat has put on its agenda its rehabilitation project, had the projects prepared, and initiated the implementation process as of 2017 (Figure 1).

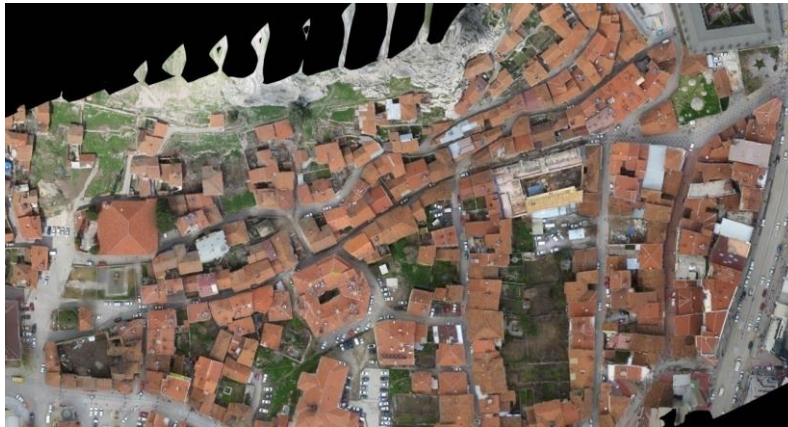
Figure 6. Aerial photo of the project area (Archtech Mimarlık Ltd. archive)

There are 64 buildings facing the two streets, including 40 traditional buildings out of which 9 are registered, 17 new buildings, 6 monumental buildings, and 1 mosque (Figure 5, 6, 7, 8). The municipality has conducted maintenance work during the early 2000s on the outer facades of traditional buildings facing Halit Street, which were not part of a project.

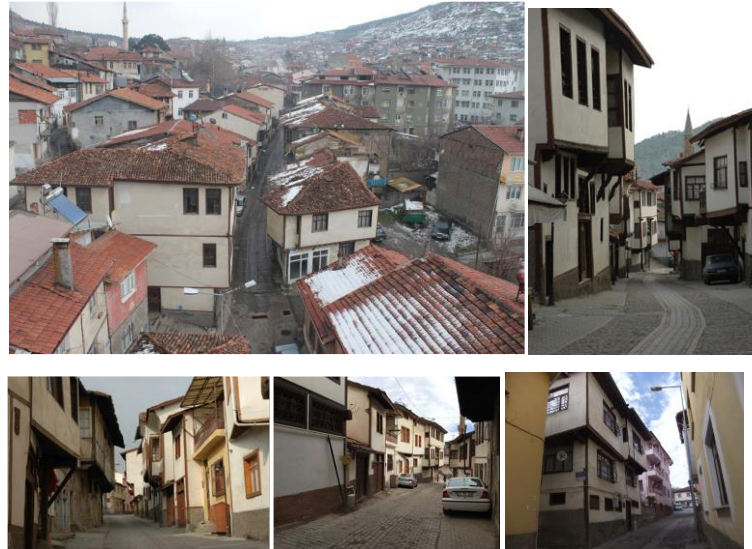
Figure 9. Views from the project area *(by the author)*

Buildings line both streets that connect Gaziosmanpaşa Boulevard with Sulu Sokak with an average elevation of 5.5 %. Houses situated on the street, the sharpest elevation of which is 8,5 % and the width of which varies between 4 to 7,5 meters, in an organic order consistent with the features of the land and its ownership.

The frontal facades of the buildings face the street and demark the borders of the street. All buildings on the street are attached and situated next to each other in a row. The attached rows are broken only when giving passage to roads. 3 buildings have gardens in front, and 6 buildings have gardens at the side and at the back facades. With the exception of those with front gardens, the entrance to the buildings is accessed from the street. There are also reinforced concrete buildings in between the traditional buildings (Figure 9, 10, 11, 12, 13).

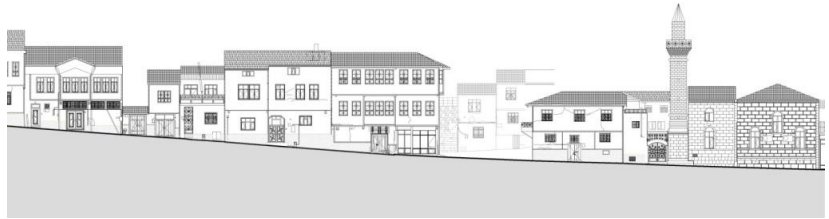
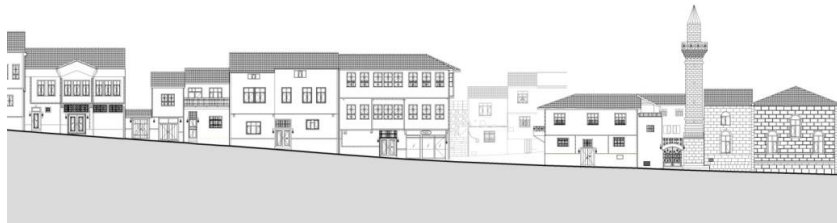
Figure 10. The survey of north silhouettes (*Archtech Mimarlık Ltd. archive*)

Figure 11. The restoration of north silhouettes (*Archtech Mimarlık Ltd. archive*)

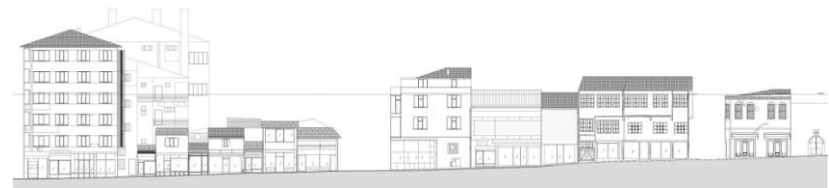
Figure 12. The survey south silhouettes (*Archtech Mimarlık Ltd. archive*)

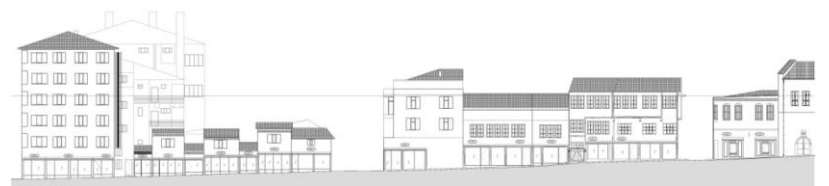
Figure 13. The restoration south silhouettes (*Archtech Mimarlık Ltd. archive*)

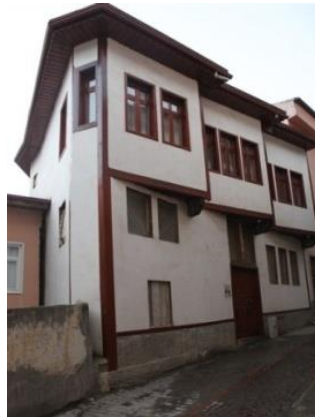
Figure 14. The traditional house at block 133, lot 109 (by the author)

Projections constitute the most prominent and characteristic elements of street façades and they vary a great deal. Projections of all houses, usually supported by arches, called "*eli böğründe*", are built uniformly. Almost all of the traditional houses have one storey above the ground floor, and only one has two storeys above the ground floor. The outer facades are plastered with white sweet lime plaster, and their windows are proportioned by a ratio of $\frac{1}{2}$ and have wooden frames. The area has 13 ground floor+one storey, 8 ground floor+mezzanine floor+one storey, and 1 ground floor+2 storey houses (Figures 14, 15, 16, 17, 18, 19, 20, 21, 22, 23, 24, 25).

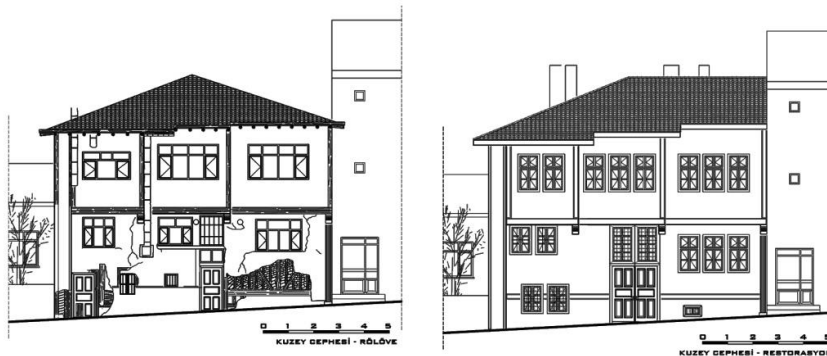
Figure 17. The survey and restoration façades of the traditional house at block 133, lot 109 (Sivas Kültür Varlıklarını Koruma Kurulu archive)

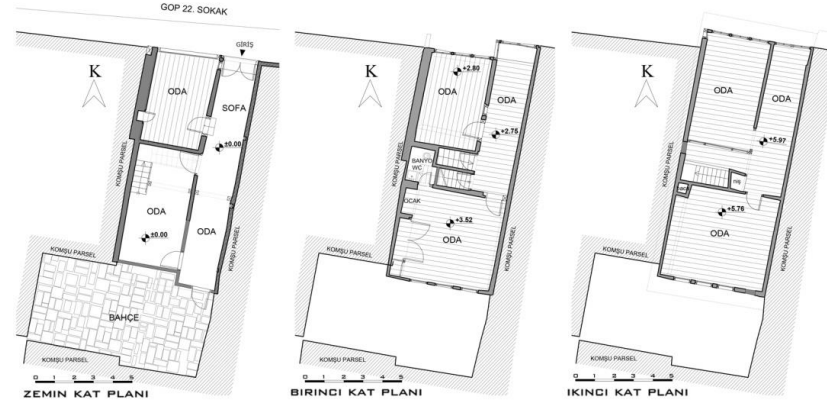
Figure 20. The restoration plan of the traditional house at block 135, lot 23 (Yaprak Mimarlık Office archive)

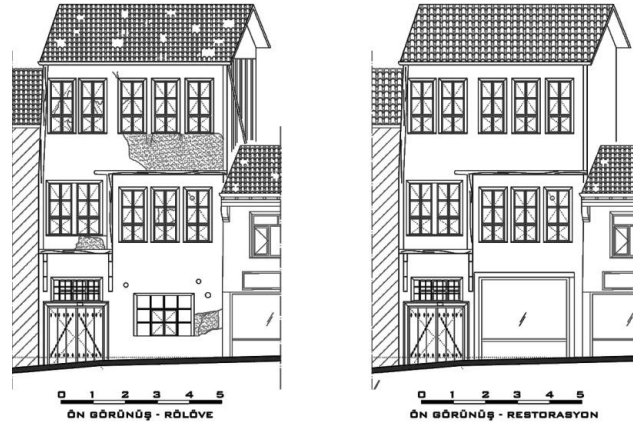
Figure 21. The survey and restoration façades of the traditional house at block 135, lot 23 (Yaprak Mimarlık Office archive)

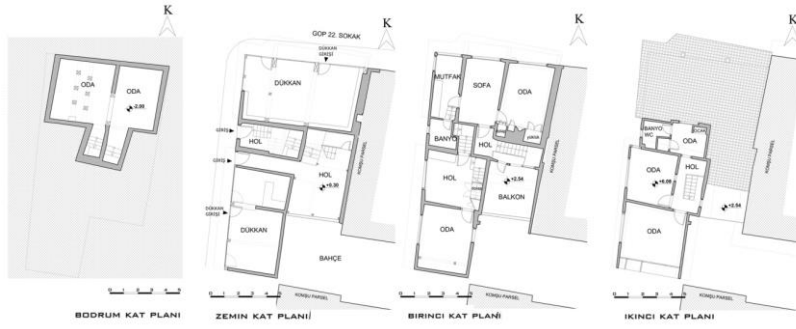
Figure 23. The survey plan of the traditional house at block 135, lot 75 (*Yaprak Mimarlık Office archive*)

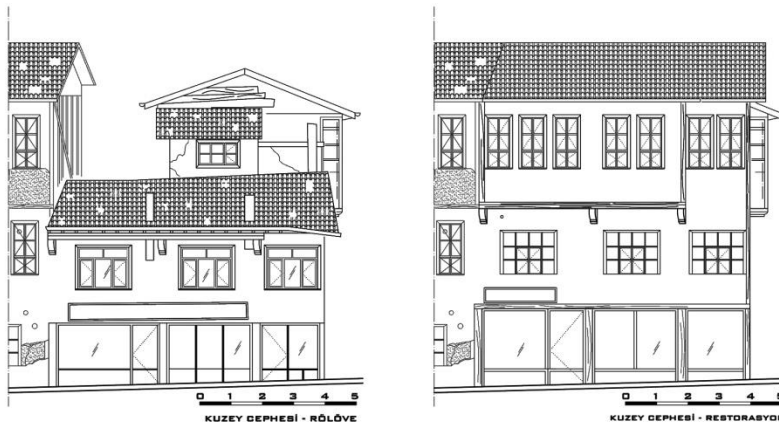
Figure 25. The survey and restoration façades of the traditional house at block 135, lot 75 (*Yaprak Mimarlık Office archive*)

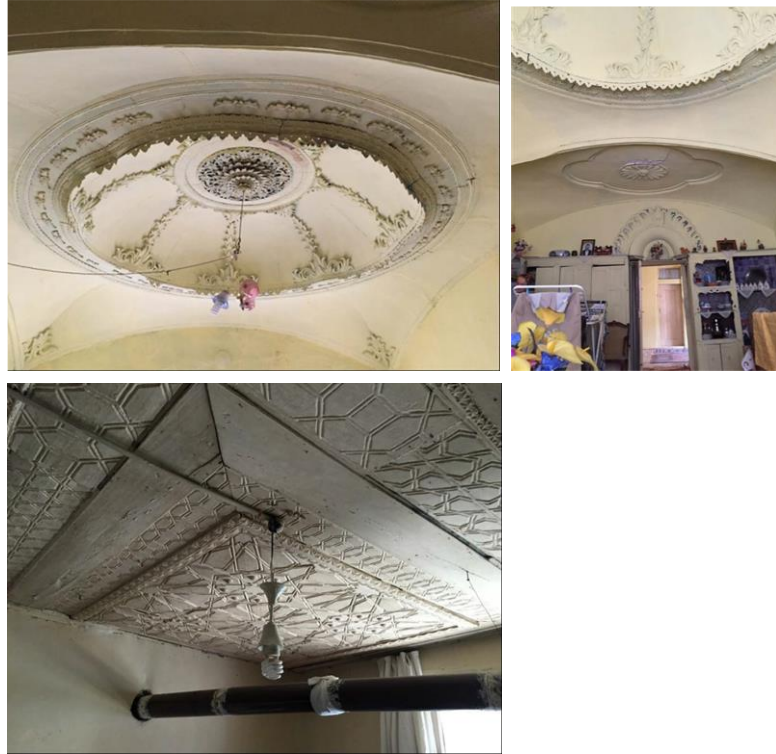
Figure 26. Views of interior space of the traditional house at block 241, lot 1 *(by the author)*

Indoor elements and decorations have the characteristics seen in Traditional Houses of Tokat. While these houses look very plain and modest from outside, their indoor decorative elements are quite ostentatious, and they feature hearths, wooden ornamentations, light fixtures, ornamented ceilings, and built-in closets (Akin and Hanoğlu, 2013) (Figures 26, 27, 28).

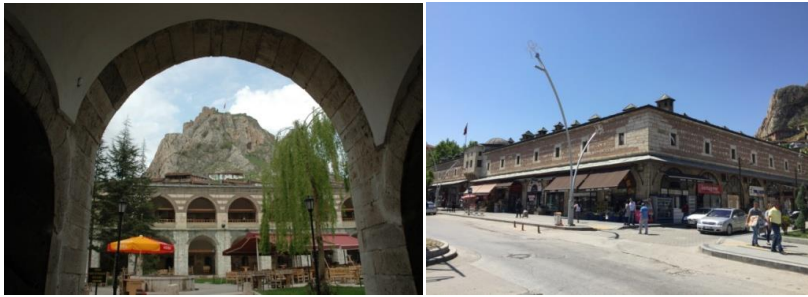
Figure 29. Taşhan (*by the author*)

Taşhan (Voyvoda); located at the intersection of Gaziosmanpaşa Boulevard and Gaziosmanpaşa 22nd streets, Taşhan (*Stone Inn*), an Ottoman period commercial building, was built between 1626-1632 (Mercan et al., 2003) (Figure 29).

These streets contain three inns, a bathhouse, and two mosques which can actively be used. Located at the intersection of Gaziosmanpaşa Boulevard and the Gaziosmanpaşa 22nd streets, Taşhan is still in use today. Located on Gaziosmanpaşa 22nd Street, Yazmacılar Han, the restoration of which has been completed, was considered for use by workshops and shops where courses for the vanishing hand-printing of cloths would take place. Tokat has a great bathing culture, and the Pervane Hamam in the project area is expected to keep on with this tradition. Katırcılar Han in the area was proposed to be restored as a social facility with both open and closed spaces following its immediate expropriation. In addition, Ulu Camii will have programs ensuring that larger crowds have access to the street.

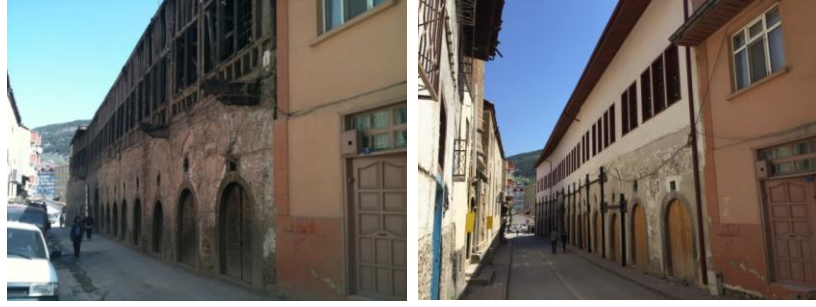
Figure 31. Yazmacılar Inn (by the author)

Yazmacılar (Gazi Emir, Gazioğlu) Inn; this two storey inn with an inner courtyard has a quadratic plan, and its construction date is unknown. Located on Gaziosmanpaşa 22nd Street, it used to be private property, but went into the ownership of the Regional Directorate of Foundations. Today, its restoration work is complete (Figure 31).

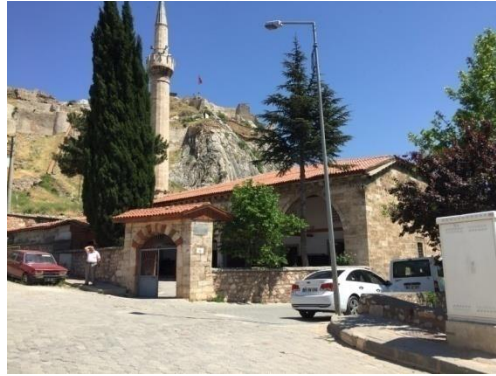
Figure 32. Ulu Mosque (by the author)

Ulu Mosque; located in Cami-i Kebir neighbourhood to the North of Halit Street, the inscription on the eastern entrance of the mosque shows the date of 1678, but this is the date of its renovation. In reality, it was built during the Seljuk period, but was damaged because of fire, earthquake, etc., and was rebuilt during the Ottoman period, based on its original foundations (Erdemir, 1986) (Figure 32).

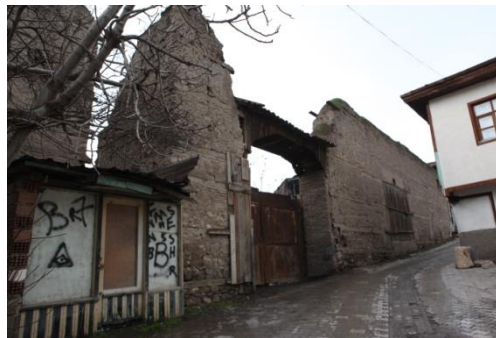
Figure 33. Katırcılar Inn (Archtech Mimarlık Ltd. archive)

Katırcılar Inn; there is no definite information about the construction date of this dilapidated building of an inn, of which the northern façade is on Halit Street (Figure 33).

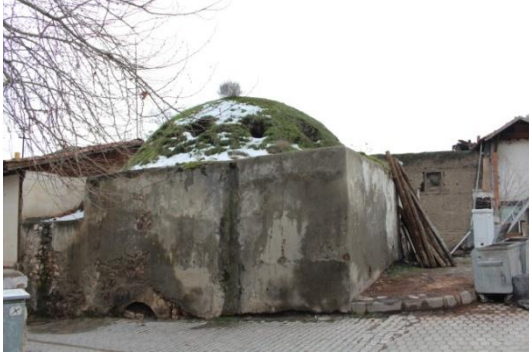
Sık Dışını Helâsı; the construction date of this building located on Halit Street is unknown. It is a single space, domed building, with unoriginal additions inside. Since it was used as toilets for a while, the populace calls it by this name. The small round windows on the dome indicate that it must have been a section of a bathhouse. The higher ground elevation of the building was lowered during the excavations conducted in 2017 to its entry elevation, and the

house attached to its eastern façade was knocked down (Figure 34).

Figure 34. Sık Dişini Helası
(Archtech Mimarlık Ltd. archive)

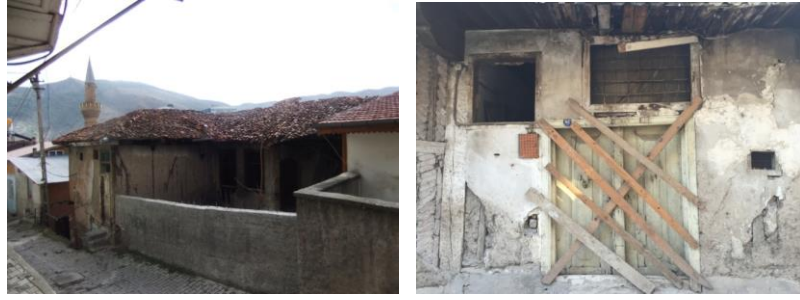
Interventions made to buildings over time and reasons emanating from physical conditions have caused historical buildings to age. For this reason, buildings which have not been maintained for a long time have serious structural damages (Figure 35). Buildings with structural damage and adjacent to the road are also of concern for life safety. Physical comfort conditions of buildings which have not been maintained are also not in good shape.

Figure 35. The structural damages
(by the author)

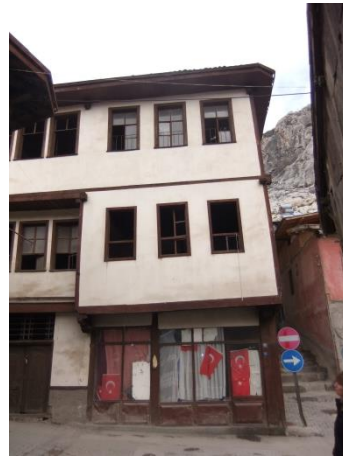
Figure 37. A view of the traditional house at block 242, lot 1 (*by the author*)

For this purpose, an unused, registered traditional house with ground floor+2 storeys was identified for holding courses on by gone handicrafts, music, etc., as part of the social activities to be undertaken on the street (Figure 37). The front and side facades of this traditional house with an L shaped plan, located at block 242, lot 1, seemed to be damage-free, but there were collapsed areas at the back façade and inside. This large traditional house, situated at the corner of a four-road intersection, features many properties of Tokat's traditional houses. In consideration of its accessible location within the area and its size, it was assigned the function where cultural activities would be conducted.

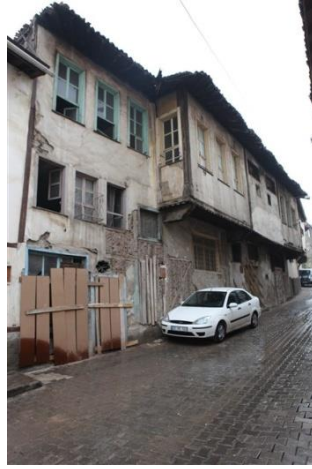
Figure 38. A view of the traditional house at block 243, lot 5 (*by the author*)

In consideration of tourism activities for groups of visitors in the city and the street, a boutique hotel was proposed within the traditional urban fabric. For this function, an empty, registered traditional house was selected, which was the largest house with the largest garden on the street (Figure 38). Structurally this house, located at 243 block, lot 5, is not in good condition. It has a floor plan arranged around an inner anteroom. Despite some of the later additions, this floor plan is original. In consideration of the size of the building, the number of rooms, and the existence of

a backyard, it was considered to be suitable for the function of a boutique hotel.

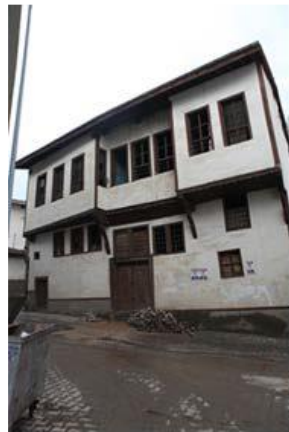
Figure 39. A view of the traditional house at block 242, lot 9 (*by the author*)

The traditional house, located at block 242, lot 9, was selected as a venue where Tokat's local food would be served to all users, and which would also be used for small organizations (Figure 39). The front and side façades of this traditional house with ground floor+mezzanine+1 storey are adjacent to the street and the building thus has an L shaped floor plan. The entryway is from the front façade and it opens into a hallway. This hallway, the ceiling of which is covered with the floor planks of the first floor, opens directly into the garden. The surrounding anteroom on the L-shaped upper floor is open to outdoors, and thus the building has a floor plan with an outer anteroom. This type of floor plan having an outer anteroom, where passage between rooms is made possible in the open, was also encountered in the Yağcıoğlu Mansion in Tokat. In consideration of the size of this traditional house and the existence of a workshop, fountain, kebab range, and oven in its large garden, the ground floor was assigned the function of a restaurant, and the upper floor to be used for social organizations and meetings.
