ICONARP
International Journal of Architecture & Planning
Received 19 Mar 2019; Accepted 10 May 2019
Volume 7, Issue 1, pp: 226-250/Published 28 June 2019
DOI: 10.15320/ICONARP.2019.74-E-ISSN: 2147-9380

A Study on Accessibility of Disabled People: Case for Kızılay Shopping Center, Ankara

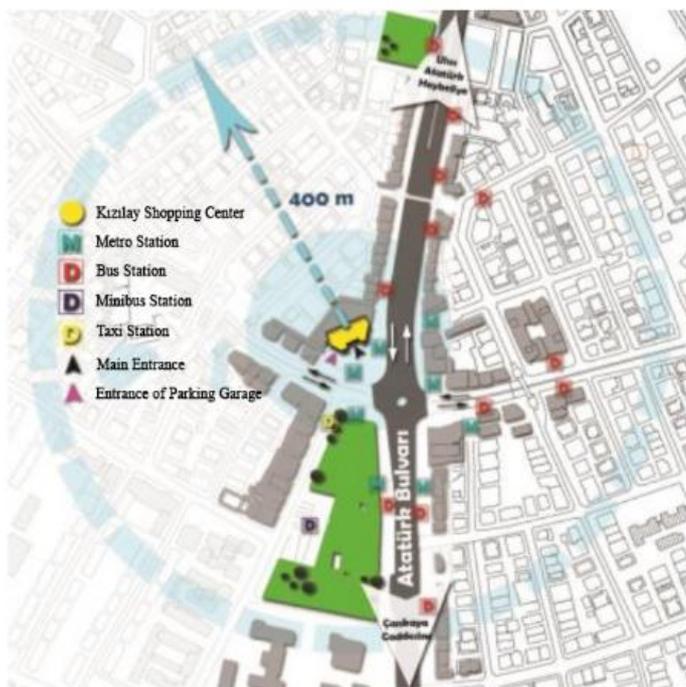
Figure 2. Accessibility of Kızılay Shopping Center

metro station. As shown in Figure 2, the distance of the most remote public transport stop to Kızılay shopping center is 400 m. According to Kuntay (2008), the pedestrian can easily reach 500 m distance in 80%, so Kızılay shopping center is easily accessible by public transport. Easy access with different types of transportation and walking distance from public transportation stops to the shopping center allows for the increase of accessibility of Kızılay's shopping center from outside the city center.

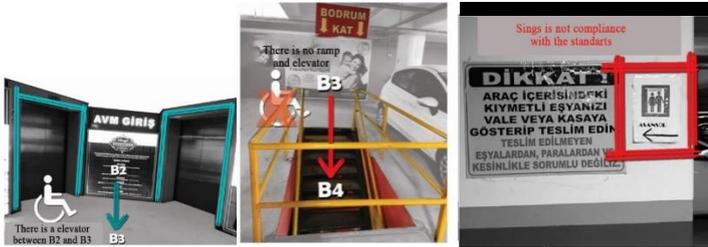
Picture 1., 2., 3. Evaluation of accessibility of parking at the shopping center

At first, it is examined parking areas. There is an indoor parking with a capacity of 300 vehicles. There is no open car park and no parking on the street (Figure 3). There is no private parking space for the disabled in the indoor parking in the shopping center. There are orientation signs in the parking lot. However, some of the signs are written on paper, so this method is not in compliance with the standards. There are two elevators for vertical circulation from the car park. While these elevators can reach as far to the third basement, access to the fourth basement is provided by stairs. Therefore, the fourth basement floor is not accessible for disadvantaged groups (Picture 1, 2, 3). Accessibility of Kızılay shopping center parking area are evaluated in terms of

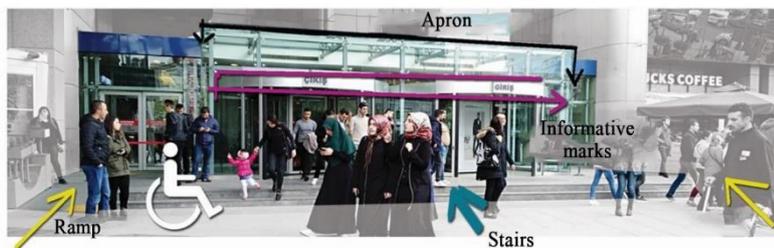
Picture 4. Building entrance review

Kızılay shopping center has four entrances. These are the main entrance of the shopping center, the entrance to the shopping floor without access to the shopping center, the second basement entrance from the car park and the entrances to the second basement from the metro station area. The main entrance of the building is subject to inspection as the main entrance of the building is accessible by persons with disabilities (Picture 4).

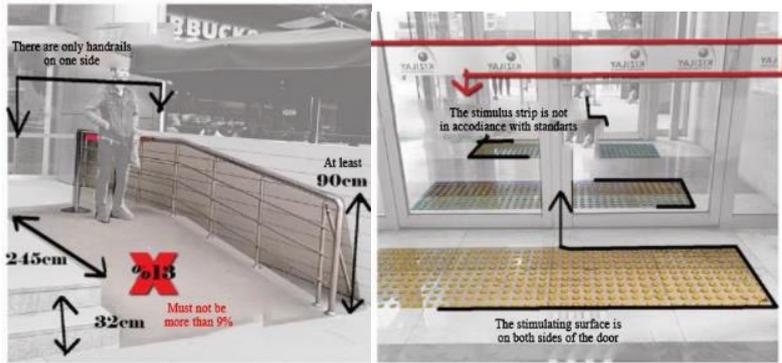
Picture 5., 6. Evaluation of factors of main entrance

The building entrance is covered with a wet non-slip surface and well brighten. The difference of elevation from the pavement of outside Kızılay shopping center to the entrance of the building is 32cm. There should be a ramp at the places with a difference of more than 1.3 cm according to the standards. There are two ramps for the disabled at the entrance of the building. The slope of the ramp is 13%. According to the standards, if the level difference is between 16cm-50cm, the slope of the ramp should be 9%. Therefore, the slope of the ramp is not compliant with the standards. There is a standard handrail next to the ramp. There is no stimulating surface 30 cm before the beginning of the ramp and after the end of the ramp along the width of the ramp up to 60 cm wide. There is no obstacle to restrict the movement of disabled pedestrians at the start and end of the ramp. When we look at the stairs in the building entrance, the height of the stairs is 16 cm and the width is 30 cm. There are no handrails on either side of the staircase. There is no stimulating surface along the width of the 60 cm wide staircase, 30 cm before the beginning of the staircase and 30 cm after the end of the staircase. When we look at the building entrance door, it is a photocell door consisting of large glass surfaces. According to the design standards, if there are large glass surfaces at the building entrance doors and around it, there should be a 7.5cm width stimulating contrasting color tape , which are first-level at the height of 130cm-140cm from the ground and second-level at the height of 90cm-100cm from the ground. There is a safety controller (x-ray) conforming to standards at the building entrance. After the entrance there is a consultation desk. Informative and stimulating signs can be seen and felt after entering through the door (Picture 5, 6, 7).

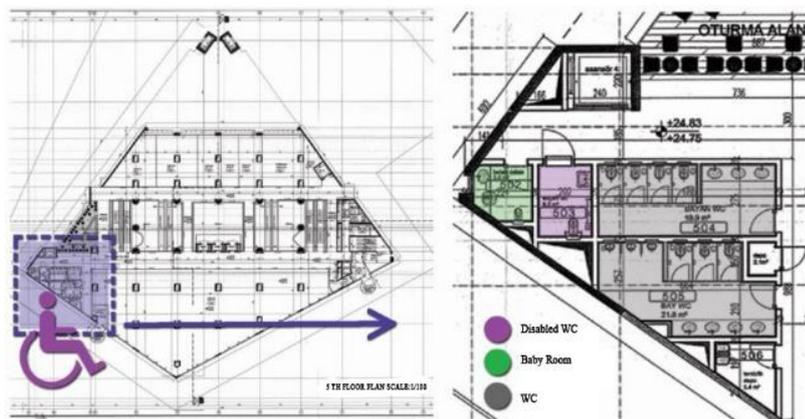
Figure 4: Location of the disabled toilet

Thirdly, toilets are evaluated. There are 122 toilet cabins in Kızılay shopping center, 5 of these 122 toilets belong to disabled people. These are located in the first basement, the first floor, the third floor, the fifth floor and the eighth floor (Figure 4). There is no elevation difference when accessing the toilet from the entrance of the disabled toilet cabin and the doors of these toilets open to the outside. Informative signs are not sufficient for disabled toilets. In addition, the attendant must be called to use the disabled toilet (Picture 8).

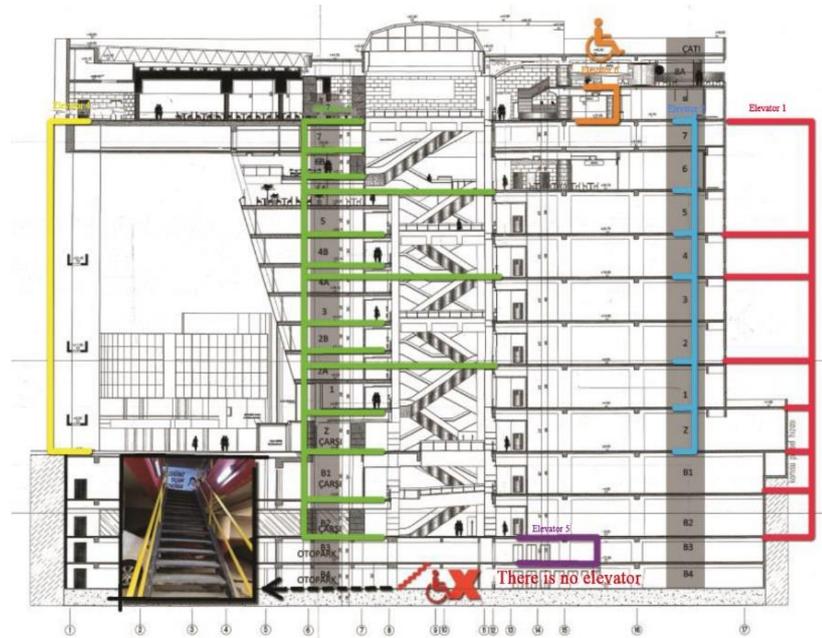
Figure 5. Cross-sectional view of elevators serving floors

Fifthly, vertical circulation is analyzed. Kızılay shopping center has staircase, elevator and escalator for vertical circulation. There are 9 elevators in the shopping center. One of them is for emergency cases and, the others provides to access between floors. There are 6 elevators with different features to provide circulation within the building (cabin dimensions, etc.). (Figure 5) (Picture 9, 10, 11, 12, 13, 14). There is no lift to provide vertical access only between the floors of the basement 3 and the floors of the basement 4 (Figure 6). There is no threshold, stair and elevation difference in the cabin access. Unobstructed access distance is provided less than 30 m from building entrance to elevator. In addition, access to the elevator with information signs was facilitated. Within the shopping center, there are normal stair steps, escalators and fire escape stairs (Figure 7). It is observed that step ladders are designed appropriate for the use of disabled individuals. The stair surface is flat, stable and durable. The stair surface is covered with non-slip material in a wet-dry state. Height of stairs are 16 cm and there are handrail on both sides. There is no stimulating surface along the width of the 60 cm wide staircase, 30 cm before the beginning of the staircase and 30 cm after the end of the staircase (Picture 15, 16).

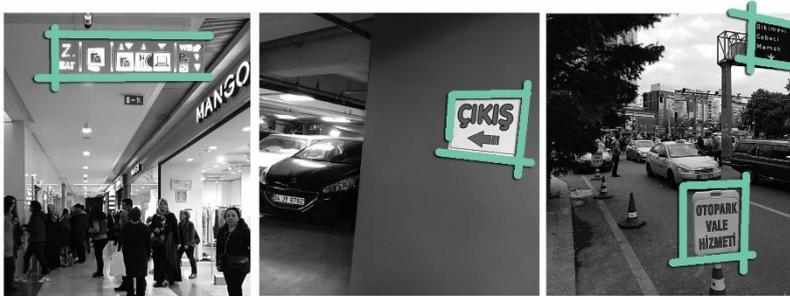
Picture 17., 18., 19. Direction and markings evaluation

Thanks to the information signs in Kızılay shopping center, there is a possibility of walking without getting lost easily. After the main entrance door of the building, there are information signs, directional signs and functional signs that are legible and understandable for usage areas in the building (Picture 17, 18, 19). However, all manuscripts and markings are not in accordance with the standards. It is observed that all the markings are not used Braille, embossed letters and symbols for the visually impaired people.
