# Seismic Design Considerations for Architectural Design Aspects

Serra Zerrin Korkmaz\*

**Keywords:** Earthquake, irregularity, architectural design, earthquake code, torsion

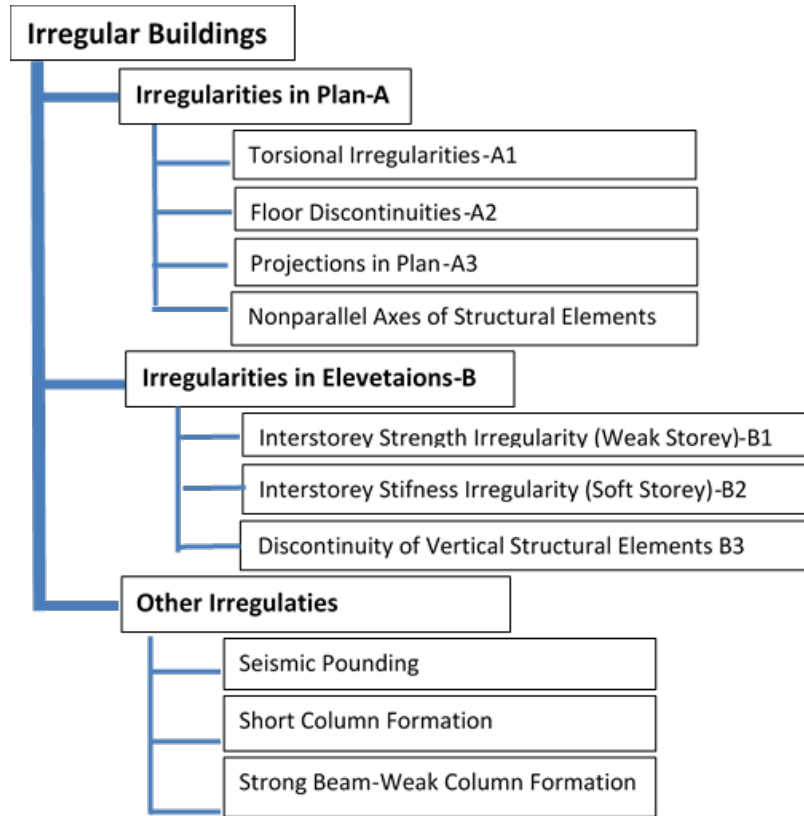
**Figure 1.** Irregularities defined in the Turkish Earthquake Code (TBEC 2018)

In TBEC (2018), irregularities are defined under the two basic headings of irregularities in plan (denoted as A) and irregularities in elevation (denoted as B). Irregularities in plan are consistent with one of four different structural irregularity types: torsional irregularity, floor discontinuities, projections in plan, and nonparallel axes of structural elements (i.e., the configuration of structural elements on a nonparallel axis) (Ozmen & Unay, 2007). There are also three types of structural irregularity in elevation (Figure 1). These types are defined under different sub-headings (Tugba Inan & Korkmaz, 2011).

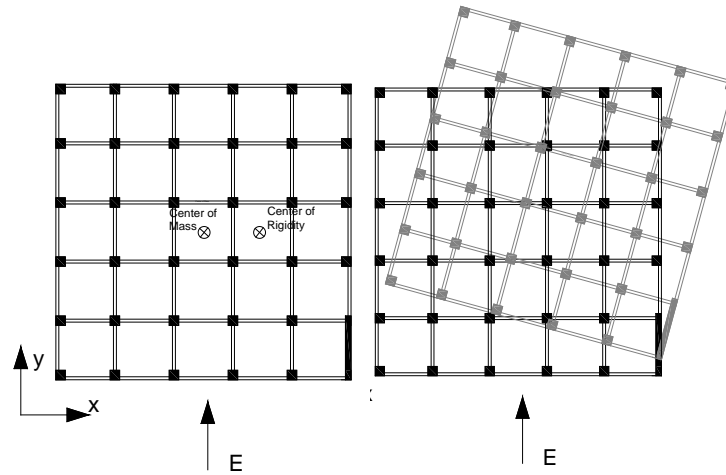
**Figure 2.** Calculation of maximum and minimum story drifts

Story drifts are calculated by considering the effects of  $\pm 5\%$  additional eccentricities in both earthquake directions. The maximum ( $\Delta_{i\max}$ ) and minimum ( $\Delta_{i\min}$ ) story drifts were determined for the two orthogonal earthquake directions on each individual story of the building (Figure 2).

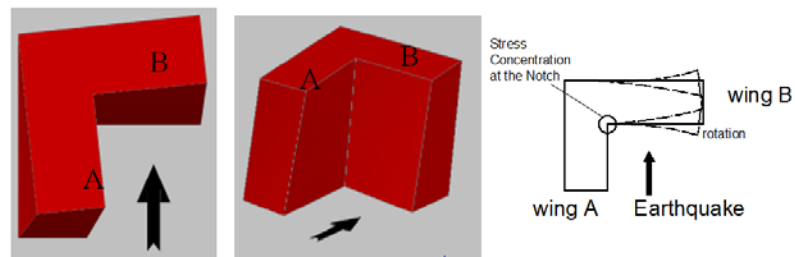
**Figure 4.** Behaviour of an L-shaped structure with a projection.

The problem with projections in plan is explained by means of Figure 4. If several blocks meet, the structure becomes susceptible to EQ loads. The inside corners are called re-entrant corners and the connection point is called the notch point. If an earthquake comes from the Y direction as shown, the projection located parallel to the earthquake direction (block A) behaves more stiffly than the perpendicular projection (block B). Both projection blocks experience different displacements and push or pull each other at re-entrant corners or notch points. Critical stresses accumulate at the notch points where the projections connect. The magnitude of the accumulated stresses depends on the wing height, slenderness ratio, length and length ratio. A good example of damage in a re-entrant corner was observed in the 1999 Marmara Earthquake (Figure3).

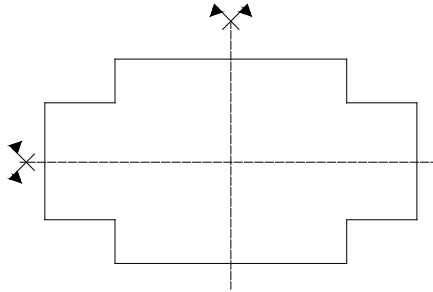
**Figure 5.** Plan geometry with symmetry but also irregularity

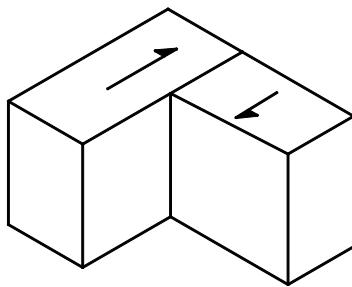
**Figure 6.** Horizontal shearing effects in projections in plan

The horizontal shearing effect is a common problem due its occurrence in very short as well as tall buildings (Figure 6). The taller the structure, the greater the dimension of critical movement near the top will be (J. Ambrose & Vergun, 1999).

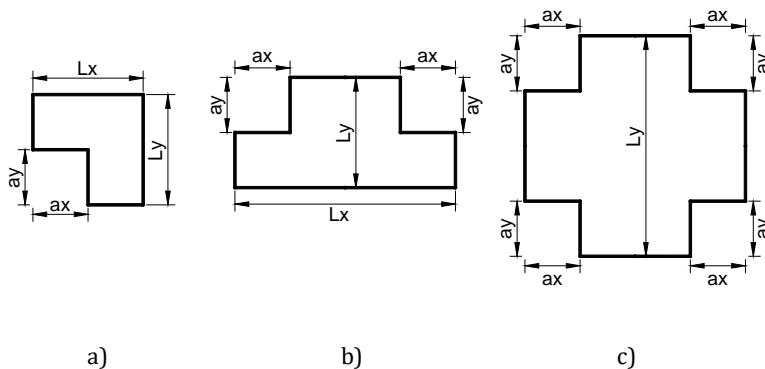
**Figure 7.** A3 type irregularity ( $ax/Lx > 0.2$  and  $ay/Ly > 0.2$  at the same time)

According to TBEC (2018), for an A3 type irregularity to exist, the dimensions must satisfy  $a_x/L_x > 0.2$  and  $a_y/L_y > 0.2$  simultaneously. In Figure 7-a, the explanation is clear. If  $L_x = 10$  m, and  $a_x = 2$  m, then there is an A3 type irregularity. But in the case of Figure 7-b,  $L_x$  must be 10 m and  $a_x$  must be 2 m to form an A3 type irregularity. The total projection length becomes 4 m in the X direction.

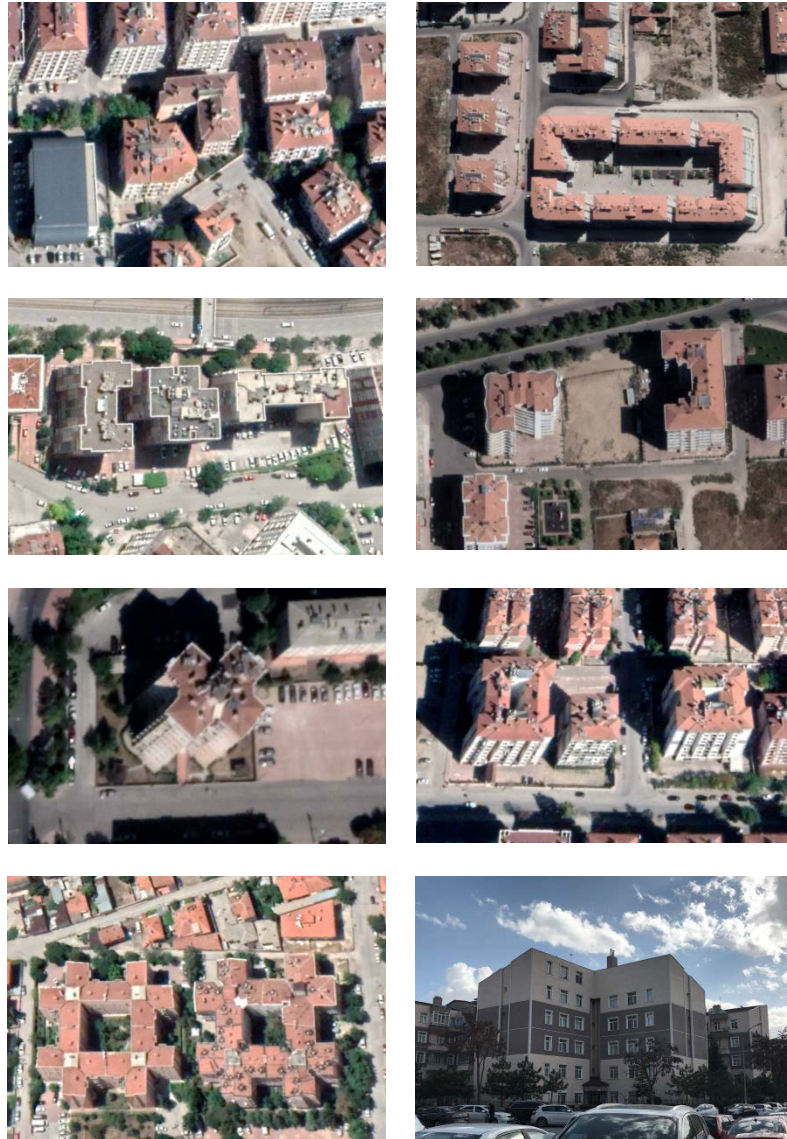
**Figure 8.** Several building layouts with projections in plan

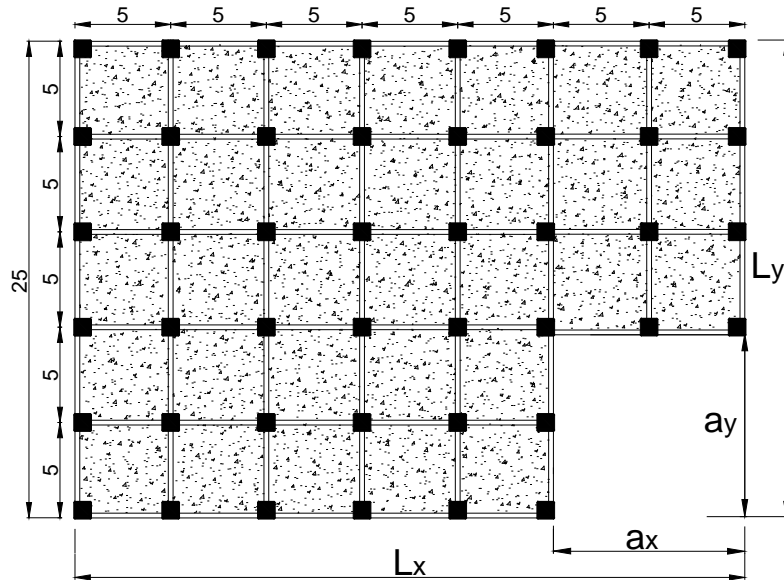
Figure 9. Model structure for projections in plan

The building in Figure 9 was analyzed to determine the critical projection ratio. The structure had the same plan area as that in the previous case, but this building had different projection ratios ( $a_x/L_x$ ). The projection lengths were determined to measure 2.5 m, 5 m, 10 m and 15 m in the X or Y directions. The span lengths or distances between columns were kept constant for all cases except for the 2.5 wing length cases. The dimensions of the columns in the wings were identical to the column dimensions in the main structure.

Representative illustrations of the analysis cases are depicted in Table 1. The number of storeys was chosen as a parameter and varied between 1 and 13 storeys. The dimensions of the square columns were changed according to the number of storeys. Except for the models in the first column (cases I, M, and R), an A3 type irregularity occurred because the projection ratios in both directions exceeded the limit ratio of 20%.

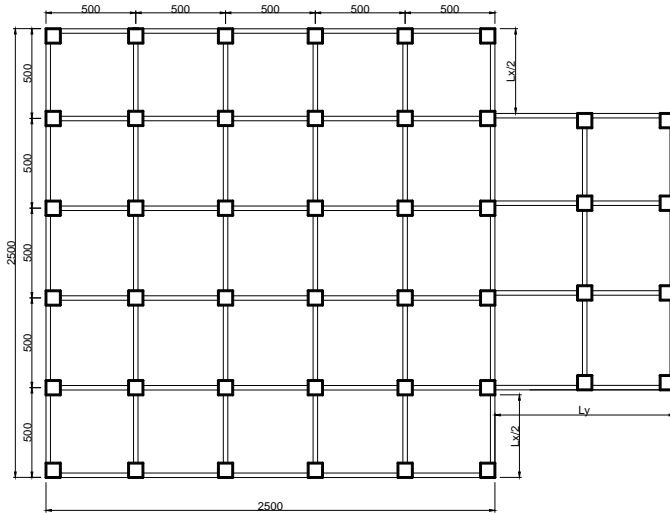
Figure 11. Effect of wing location

The effect of wing configuration and location was also investigated (Figure 11.). The wing on the top right of the model was placed on the middle right of the structure (in plan). This case was run for only the  $a_y=10$  m and  $a_x=15$  m dimensions ( $a_y=10$  m,  $a_x=15$  m, Mid. Pos.) and the corresponding  $\eta_{bi}$  values were compared with those of the first configuration in Figure 10-b. There was no difference between these two configurations.

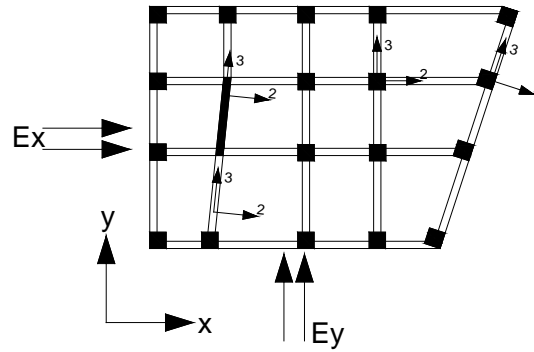
**Figure 12.** Non-orthogonal axis irregularity

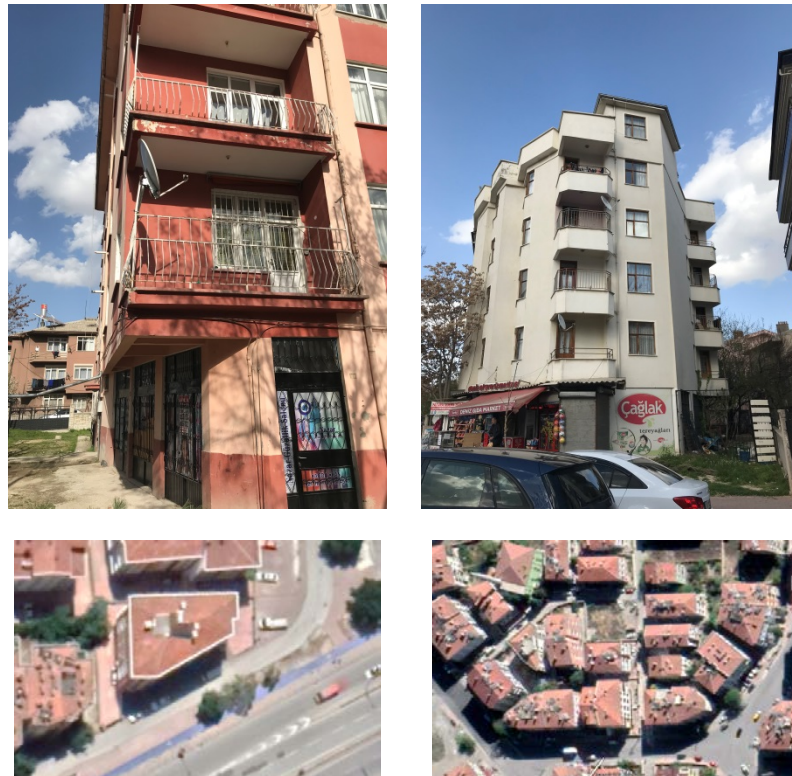
**Figure 13.** Building layouts with nonparallel axes

Some building layouts with nonparallel axes are given in Figure 13.

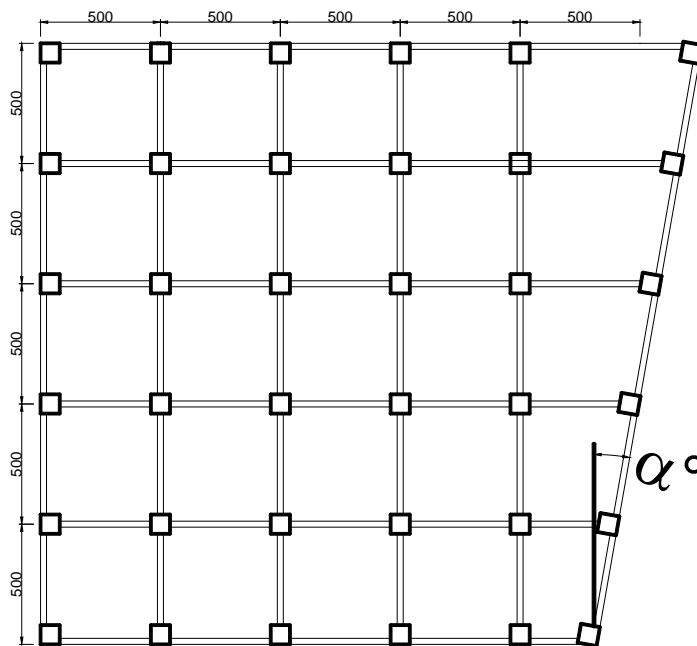
Figure 14. Non-orthogonal axes

To investigate the effects of non-orthogonality on the distribution of moments and shears in vertical structural elements and torsional irregularity, a 9-story model building with one non-orthogonal and five orthogonal axes was studied (Figure 14). A dynamic analysis was performed to obtain the internal forces and base shear. A model building with 36 columns and 6 axes parallel to the both the X (1 to 6) and Y directions (A to F) was selected. All axes were orthogonal in the reference model, while only the F axis was non-orthogonal in the other models. Four cases with different non-orthogonal axis orientations were considered, and these orientations were altered by changing the angle  $\alpha$  between the principal axis of the columns and the orthogonal Y-direction. The total area of the structure, dimensions of the columns and beams were kept constant in each model, while the angle  $\alpha$  was varied to measure  $0^\circ$  (reference model),  $0^\circ$ ,  $5^\circ$ ,  $10^\circ$ ,  $20^\circ$  or  $30^\circ$  measured in the counterclockwise direction. Each case was analyzed for four earthquake directions: parallel to the X-axis, parallel to the Y axis of the structural system, parallel to the main principal axis and perpendicular to the main principal axis of the non-orthogonal columns.

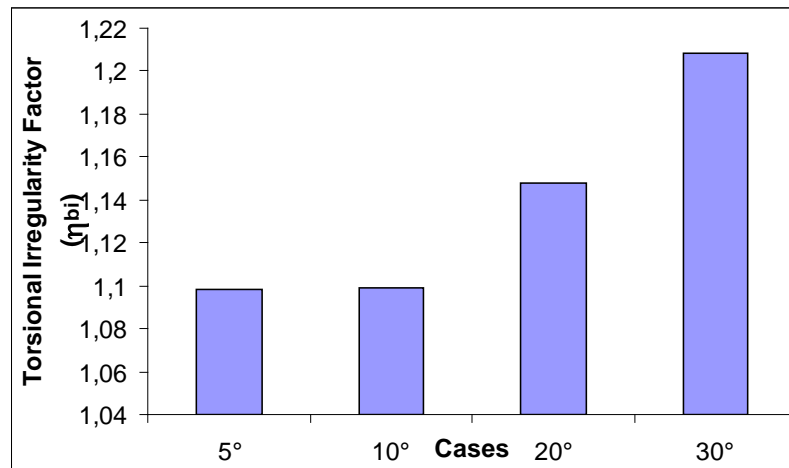
**Figure 15.** Torsional irregularity factors for different axis angles

The torsional irregularity factors were calculated from the relative point drifts of the columns and the results of which are illustrated comparatively in Figure 15 for  $\alpha = 0^\circ, 5^\circ, 10^\circ, 20^\circ, 30^\circ$ . It is seen that, there was no clear difference between the 5- and 10-degree cases, while the  $\eta_{bi}$  value of the 30-degree case fell above the code limit of 1.2.

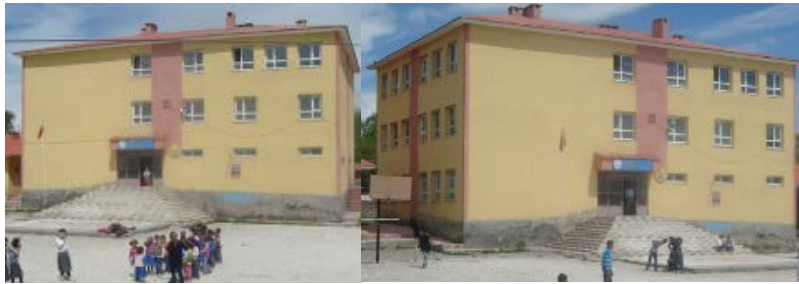
**Figure 16.** Gedikbulak Village school, Van, Turkey (source: <http://okulweb.meb.gov.tr>)

A school building in the Van city of Turkey (Figure 16), has a symmetrical rectangular plan. The structure had two parallel shear walls on its adjacent corners, creating an overly rigid side, and was torsionally balanced along the wall direction. In the other direction, however, the symmetry of the vertical members was disturbed. There were two separate parts, a flexible side and a stiff side, because the rigid walls were located on one side of the building. From the outside, the structure appeared regular. Unfortunately, the earthquake came from the weak direction. Torsion occurred around a vertical axis, leading to the building's destruction. The less rigid portion of the structure displayed more torsion than the rigid side. First, the school building twisted, and then farthest edge of corner columns failed and collapsed due to the torsional eccentricity. The concrete quality and details of the

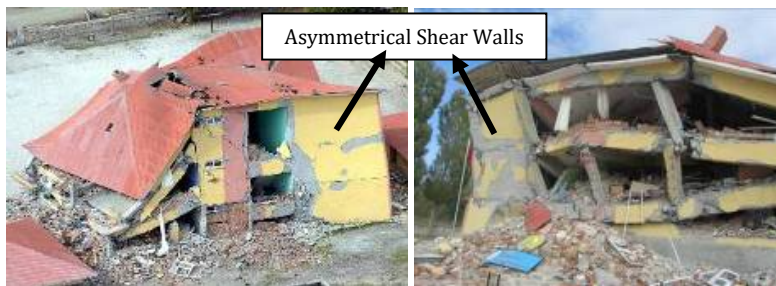
**Figure 17.** Primary school in Gedikbulak Village, after failure (source: <https://fotogaleri.ntvmsnb.com/helikopterden-deprem-alani.html?position=37>)

reinforcement arrangements were the other factors affecting the failure (Figure 17) (Korkmaz, 2015).

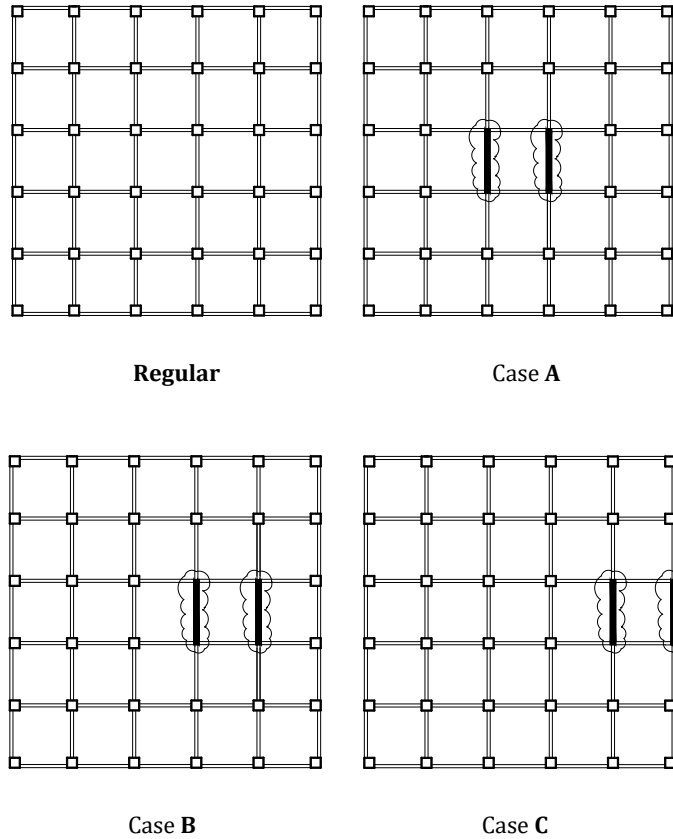
**Figure 18.** Models for analyzing the effect of shear wall location

walls, shifting them to create three different cases of eccentricity, as shown in Figure 18. In Case B, two shear walls were shifted 5 m in the X direction, while in Case C, the shear walls were shifted 10 m along the X direction. The modelling approaches for each case were similar to the assumptions given for Case D.

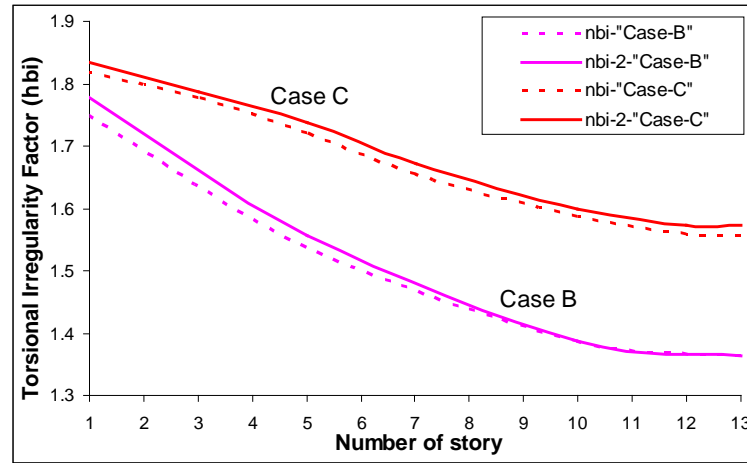
**Figure 19.** Torsional irregularity factor with respect to the number of storeys

Variations in the torsional irregularity factor with respect to the number of storys for cases B and C are given in Figure 19. The graphs clearly show that Case C had a higher torsional displacement than Case B. Calculated torsional irregularity factors were greater than 1.2. It was interesting to note that the  $\eta_{bi}$  values were higher in structures with 1 to 4 storys than in structures with 10 to 13 storys. The reason for this result could be attributed to the fact that, as the number of storys increased, the dimensions of the columns also increased. On the other hand, the lengths and thicknesses of the shear walls were kept constant. The influence of a shear wall on the lateral load carrying system decreased as the number of storys and column dimensions increased.

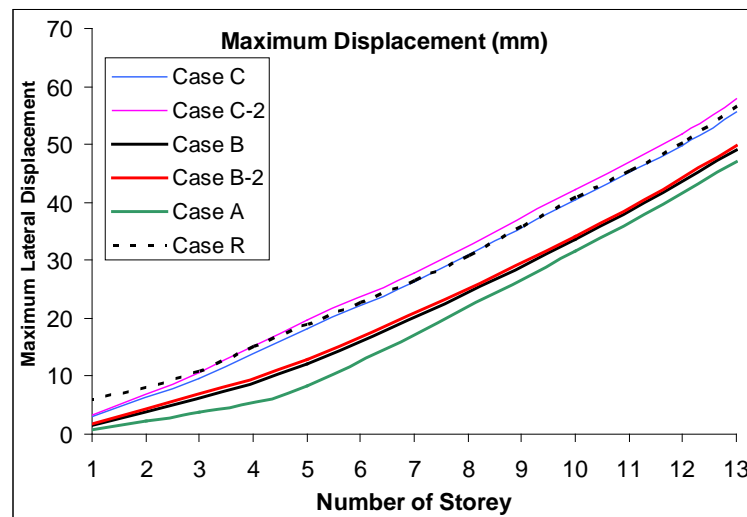
**Figure 20.** Maximum lateral top displacements under orthogonal EQ loading cases

In Figure 20, the calculated maximum top story lateral displacements, under the orthogonal earthquake loadings, are plotted with respect to the number of storys. Cases B and C corresponded to the displacements with an additional eccentricity of 5%, while the values for Cases B-2 and C-2 are calculated from the cases with additional eccentricities of (Dix 5%). Case R shows the displacements of the reference building with no shear walls. Symmetrically placed shear walls decreased

the maximum lateral displacement. On the other hand, Case C (with 5% additional eccentricity) displays values very close to those of Case R (with no shear wall). The shear wall configuration of Case C did not limit the lateral displacements but did cause torsion
