# The Accessibility in Shopping Centres: The Cases of Istanbul Profilo and Kozzy Malls

Shopping centres are public areas which were used by people from every social strata and different age groups for consuming commodities or leisure. The aim of this study is to emphasize not only public areas accessibility of shopping centres but also consider interior space characteristics in terms of accessibility.

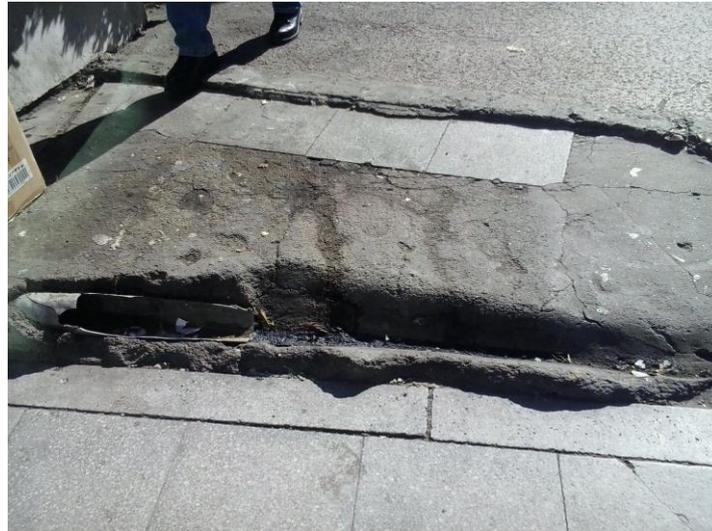
**Main pedestrian ways accessing through the shopping centre:** In the main pedestrian ways, there is not an approach including everyone. It includes different dangers for also almost healthy individuals; the problems are like hinders, holes, unstable pavement (Figure 1). Therefore there are almost limited tactile paving for blind person and ramps for wheelchair users and baby carriages. The pedestrian access to the Profilo Shopping Centre from the Büyükdere Main Street to Cemal Sair Street is a commonly used way because of traffic lights. Despite the renewed kerb ramps, audible instructions on traffic signals and guiding strips on the Büyükdere main street in 2012, there was no renovation on the pedestrian ways to Profilo Shopping Centre. Problems of the streets accessing main entrance of the centre are similar to the streets accessing entrance door on the side. Further, access to the side door is stepped because of the angled pavement.

**Figure 1.** Pavement on Cemal Sair Street (Photograph: Selhan Usal, 2013).

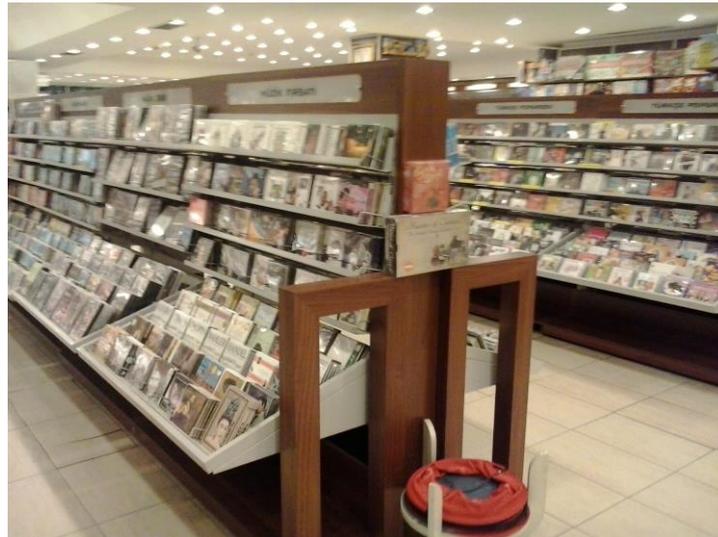
In the analysed shops, for the wheelchair user it is only possible to reach the CD shelves by turning the chairs to the side (Figure 2). The 50 cm high and 50 cm deep CD product shelf's top shelf is 130 cm high. This highness is provide the stretching out length of wheelchair user's arm. Additionally the highness of the cash counter of the same shop, and the non-available low part of the cash counter is a problem of the wheelchair user's accessibility and communication.

**Figure 2.** Shelves in the Book and CD store (Photograph: Selhan Usal, 2013).

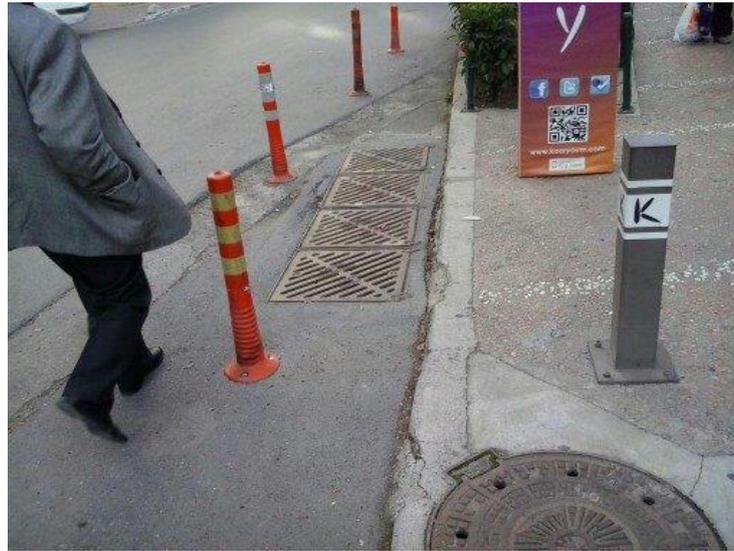
There is a ramp application accessing the shopping centre from the Kozyatağı area, but the hinder in front of the ramp at the crossing from the street across (from Buket Street) the shopping centre and that there is no ramp in front of the centre, is creating difficulties (Figure 3). There are ramps placed in front of the main entrance of the shopping centre and pavements beside (entrance part from Şakacı Street to Buket Street). But the pavement is because of its surface properties not smooth and has started to form partly roughness and greatly holes. The surface material is risky for elderly, children, blind people and wheelchair users. There is also no proper guiding floor cover applications for blind people on the both pedestrian ways to the mall.

**Figure 3.** Pavement situated on entrance area (Photograph: Selhan Usal, 2013).

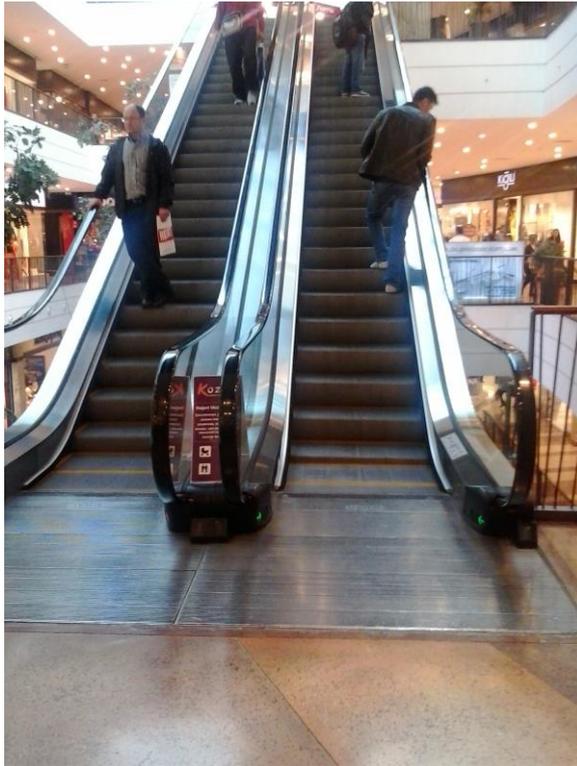
**Circulation areas in the shopping centre:** Since the shopping centre is small sized, the circulation areas are easy to detect. However, there are no guiding strip on the floor covers (Figure 4). The accessibility to the elevator in the food court can be difficult because of the tables placed around the gallery and the service circulation. The entrance door is a revolving door and has the proper width for the passing of wheelchair users or crutches users. However, there is an obligatory door wing at the side, the usage of it was never observed.

**Figure 4.** Circulation area without guiding strip application  
(Photograph: Selhan Usal, 2013).
