# Changes and Problems of Conservation in Ankara-Ulus Historical City Center: Koyunpazarı Slope and Atpazarı Square

Filiz Karakuş<sup>1</sup>, Z. Gediz Urak<sup>2</sup>

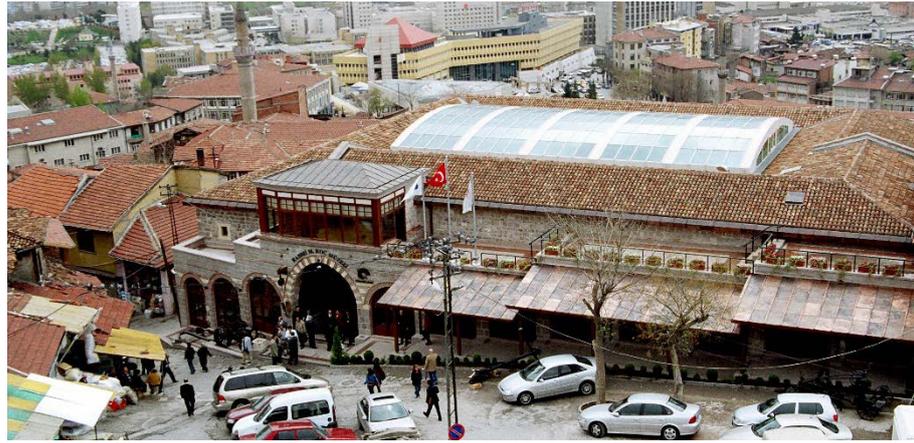
While all of Çengelhan was registered on behalf of Ankara Metropolitan Municipality, the deed was canceled according to the law no. 7044 and registered on behalf of the General Directorate of Foundations in 1997, and the necessary expropriation procedures were carried out by the General Directorate of Foundations (Ankara Regional Directorate of Foundations Archive). With the decision of Ankara Council for the Protection of Cultural and Natural Assets dated 25/01/2002 and numbered 7741, survey projects, conservation, repair and re-functioning projects were approved with the decision dated 15/08/2003 and numbered 8715. In 2000, the inn was leased for 18 years as part of the Restore-Operate-Transfer tender made by the Ankara Regional Directorate of Foundations and has been functioning as Rahmi Koç Museum since 2005 (Figure 6) (Sevgi, 2020; Aksoy, 2010).

**Figure 6.** Çengelhan after restoration (Karakuş, 2015)

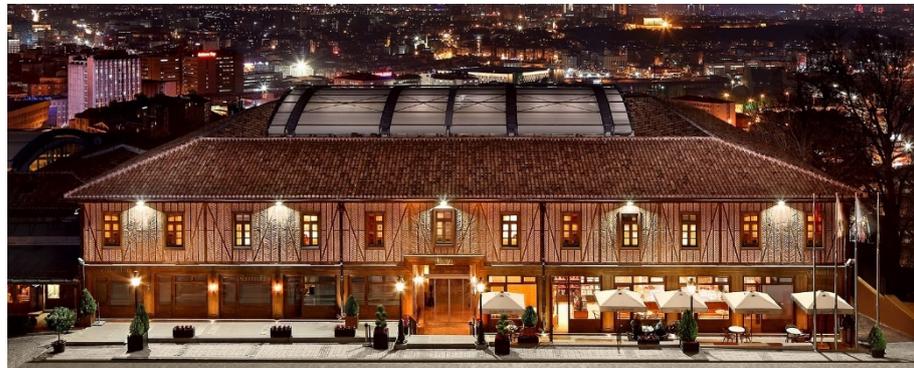
Çukurhan was registered on behalf of the General Directorate of Foundations (Ankara Regional Directorate of Foundations Archive) as a result of the lawsuit to resolve the partnership, which started in 2003 and concluded in 2004. Çukurhan's survey projects were approved by the Decision of the Ankara Regional Council for the Protection of Cultural and Natural Assets dated 2/2/2007 and numbered 2089, while the restitution, restoration projects and reports were approved by the Ankara Renewal Area Cultural and Natural Assets Protection Regional Board on 11/05/2007 and numbered 24. Çukurhan's Restore-Operate-Transfer tender was held in 2006 by the Ankara Regional Directorate of Foundations and the inn has been leased for 29 years and has been used as a boutique hotel since 2010 (Figure 7) (Sevgi, 2020; Aksoy, 2010).

**Figure 7.** Çukurhan after restoration (Karakuş, 2017)

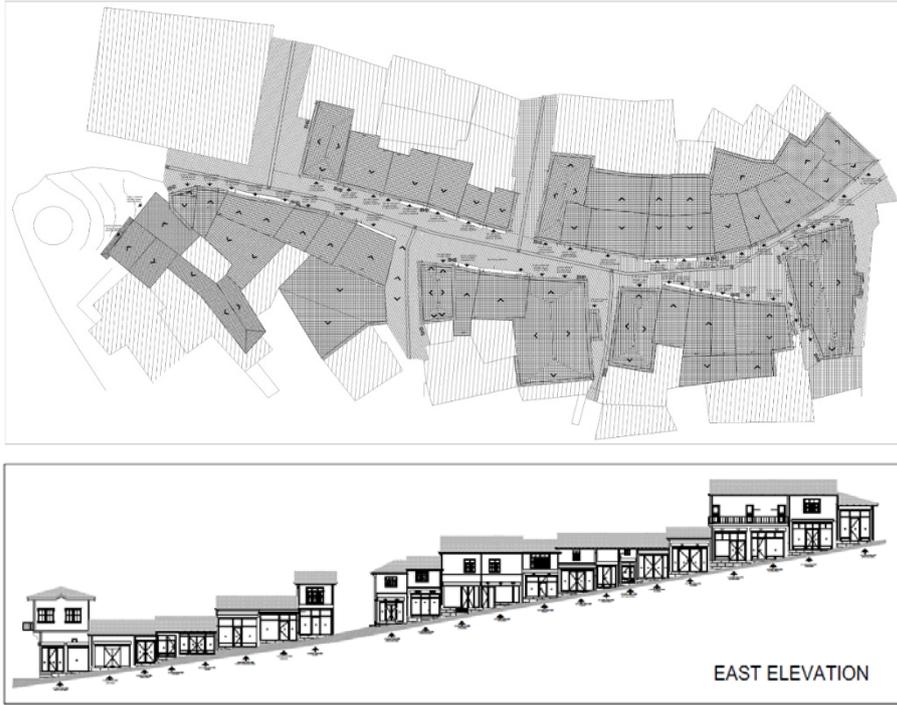
**Figure 8.** Koyunpazarı Street Rehabilitation Project, site plan and eastern view (Archive of Mimor Architecture Office)

“Koyunpazari Street Rehabilitation Project” (Figure 8) prepared by Mimor Architecture Office was approved by the Ankara Renewal Area Regional Council for the Protection of Cultural and Natural Assets on 04/07/2008 and numbered 189. The “Can Street Rehabilitation Project” prepared by Altındağ Municipality was approved by the board decision dated 3/10/2007 and numbered 62. In line with the projects mentioned, the applications were completed in 2009.

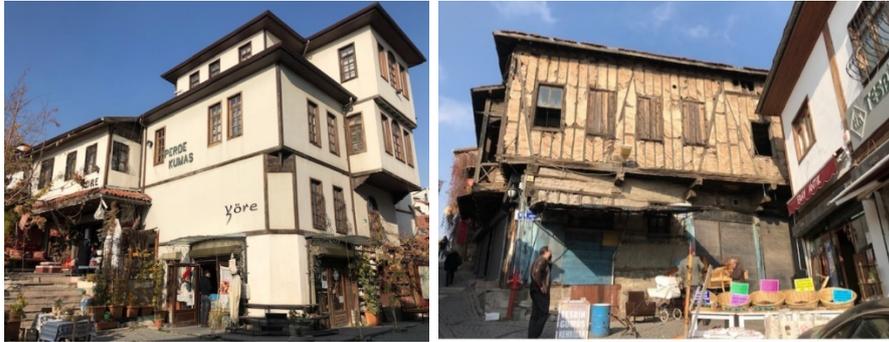
Although only the lower floors of the units 2, 19, 28 and 36, which were residential in 1998, were converted into shops at that time and the upper floors preserved their original character, in the examination carried out in 2020 it was seen that only the upper floor of the unit number 28 was used as a residence, but it was not used after the fire that occurred two years before in the upper floor. It has been determined that the accommodation function is continued on the upper floor of Bala Han number 2 (Figure 11), but the house part has been converted into a cafe. These structures constitute important focal points in the area. The building numbered 36 (Figure 12) also presents a beautiful view while approaching the Koyunpazarı Slope from Ulucanlar. Building no. 19 (Figure 12), which gives the most beautiful view while climbing from Koyunpazarı Slope to Atpazarı Square, is structurally in a very bad condition, and the teahouse on the upper floor could not maintain its function and has turned into a warehouse.

**Figure 12.** Building numbered 36 in Can Street and building numbered 19 in Koyunpazarı Street (Karakuş, 2020)

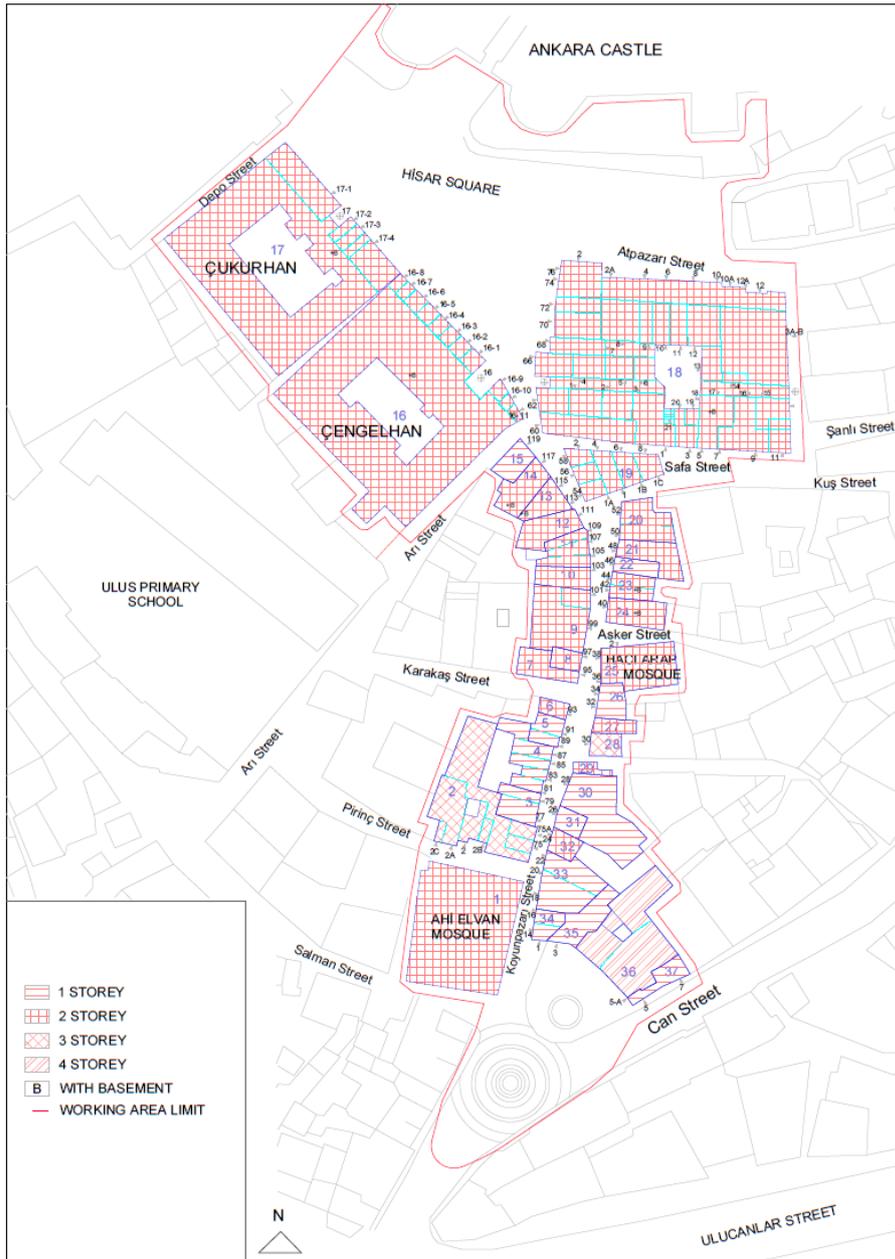
**Figure 14.** Analysis of number of floors (Karakuş, 2020)

In this area, which generally consists of one and two-storey buildings, 13 buildings (35.14%) are single-storey and 21 (56.76%) are two-storey. In the area, 2 buildings (5.41%) are three-storey and 1 building (2.70%) is four-storey (Figure 14). There was no change in the number of buildings between 1998-2020, but it was observed that the number of floors of three buildings increased by one. One floor was added to two of the single-storey buildings and one to one of the three-storey buildings.

- It has been observed that the number of buildings (37) in the area did not change during the intervening period, but two floors were added to two of the single-storey buildings and one to one of the three-storey buildings. Since the 1990s, various project studies have been carried out for the conservation of the area, but although they have not been implemented, these studies have drawn attention to the importance of the field and prevented significant physical changes in the field.

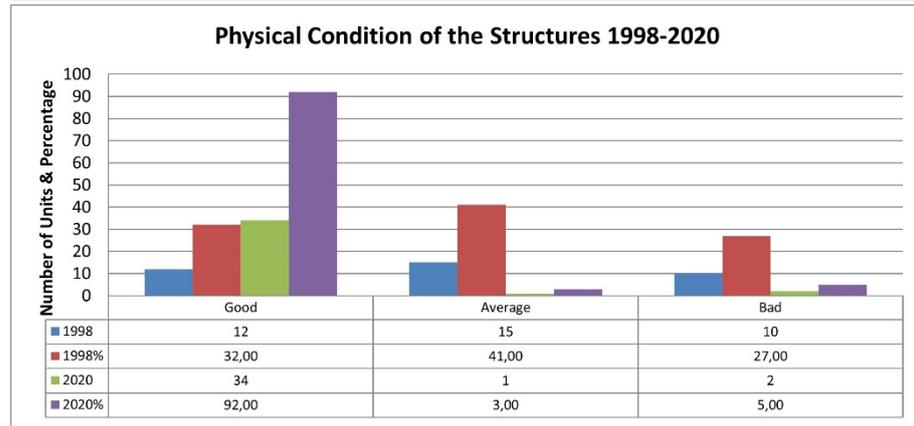
**Figure 25.** Physical condition of the structures

Considering the status of the buildings in the area, the percentage of buildings in good condition increased from 32.43% to 91.89% (Figure 25). Çengelhan and Çukurhan were repaired within the scope of the restore-operate-transfer tender held by the General Directorate of Foundations, Ahi Elvan Mosque was repaired in 2017, Hacı Arap Mosque was repaired in 2007 and Koyunpazarı Street Rehabilitation works were completed in 2009. However, Pilavoğlu Han and the building at the intersection of Koyunpazarı Street and Safa Street, two important buildings in the area, are still structurally in poor condition (Figure 26).

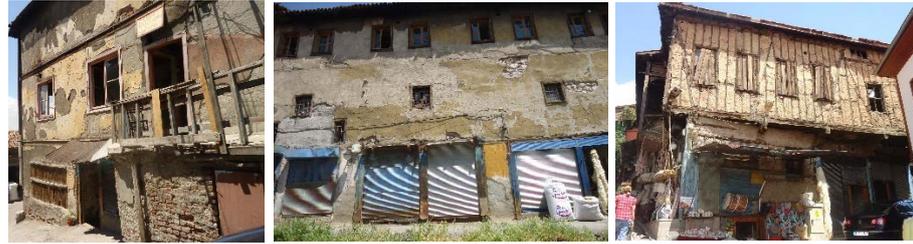
**Figure 26.** Pilavoğlu Han and the building at the intersection of Koyunpazarı Street and Safa Street (Karakuş, 2020)

The structurally poor structures of Pilavoglu Han and building at the intersection of Koyunpazarı Street and Safa Street needs to be repaired urgently. In order to carry out repairs in Pilavoglu Han, property problems should be solved and, if necessary, expropriated and the relevant institutions should lead the repair works.

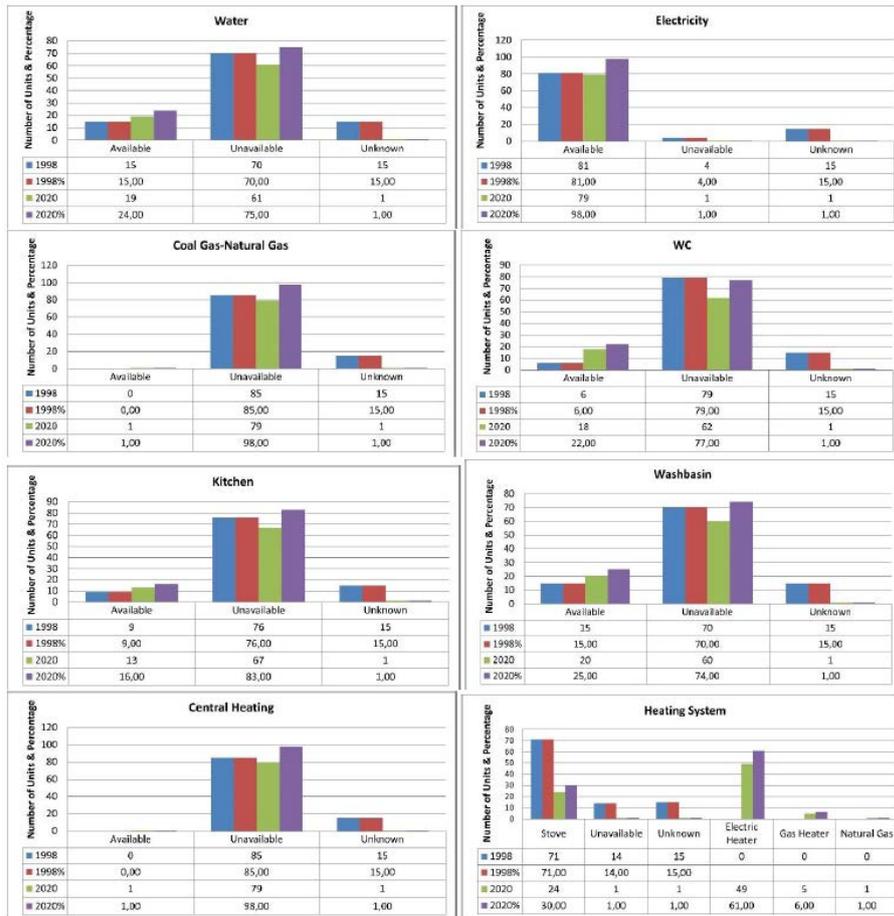
Figure 27. Commercial unit health and infrastructure conditions

Infrastructure services that are directly related to health conditions such as water, electricity, natural gas, toilet, kitchen, washbasin and heating create a very negative picture in the work area. Although there is a sewerage connection in the area, only 23.46% of the units have water connection and the majority (75.31%) do not have a water connection. Toilets and washbasins are often not available due to the lack of water. The working population in the area generally uses the public toilets adjacent to Ahi Elvan Mosque. Inside the Pilavoğlu Han, there is a public lavatory and toilet area used by the employees of the inn. All units have electricity, except for 1 workplace. There is no central heating except one of the units in the street, which has no coal gas or natural gas connection, but Çengelhan and Çukurhan have a natural gas connection and underfloor heating is provided. 49 (60.49%) workplaces in the area are heated by electric heaters and 24 (29.63%) workplaces are heated by stoves. Besides, there is no heating in 1 (1.23%) workplace. The kitchen is only available in workplaces where it is needed such as in kebab restaurants, restaurants, tea shops, and cafes. The insufficiencies in health conditions continue in the same way (Figure 27).

- The most important problem seen in the field is related to health and infrastructure conditions. Although there is a sewer connection in the area, most of the units do not have a water connection. Consequently, most workplaces do not have toilets and sinks. The population working in the area generally uses the public toilets near the Ahi Elvan Mosque. Inside the Pilavoğlu Han, there is a general lavatory and toilet area that the employees of the inn can use. In the street, which does not have gas and natural gas connections, there is only a heating system at number 60, and electrical heaters are used in other units. In Çengelhan and Çukurhan, there is a natural gas connection and underfloor heating is provided.

health conditions in the area should be improved. It should be ensured that the traditional residences around the area are made suitable for today's comfort conditions. In addition, an integrated protection policy that will include the commercial area subject to the research and the surrounding residential area should be developed.
