Cultural Heritage Across Borders: A Comprehensive Examination of the Restoration of the St. Nicholas Memorial Museum (2021-2023)

Serap Sevgi*

St. Nicholas Church is a remarkable Byzantine structure located in the Demre district of Antalya, in the southern region of Türkiye. The church and its accompanying tomb were built in the 5th century AD in memory of St. Nicholas after his death. It became a sacred cultural center and a pilgrimage site throughout the Middle Ages. Throughout history, the church underwent multiple reconstructions and substantial repairs necessitated by invasions, earthquakes, and other factors. During the Late Middle Ages, a flood of the river Myros submerged the church under approximately 6 meters of alluvial deposits. The excavations, which began in 1862 and have continued intermittently to this day, have uncovered significant remains, which were subsequently restored in accordance with the conservation approach of their respective periods. However, certain ruins persist within privately owned areas. Although the church largely maintains its structural integrity, ongoing excavations within the Ministry of Culture and Tourism's designated areas in the monaste

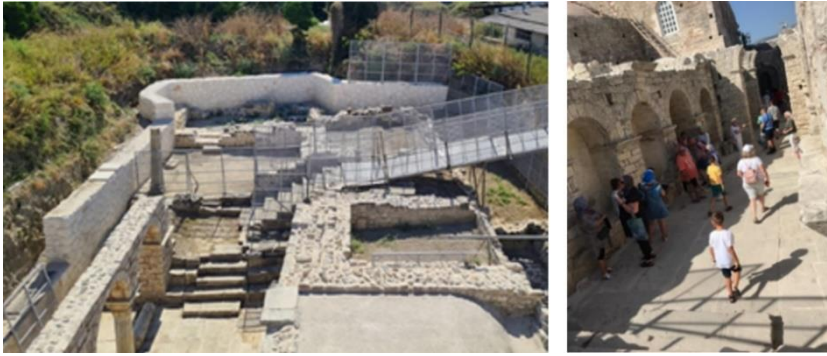
Figure 33. Temporary visitor entrance (AMoCT-PR-4).

Due to its high number of visitors, the church spaces were closed off in stages to visitors for the implementation of the works. During the removal of the roofs, temporary access was provided to the upper-level courtyard from the east of the church, through a metal construction bridge leading to the northwest podium, ensuring visitor safety. The new protective roof of the church, designed not to impose any additional load on the structure, was applied as a steel construction with titanium zinc coating, with its carriers placed outside the building. Still, it covers SBC and southeast chapels, providing natural ventilation while preventing rainwater from entering through its eaves located at appropriate distances. Wooden shingle roofs, previously used in various periods in the excavation areas, have been replaced with metal coverings to ensure visual consistency in the excavation site. After the completion of repairs, the entrance was restored from the southern direction, and the northern arcades were included in the visitor's route (Figure 33).

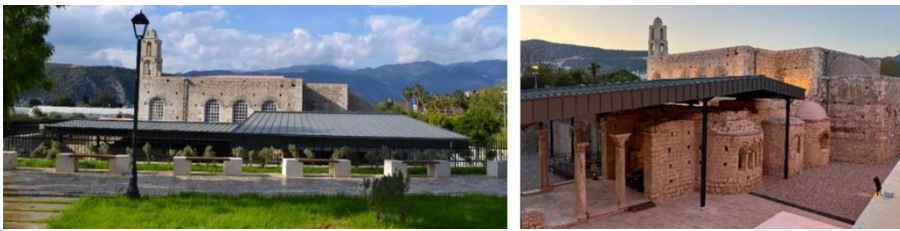
Figure 34. View of after the implementation (AMoCT-PR-4).

In regions characterized by elevated ground levels surrounding the parcel, drainage systems were systematically established along the contour lines and enclosed by rubble stone walls. Enhancements were made to the pre-existing water drainage wells and pumps adjacent to the church, both in terms of quantity and functionality. Furthermore, the restoration efforts incorporated the revival of the authentic Byzantine water channel located to the north of the church, seamlessly integrating it into the expanded drainage system (Figure 34).
