Evaluation on Accessibility in Historical Environments in Turkey: Ankara Ulus Environment Example

I. TBMM/ War of Independence Museum Accessibility Assessment

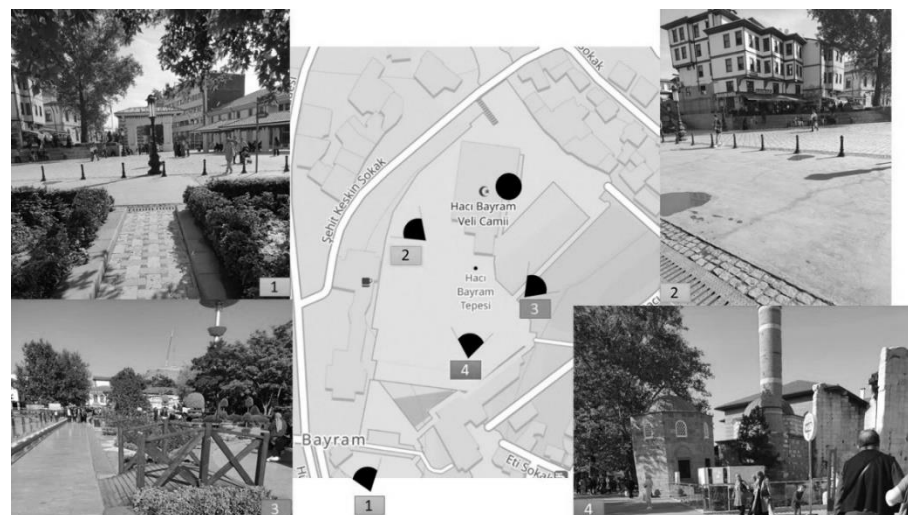
Figure 23. Hacı Bayram Veli Mosque and Surroundings

Problem: It has been observed that there is disabled parking and markings.
