A Comparative Analysis of the Change of Kula Traditional Turkish Housing Architecture in The Last 50 Years

Table 15. Comparative Analysis of Hocacılar House

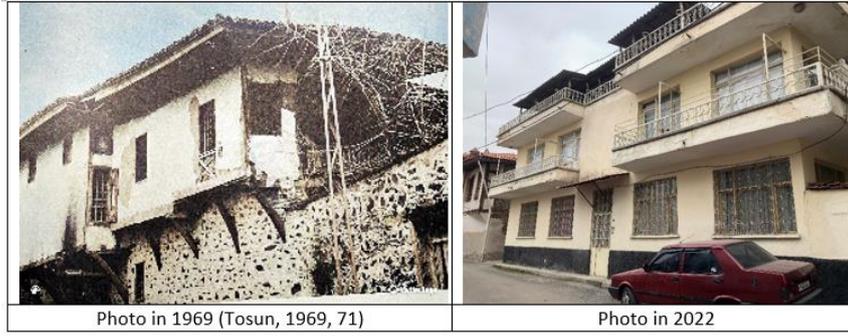
Table 21. Comparative Analysis of Hacı Yusuflar House

It was determined that the old two-storey house was demolished and a two-storey reinforced concrete building was built in its place (Table 21).

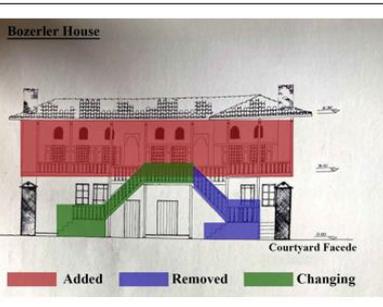
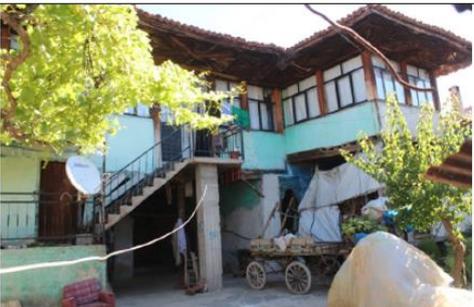
Table 24. Comparative Analysis of Bozerler House

When looking at the courtyard of Bozerler house, it is seen that life and the mansion connected to life are closed with walls. In addition, the right arm of the wooden two-armed staircase was canceled and rebuilt in reinforced concrete in the same place (Table 24).

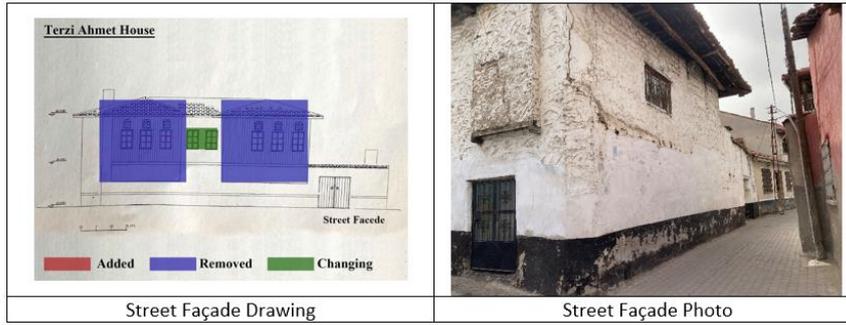
Table 25. Comparative Analysis of Terzi Ahmet House

The pavilion section and the bay window on the street front of the 'Terzi Ahmet' house have been removed. A straight wall was built instead of the bay window that was removed. A large window has been added to this wall. In addition, the windows on the surface next to the closed bay window were closed. The building is not used today and the inner courtyard could not be entered during the research. For this reason, the courtyard facade of the building could not be evaluated (Table 25).
