Research Article

# Restoration of the Greek Orthodox Churches at the End of the 19th Century in Istanbul: Case of Galatasaray Panagia Church

Ece Sönmez Pulat\*  
Deniz Mazlum\*\*

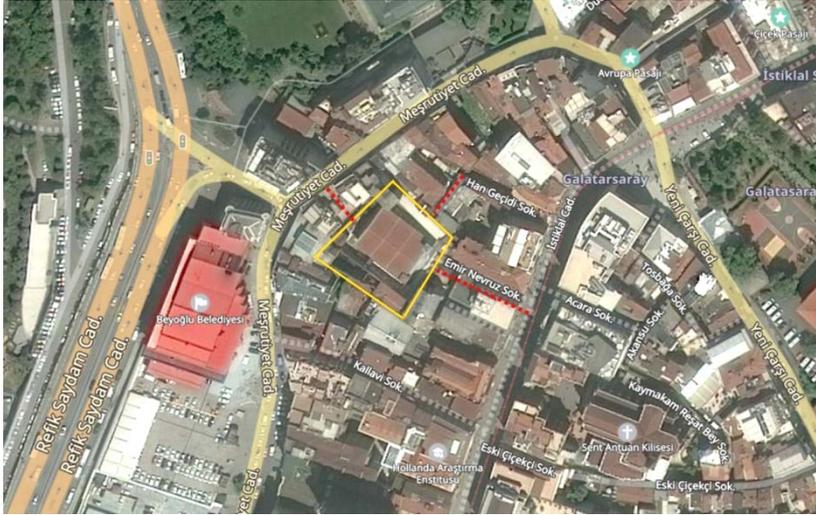
**Figure 2.** Entrances of Galatasaray Panagia Church. (Reproduced by the Sönmez Pulat based on <https://yandex.com.tr/harita> access date 10.11.2019).

The Greek community wanted to build a new church in Pera because the Greek-Orthodox churches were far from their neighborhood especially Galata. So, the church was constructed with the donations of the Greeks in Pera on the Hacopoulos's plot, which was blessed to the name of Hagia Panagia. The first stone of the foundation of the church was placed on June 26, 1804, by Dimitrios Shinas who was the translator of the Sublime Porte, Skarlatos Sevastopoulos, Yordanis Kaplanoğlu, Efstratios Petrokokkinos (Kalaycı, 2014, 495). Galatasaray Panagia Church (Ton Eisodion) had two entrances since it was constructed with the permission of the Ottoman state. One of the entrances was connected to Beyoğlu district whereas the other one was connected to Tepebaşı district where the Cemetery of Catholics was located (Hovhannesyan, 1996, 38). Today, the church is located in Beyoğlu District, Asmalı Mescit Neighborhood and it has three entrances (Fig.1). Main entrance is on Emir Nevruz Street and the other entrances are on Meşrutiyet Street and the Han Geçidi Street (Fig.2).

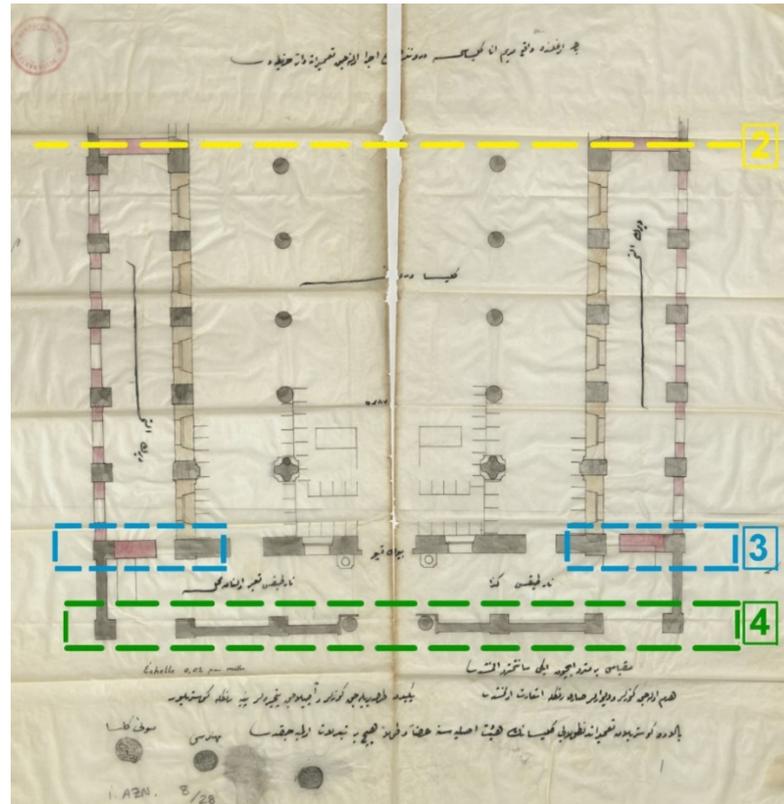
Figure 6. The document about the restoration of Galatasaray Panagia Church (BOA, İ.AZN. 8/28).

The plan drawings and cost estimation were attached to the document upon the request of the Patriarchate in 1893. The drawings prepared for the church are similar to the intervention sheet in the present-day understanding of conservation projects (Fig.6). These drawings were signed by the church trustee and engineer, thereby they were approved. The scale of the plan drawing is expressed as “Mikyas bir metro için iki santimetre alınmıştır” (the scale is 2 cm for 1 m) and there is a note as “échelle 0,02 par metre” on the drawing. These notes show that the scale of the drawing is 1/50. The drawing is in color and,

includes the following explanation: The walls to be demolished are represented in yellow, whereas the walls and windows to be reconstructed are represented in pink. There will not be any difference in the length and width of the church following the repair. The terminology used for the naming of the spaces is remarkable. For example, while “direk altı (literally beneath the posts)” indicates the semi-open portico, “narteks diye tabir olunan mahal (the space called as narteks)” is used for the narthex. “Kilise derunu (interior of the church)” is used to name the naos. The terms used for naming the spaces in the 19<sup>th</sup> century are almost the same with the present-day church terminology. Only, the parts that would be intervened are represented in the drawing, and the openings and wings of the doors are not shown. The main door on the west side is called “büyük kapu”, literally meaning the grand gate. Although the windows are drawn in detail to represent the existing situation, the doors and windows, which would be concealed within the walls because of the reconstruction, are not drawn. Only, some parts of the furnishing are represented, but there is no information about the floor coverings. In addition to the drawing, the table attached to the drawing is accepted as the first cost estimation that shows the construction materials and costs (Table 1).

There are some differences between the old drawing of the church, dated 1893, and present-day plan. One of the is indicated in yellow on the second axis in both drawings. Archival drawing indicates that the wall is constructed on the second axis (Fig.6), but at the present time, there is no wall on this axis. There is a wall on the first axis, shown in red on the plan (Fig.7). This wall is considered as a part of the original structure with respect to its thickness and the existence of the doorways.

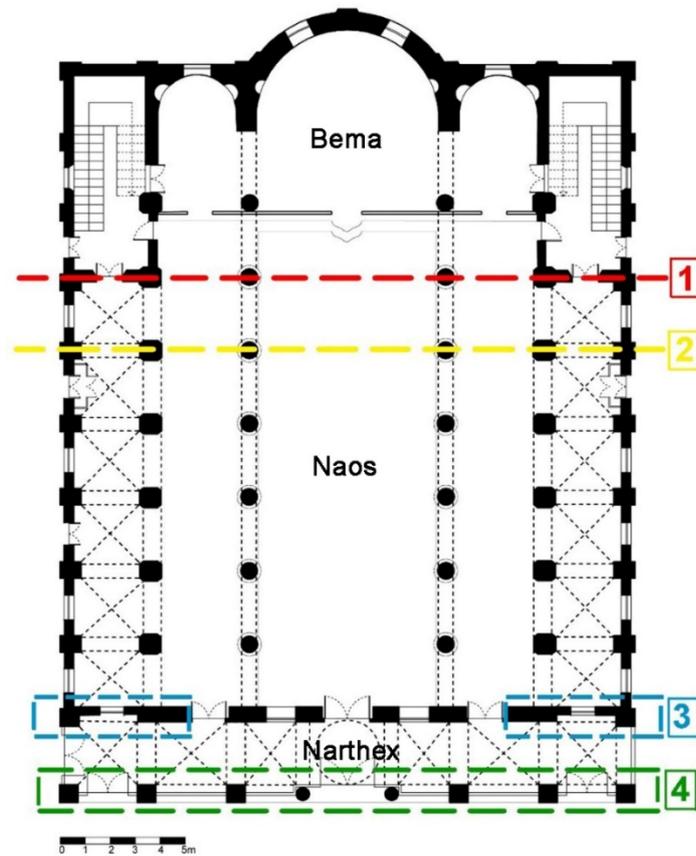
Figure 7. The present-day plan of Galatasaray Panagia Church (Reproduced by the author based on Karaca, 2008, 359).

Today, the church consist of a main naos, a narthex, a bema, a gynaecium and a bell tower. The church has a five-aisled basilica plan scheme on the east-west axis (Fig. 7). The columns and square shaped piers separate the aisles. The columns are made of oak wood and the thick mortar layer surrounding the wooden core. Therefore, the cross section of columns has become larger. There are two stairs on the east side of the church to reach the gynaecium section. The bema has three parts, the central apse is in the form of a half round on the east, and the others are straight. The pitched roof covers the naos, but the apse is covered by a flat roof. There is a bell tower on the east side and a bridge on the south side connecting the church to the priest house that is a later addition. The building has masonry structure and all facades are plastered and painted.

Even though, the plan drawing dated 1893 includes the windows within the newly constructed walls, three of these windows are being used as doors. It is not certain either the intended window openings turned into doors as a result of another intervention after 1893 or a different implementation of the first estimation. There is another difference between the present-day plan and the old drawing, and that is on the wall between the narthex and exterior naves. This observation is shown in blue in the Figure 6. This part was expressed as doors in the drawing dated 1893, but currently, there are windows instead of the doors (See blue part numbered as 3 in the Fig. 7). Lastly, the walls, which are drawn without the windows surrounding the narthex (See, green part numbered as 4, in Fig.7), may not exactly match with the current status depending on the elevation of the plan section.

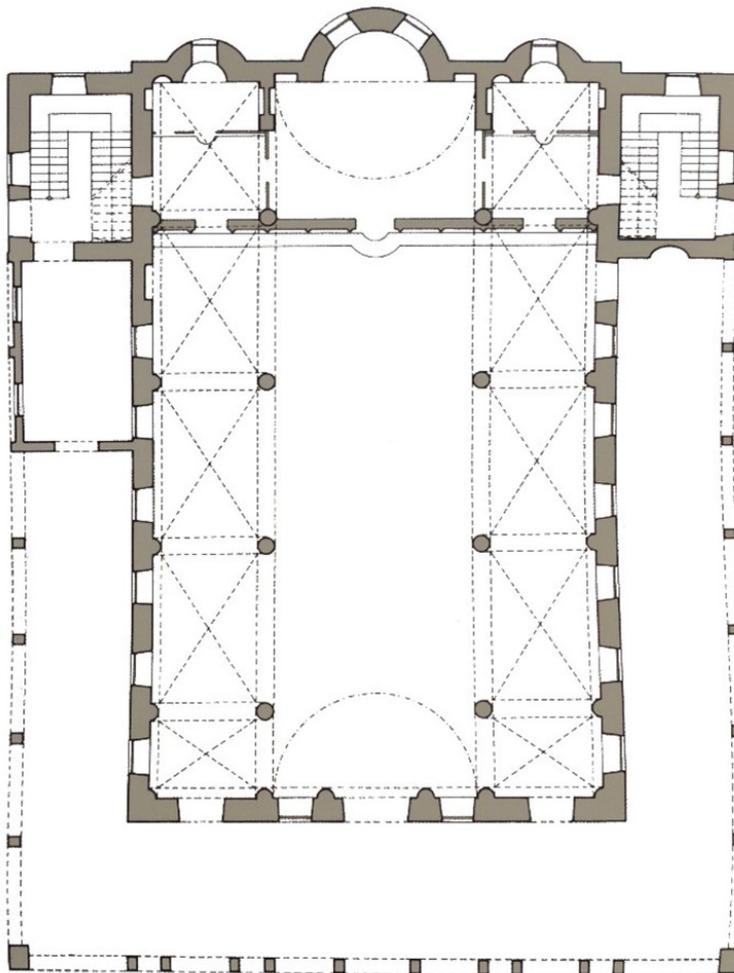
**Figure 8.** Büyükada Hagios Dimitri Church plan (Panagiotopoulou Mantopoulou et al., 2009, 22).

(women's gallery) and the staircase reaching to this space before the exterior naves (which was called as "*direk altı*" in the drawing of 1893) support the claim that the wall on the first axis is original. Hagios Dimitri Church in Büyükada, constructed in 1856, has the same plan scheme with the first Galatasaray Panagia Church (Fig.8, Fig 9). The church of Hagios Menas in Thessaloniki, built in 1852, is a three-aisled, wooden roofed basilica. It has a colonnade and a gynaeceum on three sides and a single, pitched roof (Fig. 10, Fig. 11) (Vamvoukou Kambouri, 1979, 32). All of these examples have semi-open porticoes on north, south and west side. In addition, these similar churches give information about the form of the Galatasaray Panagia Church before its restoration in 1894. It is obvious that west, north and south façades of the church were open spaces before the enlargement of the church. Then these spaces were included to the naos (Fig. 12). The first floor of the wall on north, south and west façades were constructed during the intervention in 1894 (Fig.13). Therefore, the naos space has expanded and became five-aisled.

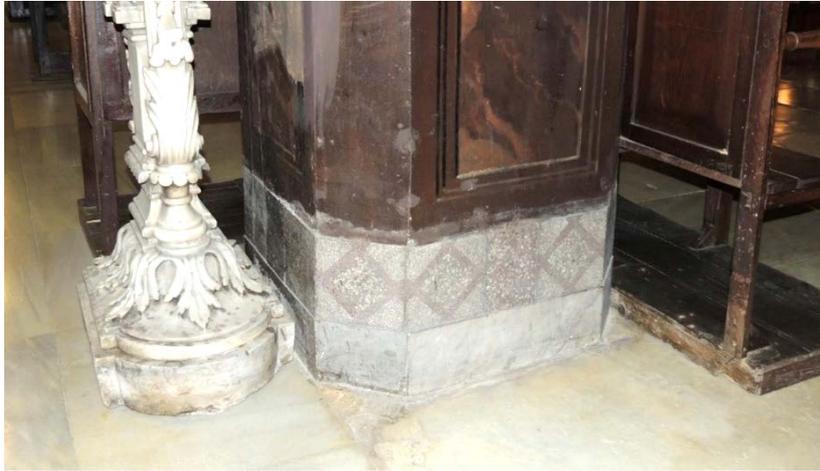
**Figure 17.** The red tiles used in the restoration of the church in 1894 (Sönmez Pulat, 2018).

The detailed material analysis of the church in terms of the kind, origin or peculiarity is not possible because the walls are plastered and painted in the present-day situation. However, it is still possible to identify some materials. For example, the marble floor coverings and red local tiles are clearly visible. These red tiles were used in the lower part of the square-shaped piers that remained from demolished walls (Fig.17). In addition, it is known that the red tiles had to be repaired based on the first cost

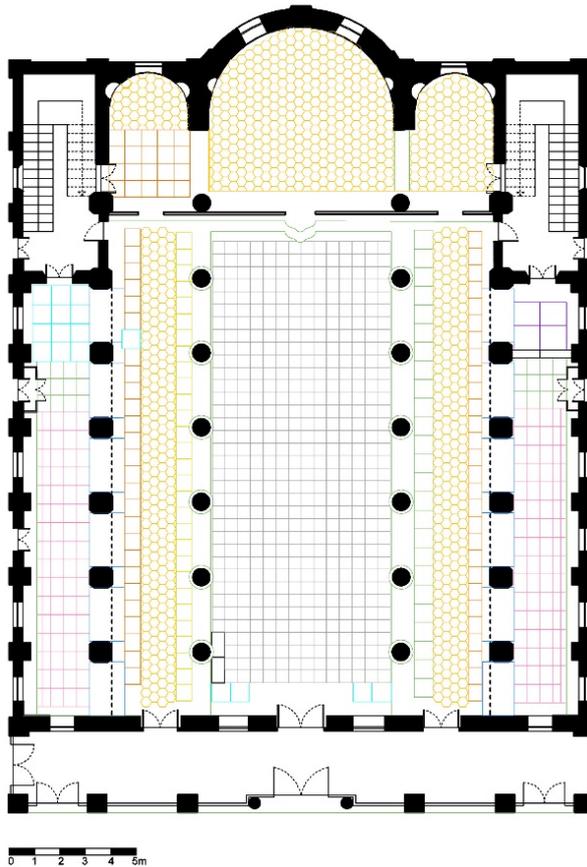
**Figure 18.** Plan of the church showing the floor coverings. (Reproduced by the author based on Karaca, 2008, 359).

estimation. Besides, the marble plates were purchased at different times according to the construction document found in the archive of the church foundation and this is related to the repair of the floor coverings. Still, there are different-sized marble plates in the church today (Fig.18).
